REPORT

AN ENGINEERING ASSESSMENT OF THE CURRENT STABILITY OF THE PILLAR MOUNTAIN SLIDE

KODIAK, ALASKA

November 20, 2013

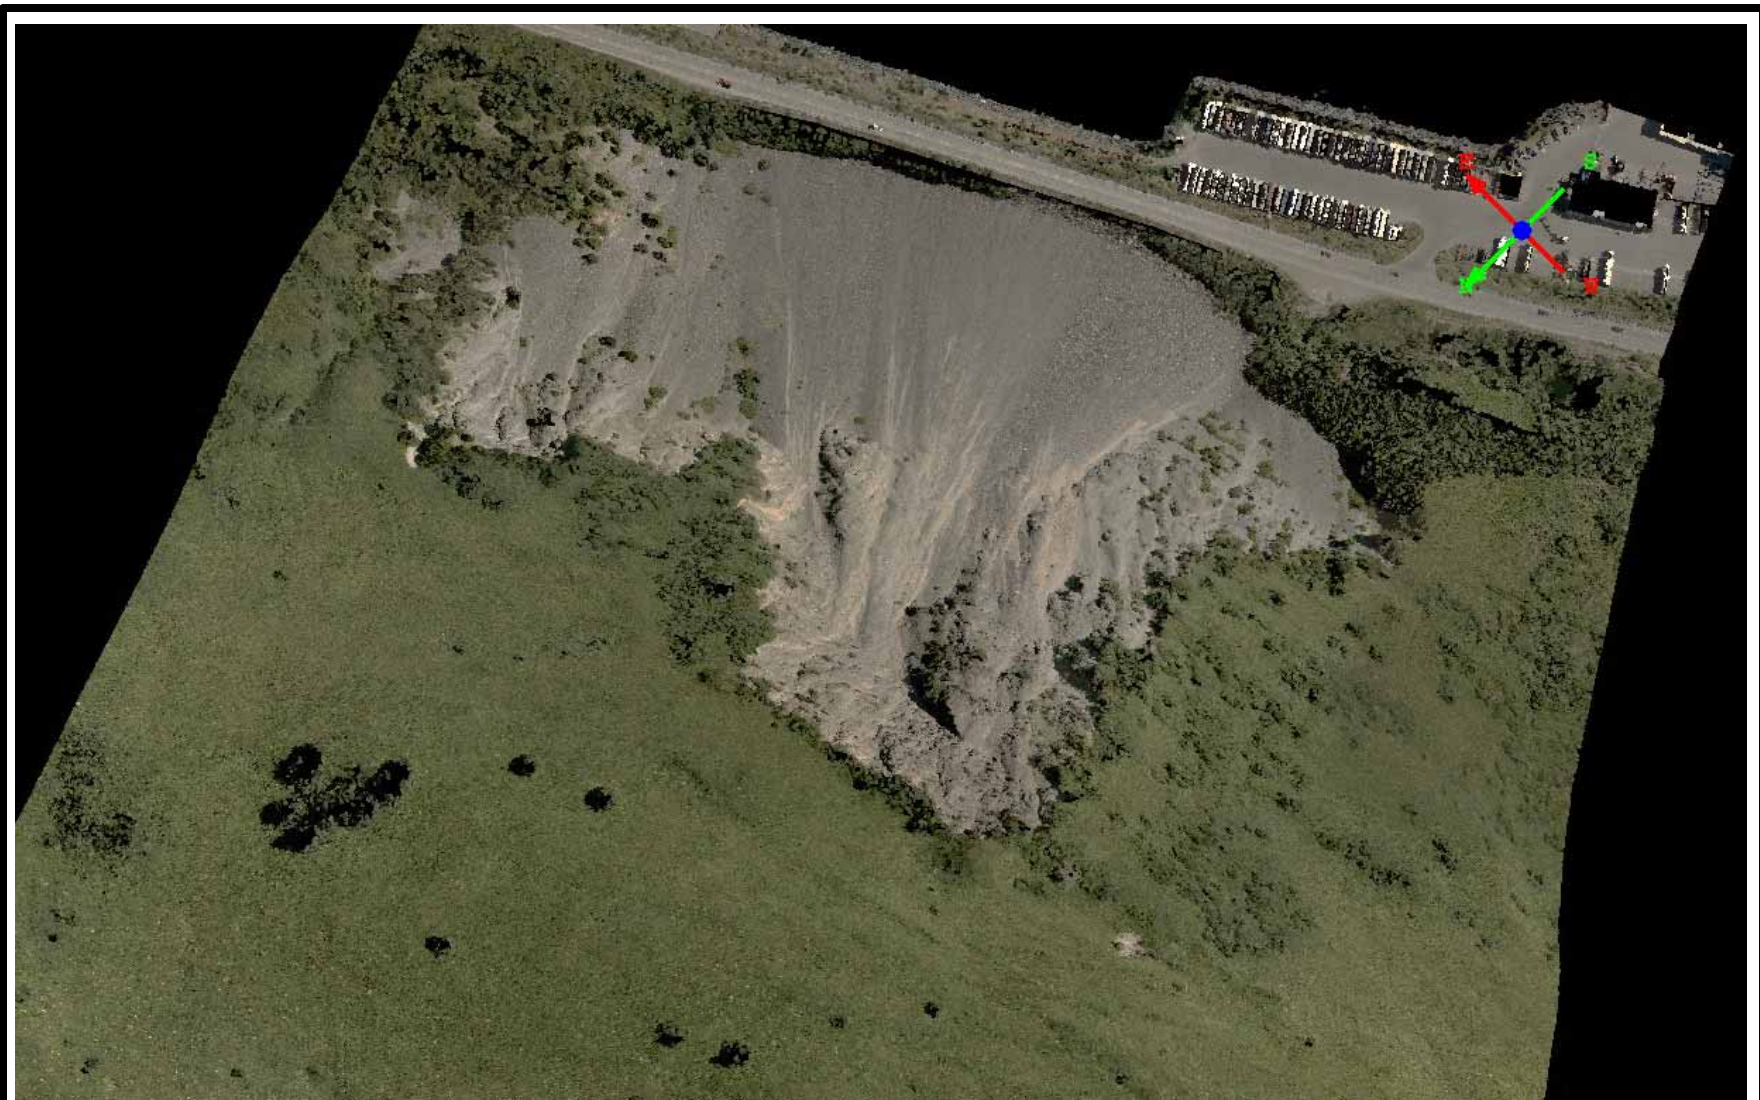
Figure 10
Project No.1300823

The slide area exhibited no significant changes from the conditions observed in 2002. Figure 9 shows a photograph taken in 2001. Figure 10 shows a similar view in LiDAR taken in 2013. Numerous photographs were taken on September 21, 2013. Several are presented as figures which are described as follows:

2013 LiDAR Image of the Slide

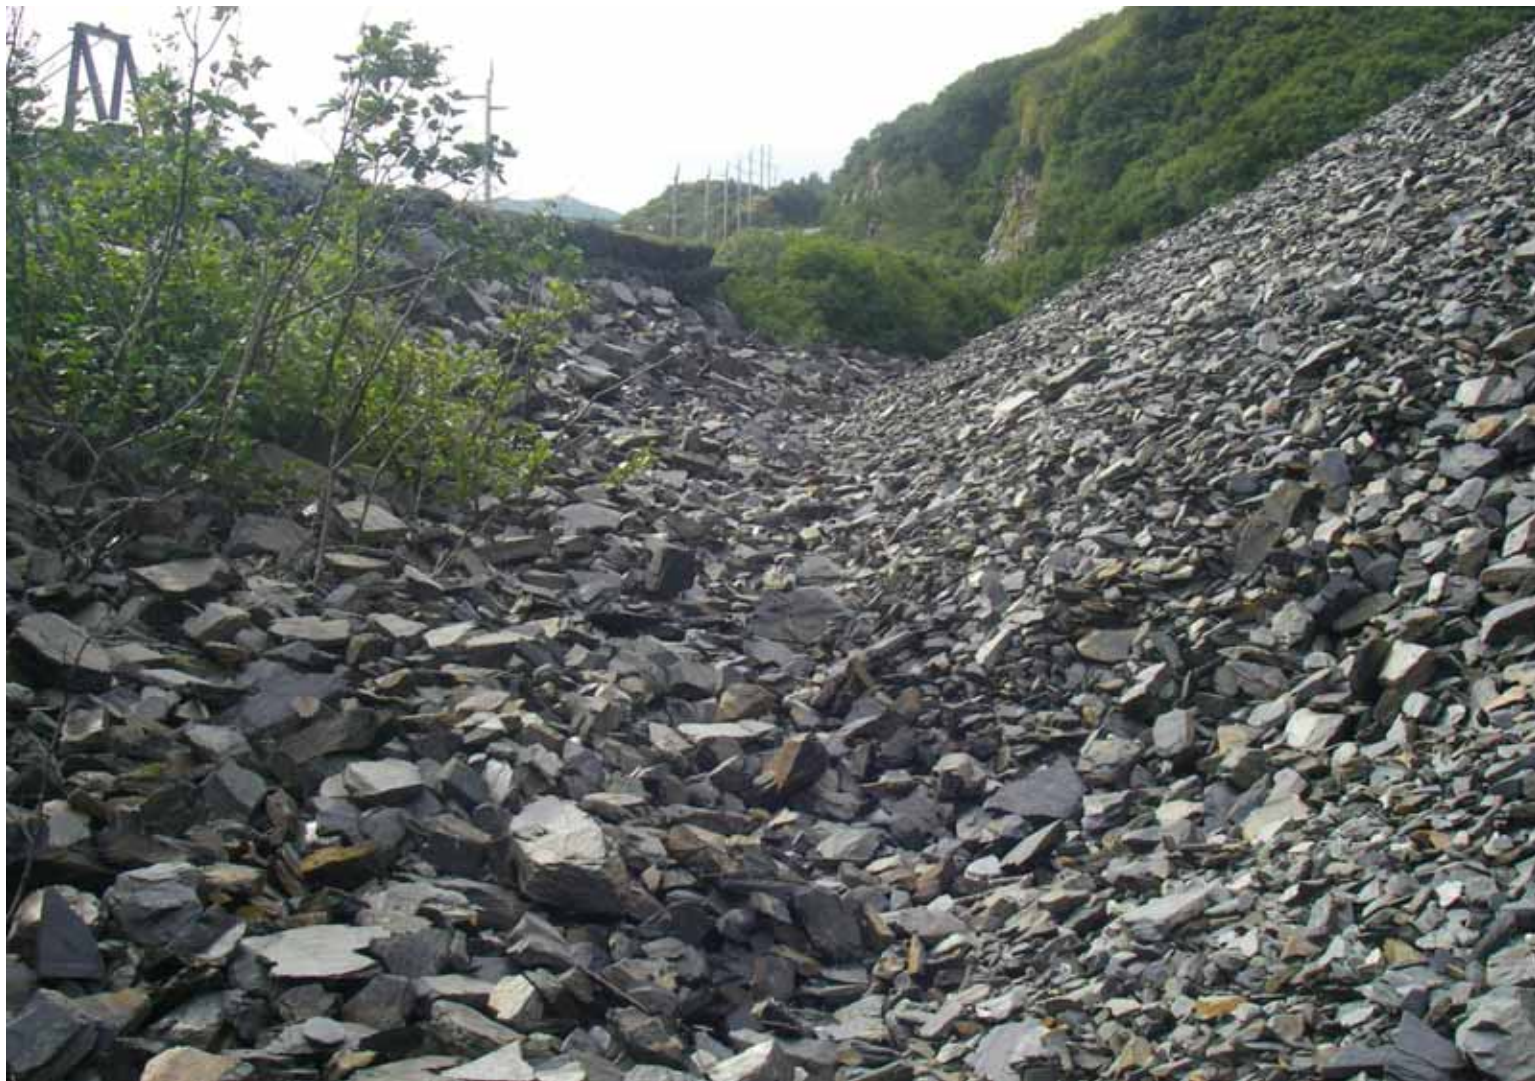
Figure 14
Project No.1300823

Toe of Talus Cone with Gabion Wall to the Left
(September 21, 2013)

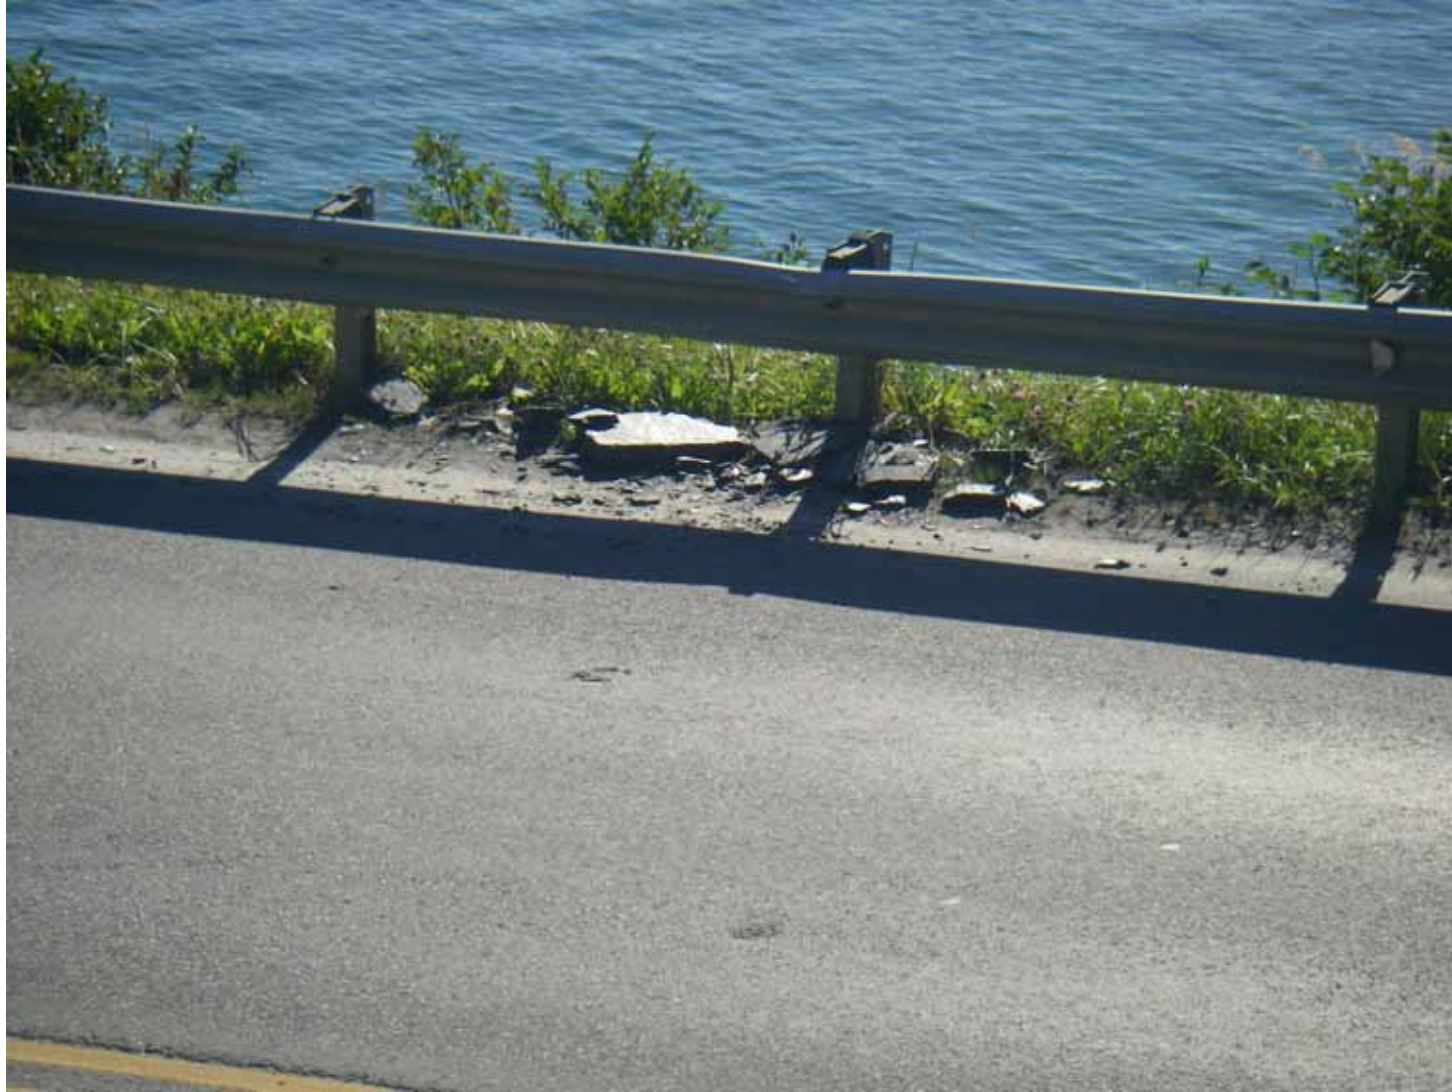
Figure 17
Project No.1300823

- Figures 16 and 18 show the condition of the gabion wall and the accumulation of talus behind it.
- Figure 17 shows impact craters in the highway pavement and talus under the guard rail across the highway from the gabion wall.
- Figures 19 through 22 show the rock structure in the head scarp above the talus slope.

Rockfall across Road and Impact Craters on Pavement
(September 21, 2013)

- The current gabion walls need maintenance including the following:
 - Removal of some of the talus that has piled up behind it.
 - Repair of the damaged baskets.

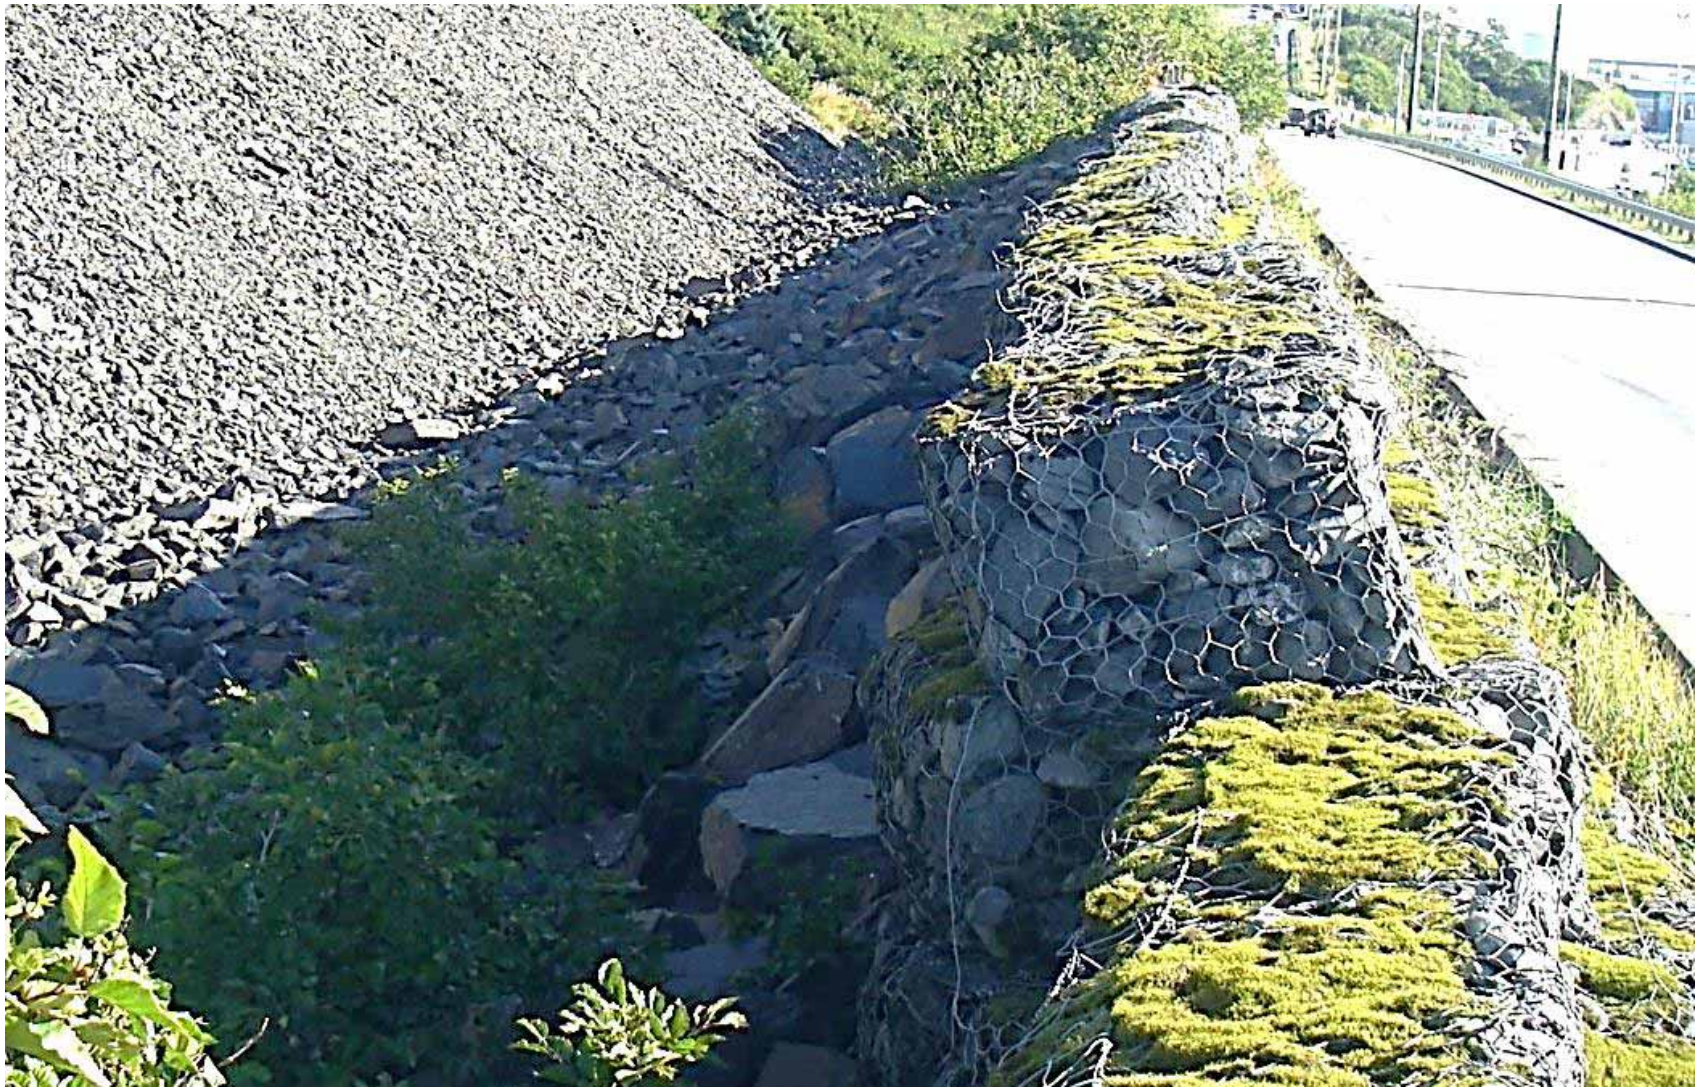
Figure 18
Project No.1300823

Larger Rocks Retained by Gabion Wall

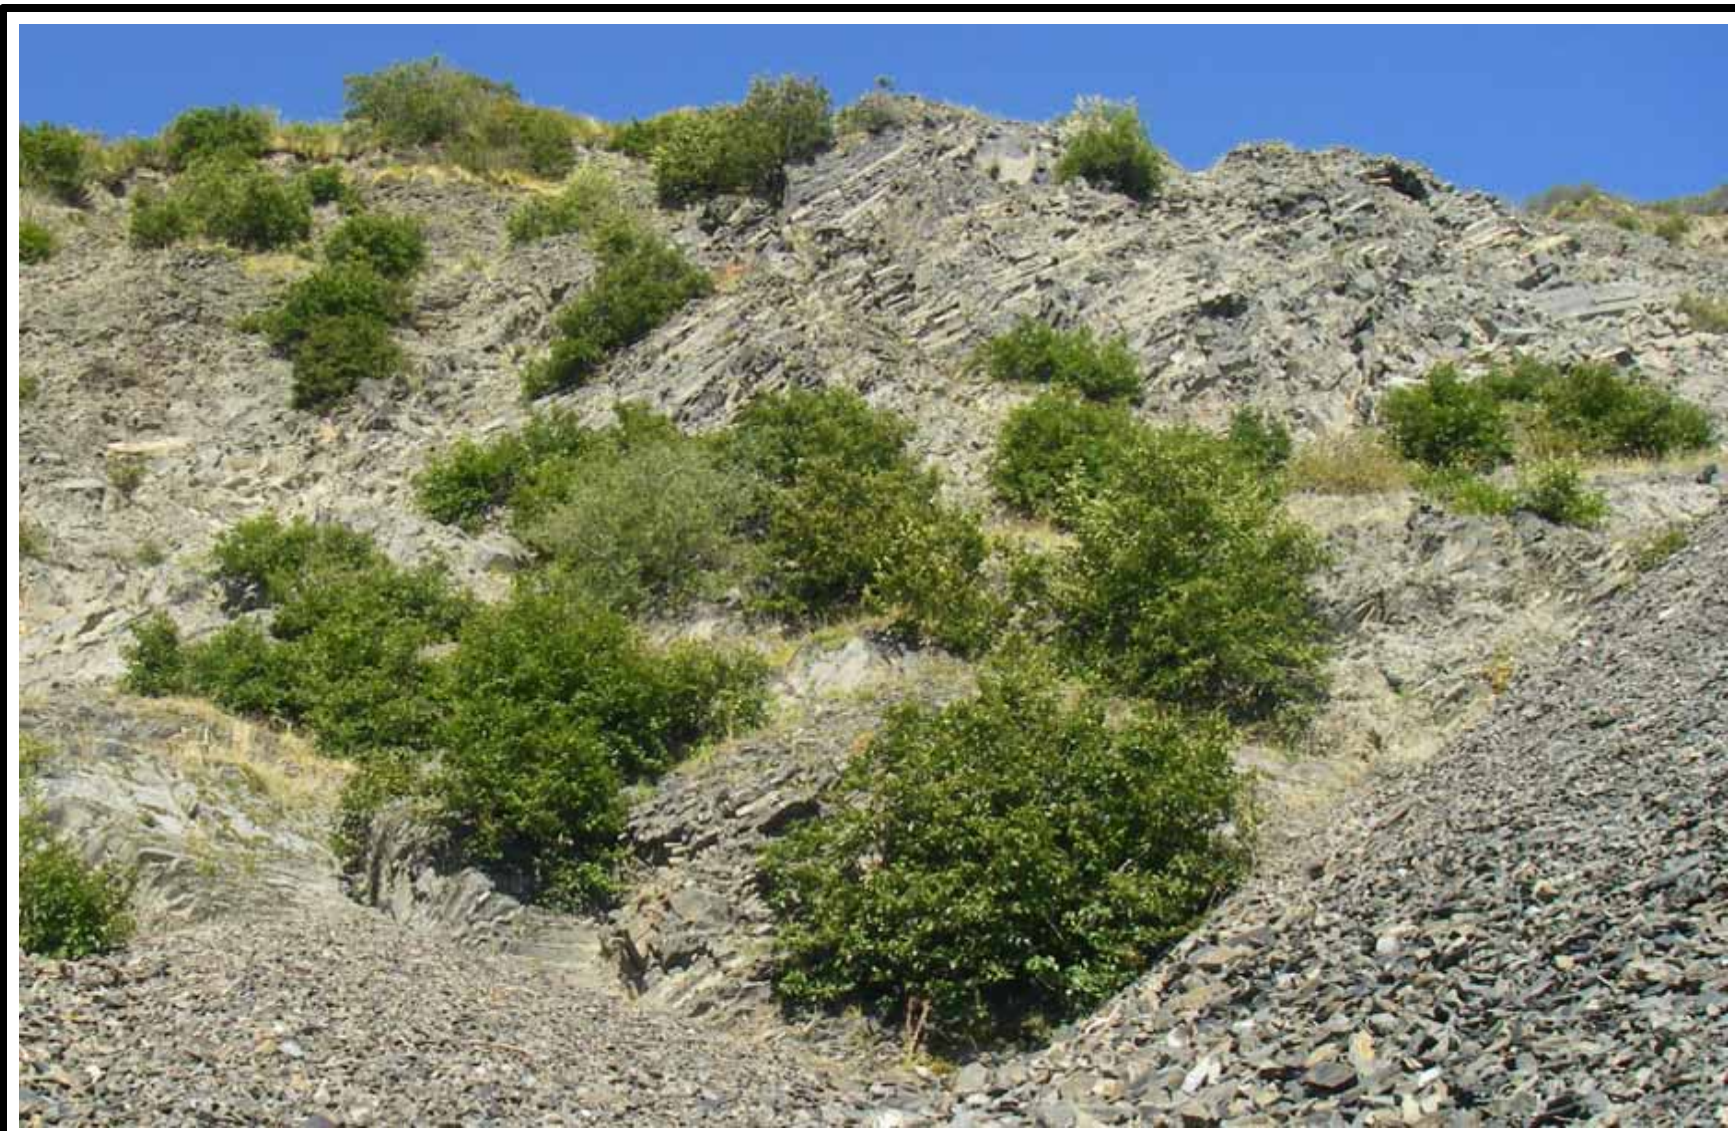
Figure 19
Project No.1300823

Typical Head Scarp Rock Structure

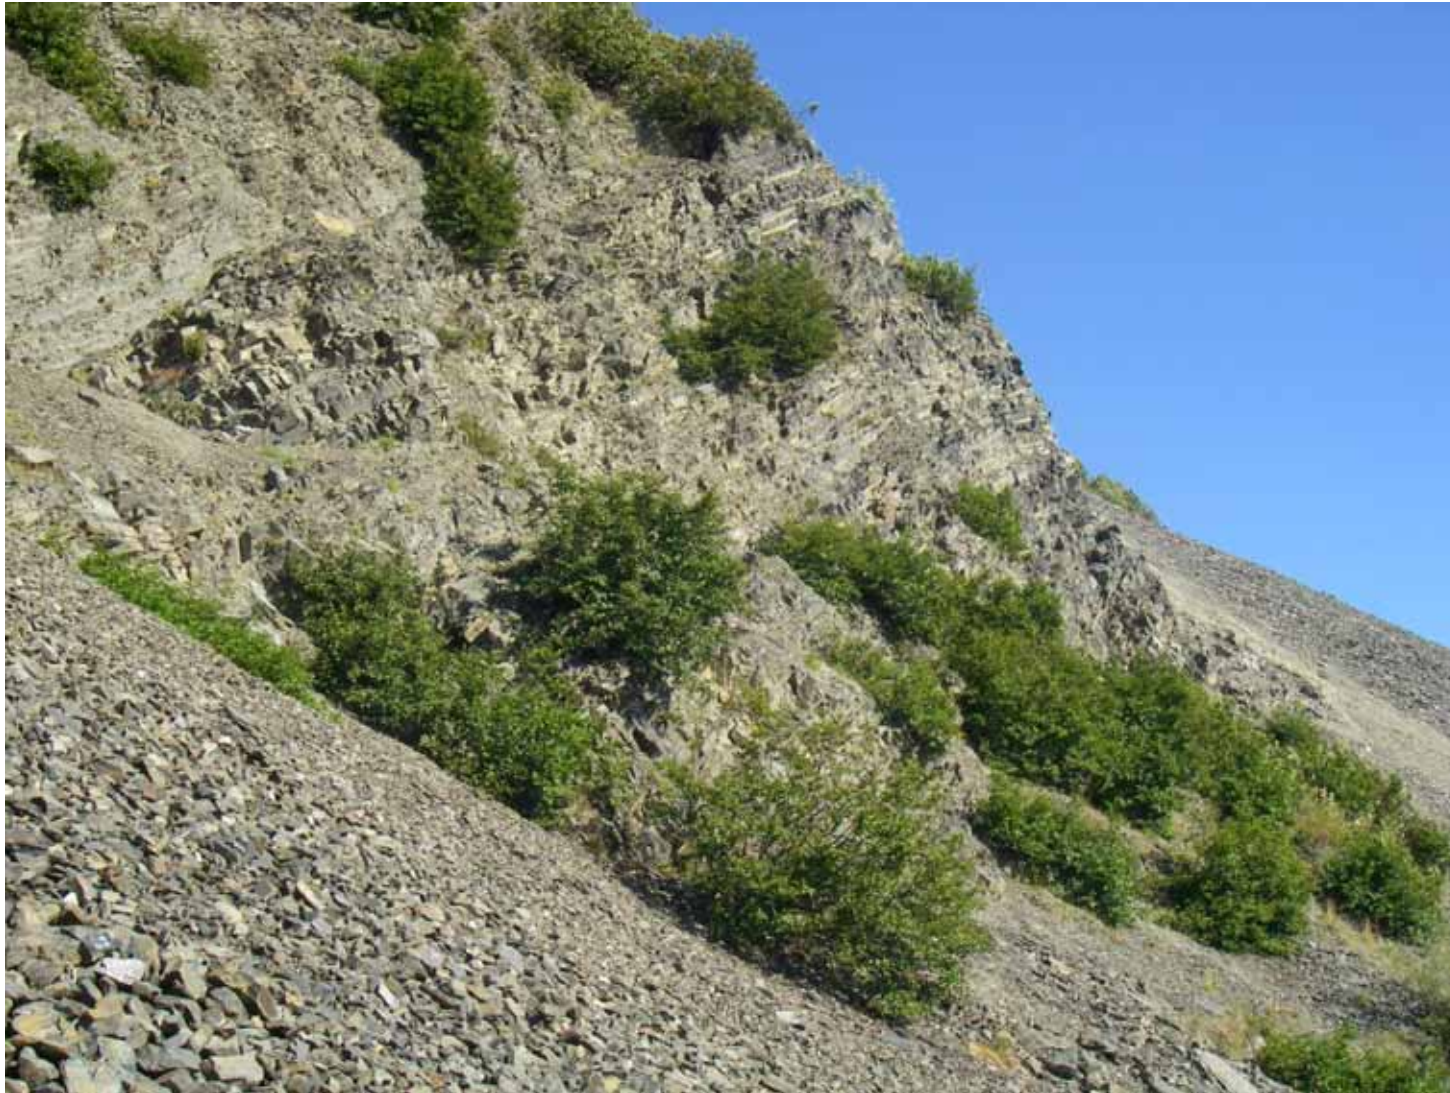
Figure 21
Project No.1300823

Cross Slope View of Head Scarp Rock Structure

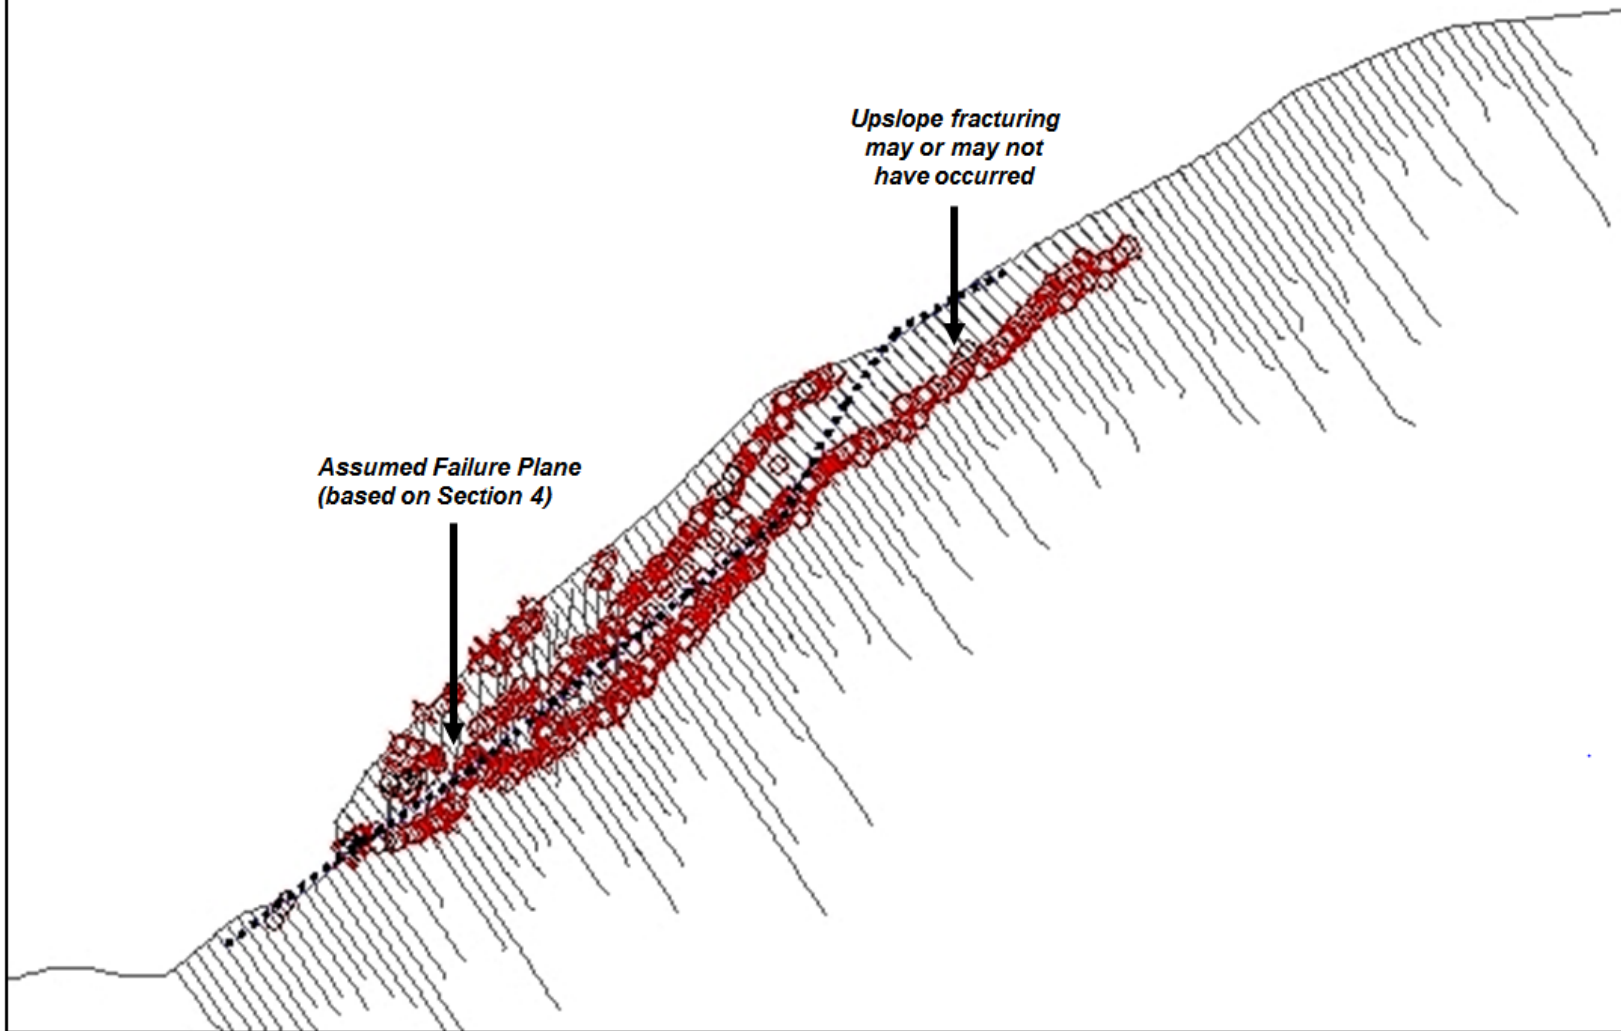
Figure 31
Project No.1300823

based on Cross Section 4 which runs through the 1971 failure. In the modeling, however, tensile fracturing developed independent of any pre-determined failure surface but comes close as is evident when compared to Cross-Section 4 in Figure 31.

The back analysis using these parameters indicates that the SSR of the Pillar Mountain slide is less than 1, for the failure volume shown in Figure 32. This indicates that the assumed strength parameters for the joint sets and continuum are fairly well calibrated and can be used in the validations of the failure mechanism and stability checks for the slide area in its current configuration. The model failure zone is indicated in the figure by calculated but not calibrated displacements which are presented as colors. This colored zone is used in this figure only to show the zone on the slope where movement was calculated above the tensile failure plane indicated in Figure 31.

Model Tensile Fracturing and Section 6 on Total Slope Profile

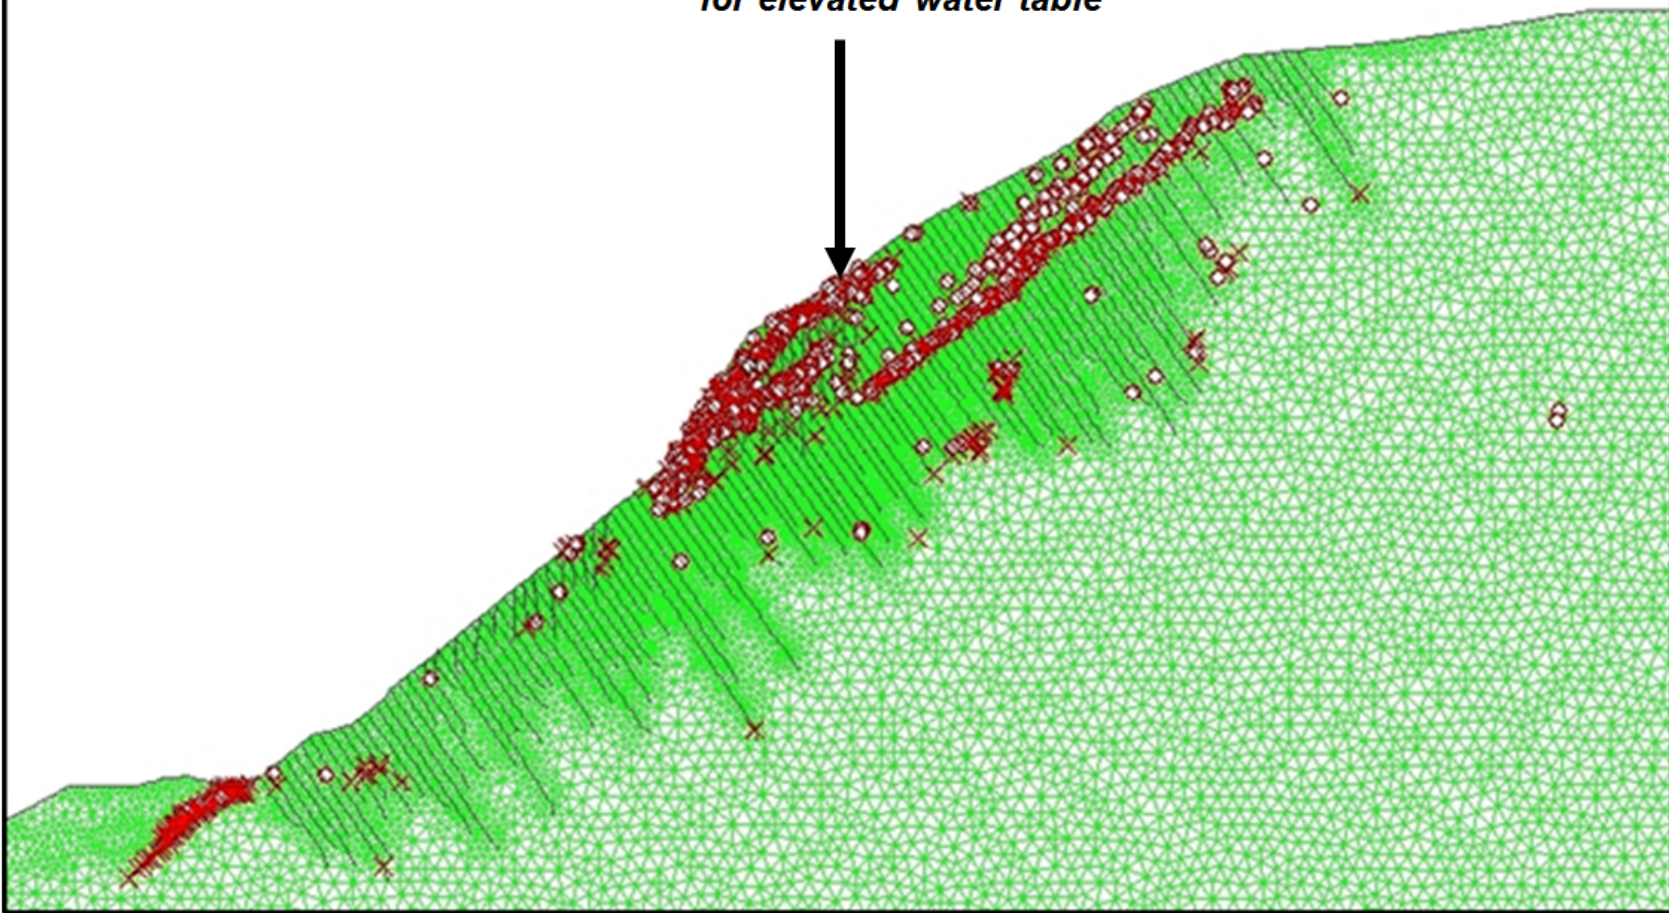
Figure 37
Project No.1300823

*Tensile fractures coalesce at
SSR iteration $1.0 < SSR < 1.3$
for elevated water table*

Tensile Fracturing/Yielded Element Progression to Failure (5 of 5) for Over Steepened Section 4

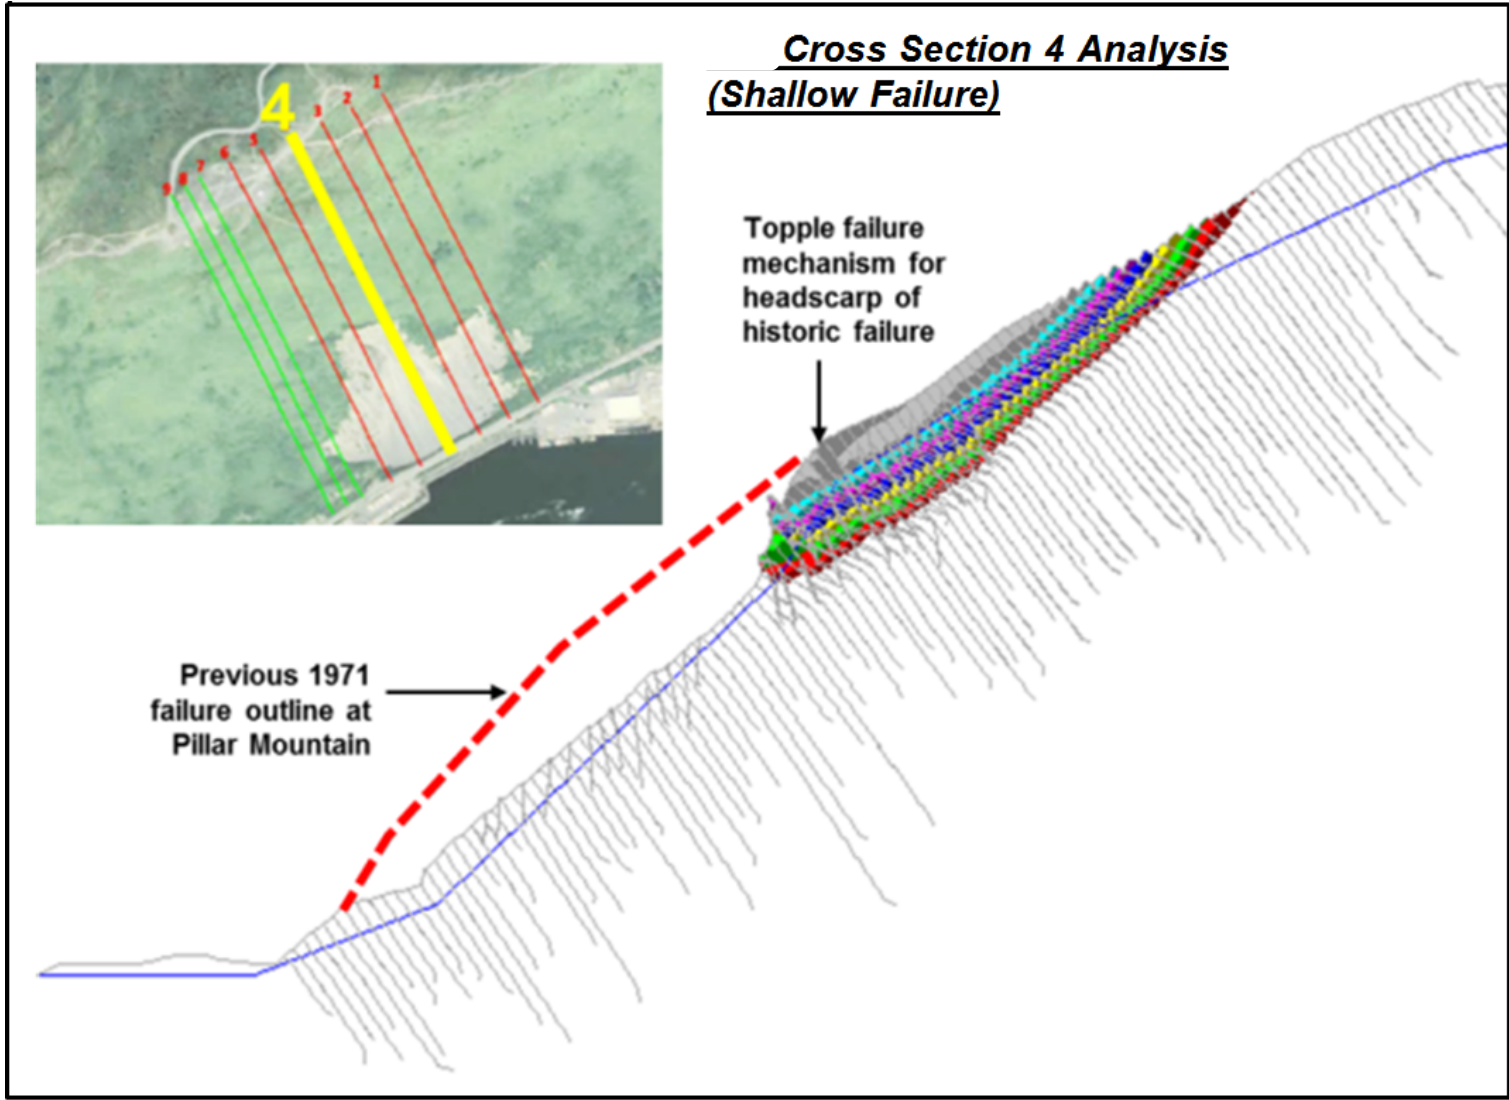
In order for the deep-seated failure to occur (See Figures 39 and 40.), shear fracturing would need to develop through the confined rock mass for a failure plane to develop. The modeling shows that the strength parameters would need to be reduced by a factor of at least 1.5 compared to the initial properties assumed from the back analysis and an elevated water table would need to be present for this type of failure to be feasible. This process was completed for both Section 1 and Section 4 for the elevated water table, the typical water table, and the typical water table with a 0.2g seismic Kh coefficient applied in the horizontal direction.

It is evident from Figures 39 and 40 that the size of failure is much larger and that failure initiates by crushing of rock at the toe of slope, extending upward in a circular-type failure mode. Shear fracturing is indicated by the red “x’s” in Figure 39 and the overall global failure magnitude is provided in Figure 40.

Cross Section 4 Analysis
(Global Failure)

For Global Failure
Crushing required at toe
for a SSR parameter
reduction of 1.5
(unlikely)

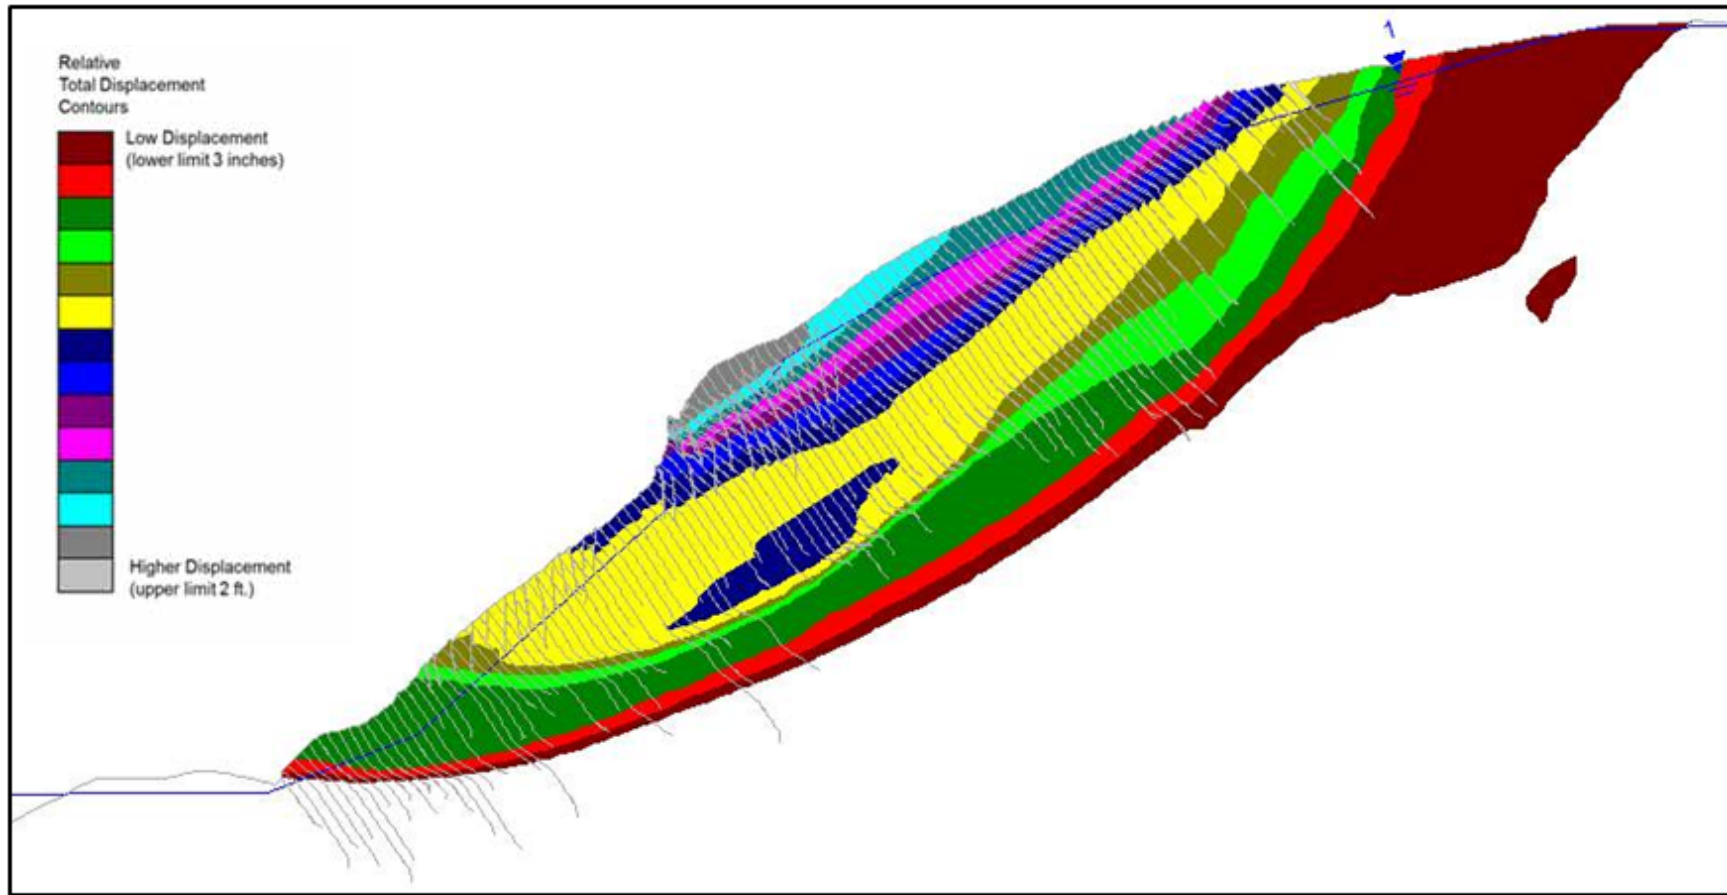
Figure 40
 Project No.1300823

Calculated Displacement Contours for Cross Section 4
 (color contours shown only to indicate total failure zone)
