**Phase I Environmental Site Assessment
(ASTM E 1527-13)**

16 August 2022

**Kodiak Fire Station Development
1240 Mill Bay Road
Kodiak, Alaska**

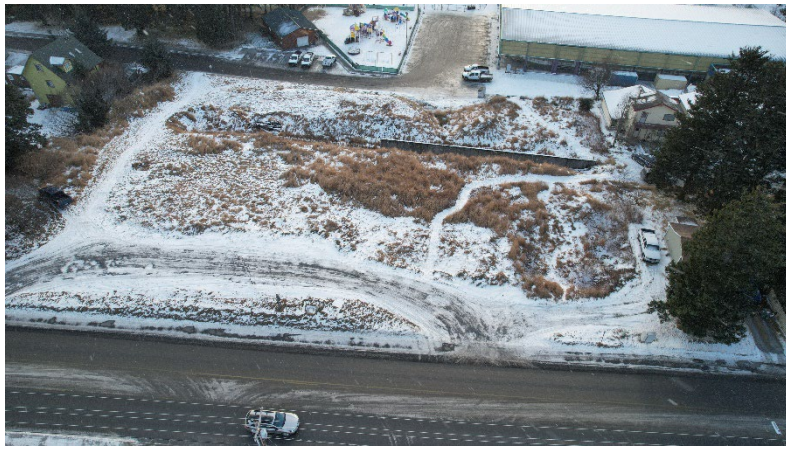
Photograph No. 1

Low altitude aerial image from the northwest edge of the property. Mill Bay Road in the foreground. Baranof Park at top.

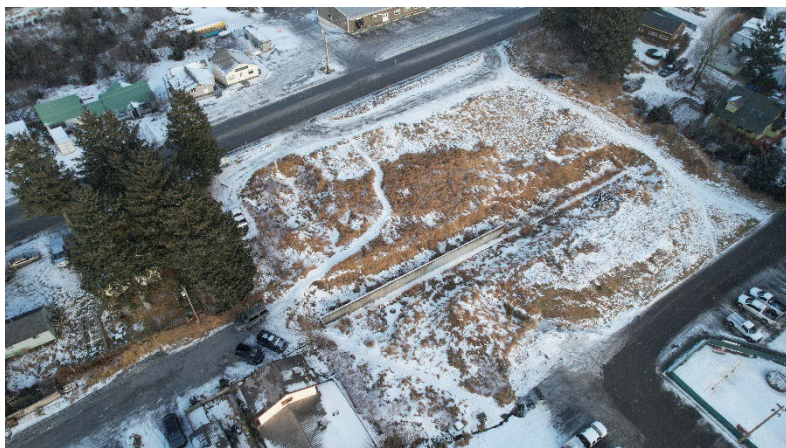
Photograph No. 2

Low altitude aerial image from the southernmost corner of the property. Pathing indicative of unrestricted access.

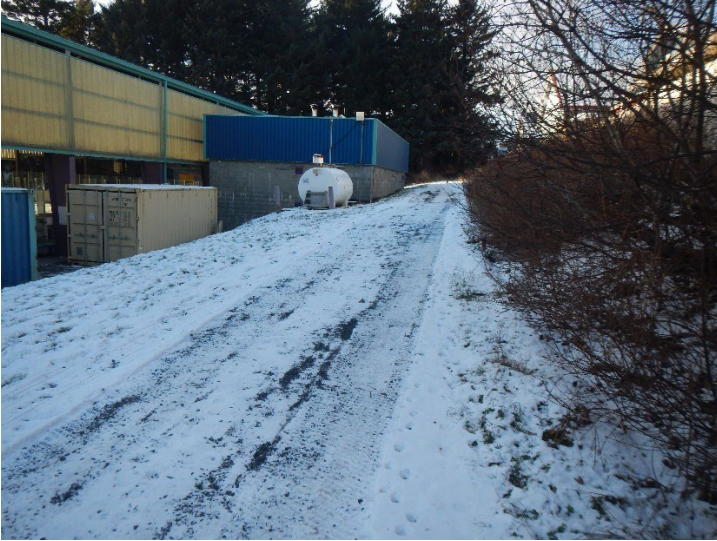
Photograph No. 4

Aboveground storage tank at Baranof Park Ice Rink near the southern corner of the target property.

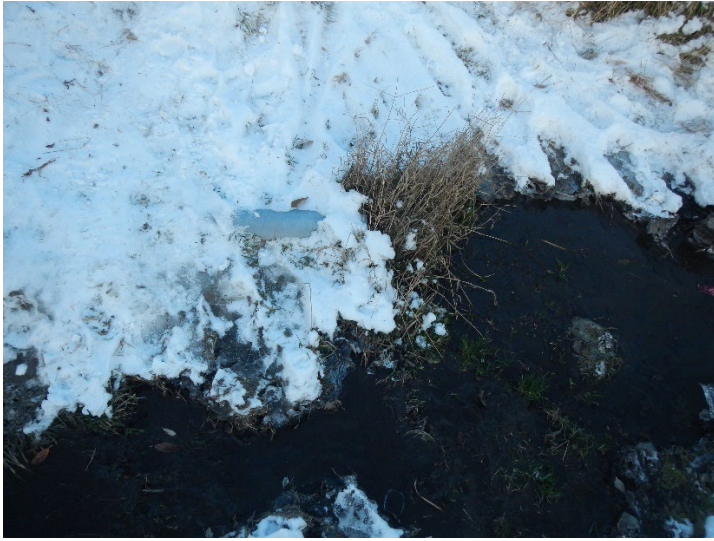
Photograph No. 6

Ponding at the southeast edge of the property. Container of unknown (frozen) substance, likely water ice.

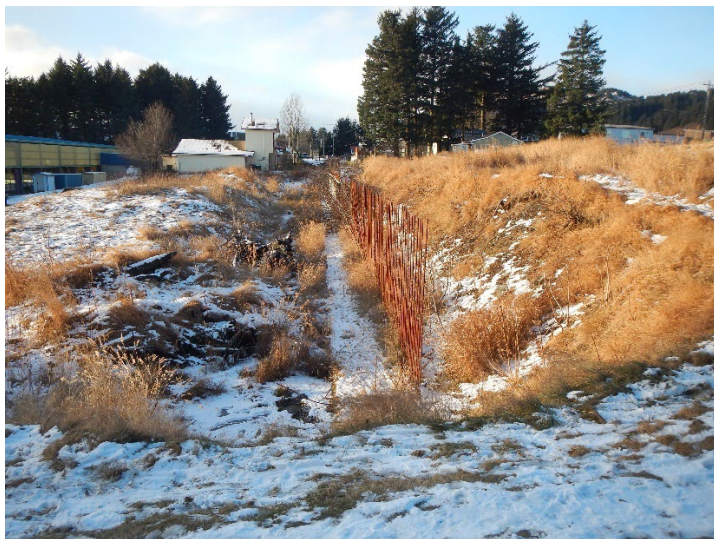
Photograph No. 7

Unfinished retaining wall from northeast end looking southwest. Ponding in trench.

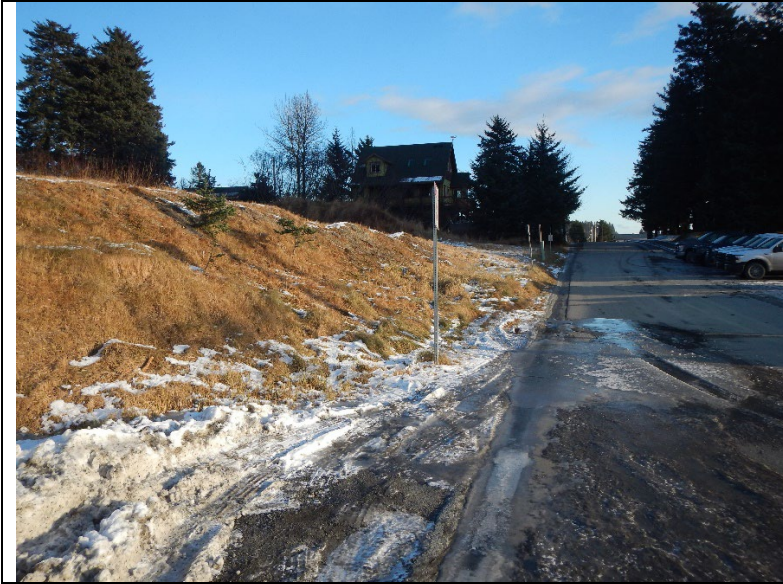
Photograph No. 9

Downgradient runoff accumulation and storm drain at southern edge of the target property along Chichenoff Street. Photo taken looking northeast.
