## **KODIAK STORM DRAIN INSPECTION REPORT**

**PREPARED FOR DOWL HKM**

**KODIAK, AK**

Inspection Date(s): February 12-13, 2014

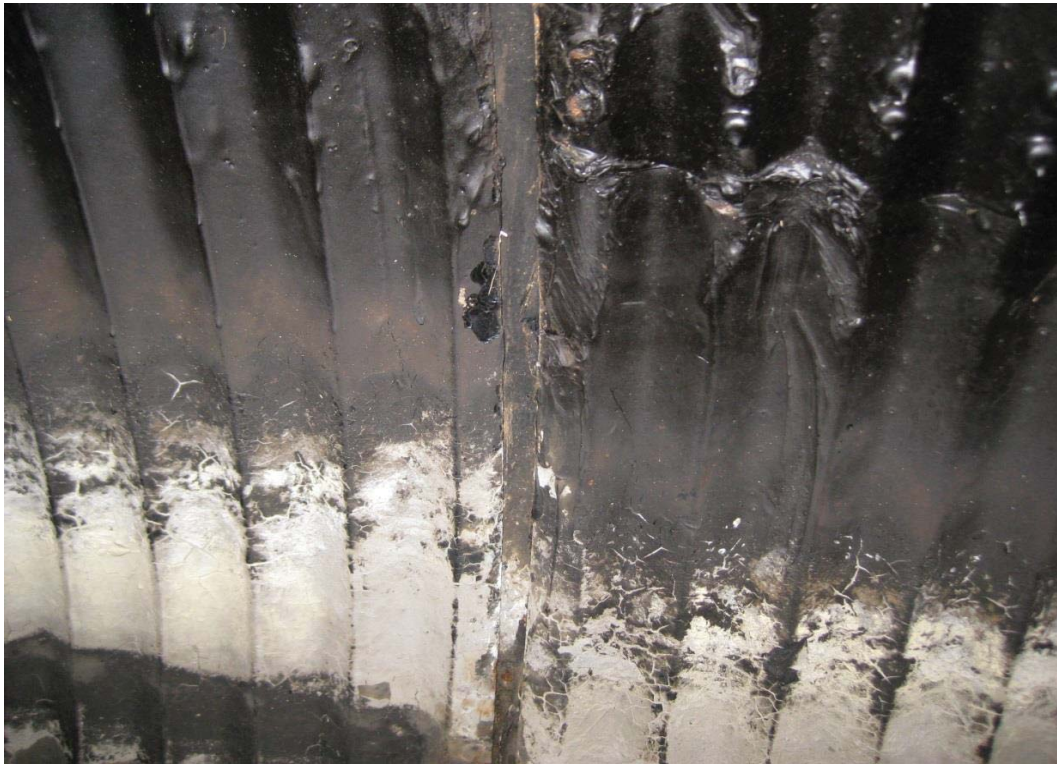
Photo 1

Drain A - 9'  
Seam at 9 o'clock with gap to 1".

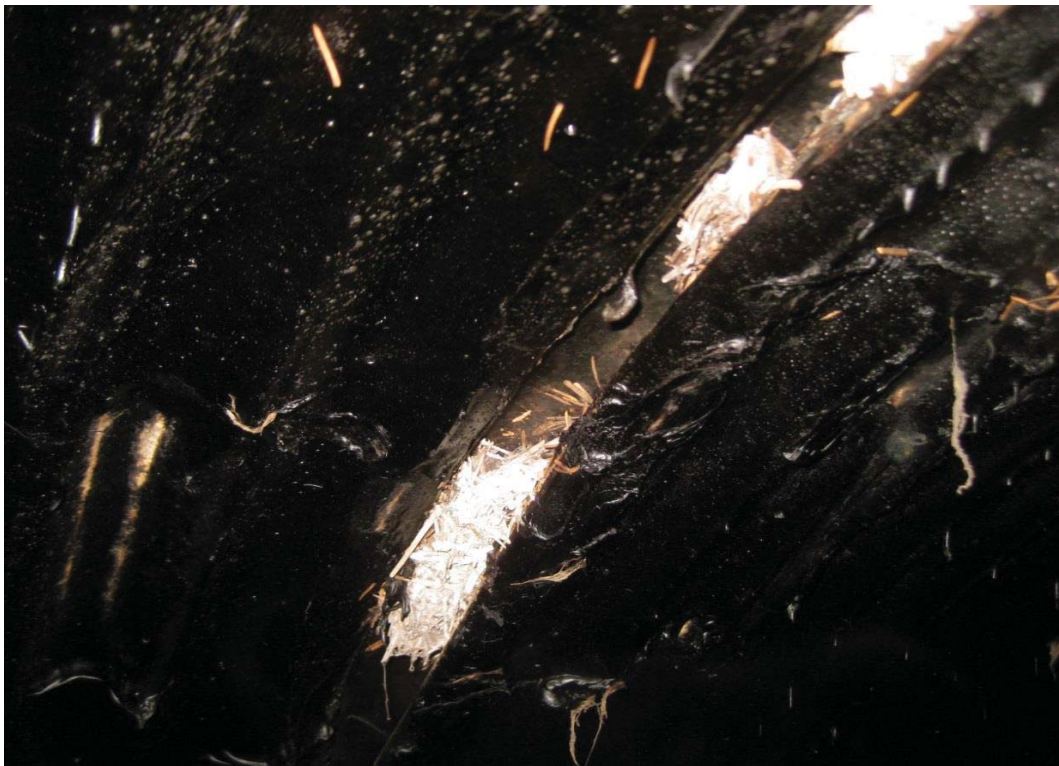
Photo 3

Drain A - 40'

Seam at 3 o'clock with gap to 1-1/4" and offset of 1". No corrosion.

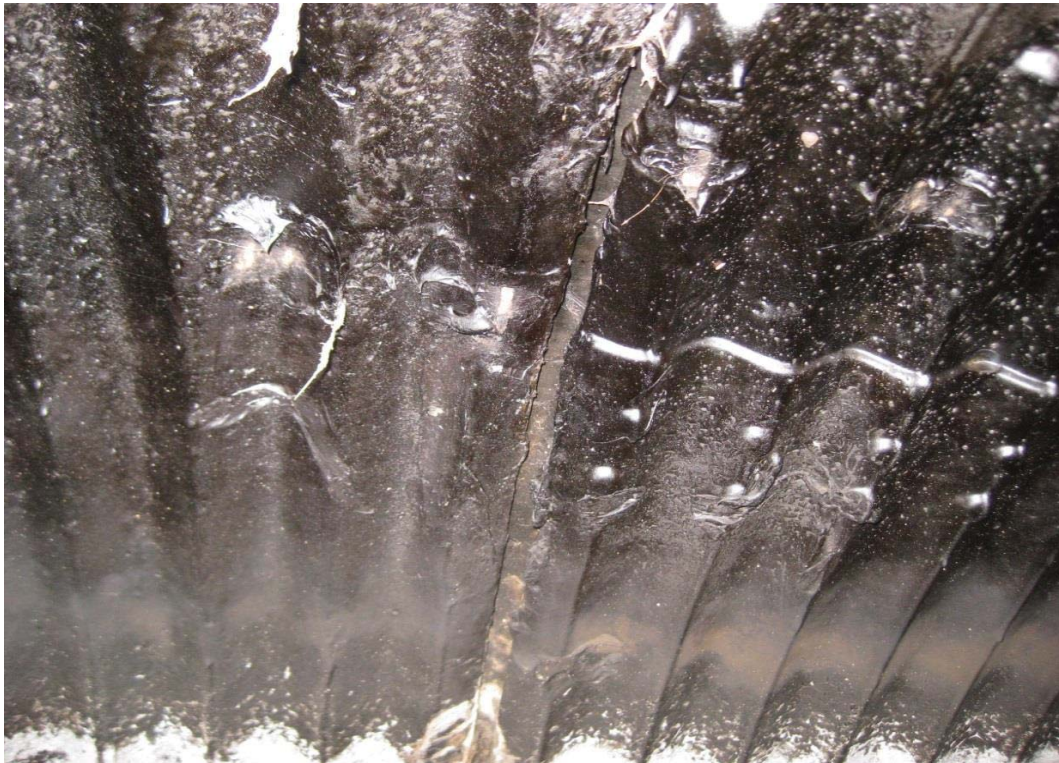
Photo 4

Drain A - 69'

Seam at 3 o'clock with gap to 3/4" and offset of 1/2". No corrosion.

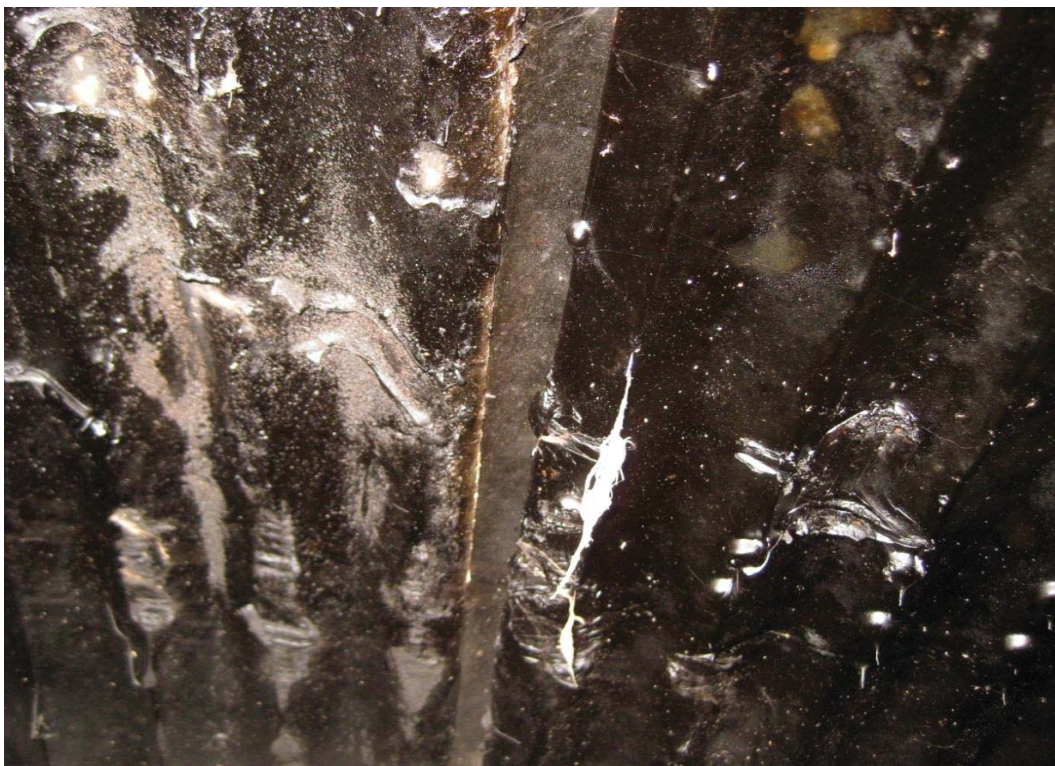
Photo 5

Drain A - 92'  
Seam at 9 o'clock with gap to 1-1/4". No corrosion or offset.

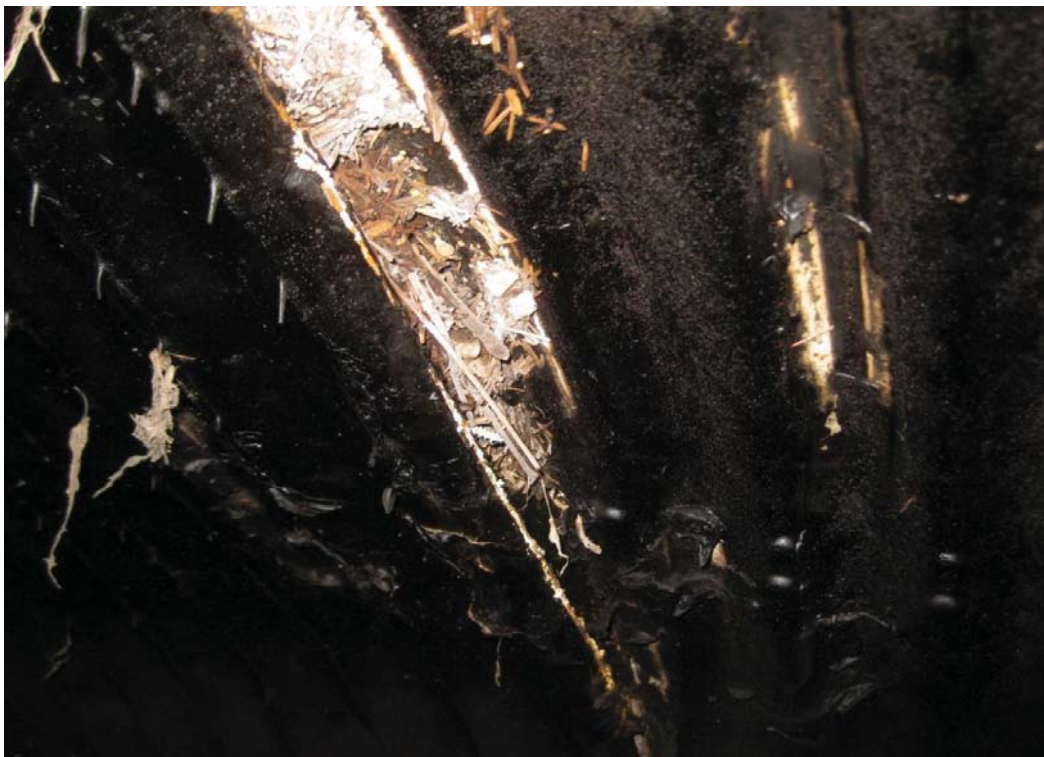
Photo 6

Drain A - 113'  
Seam at 9 o'clock with gap to 1/2" and offset of 1-1/2". Minor corrosion on edge.

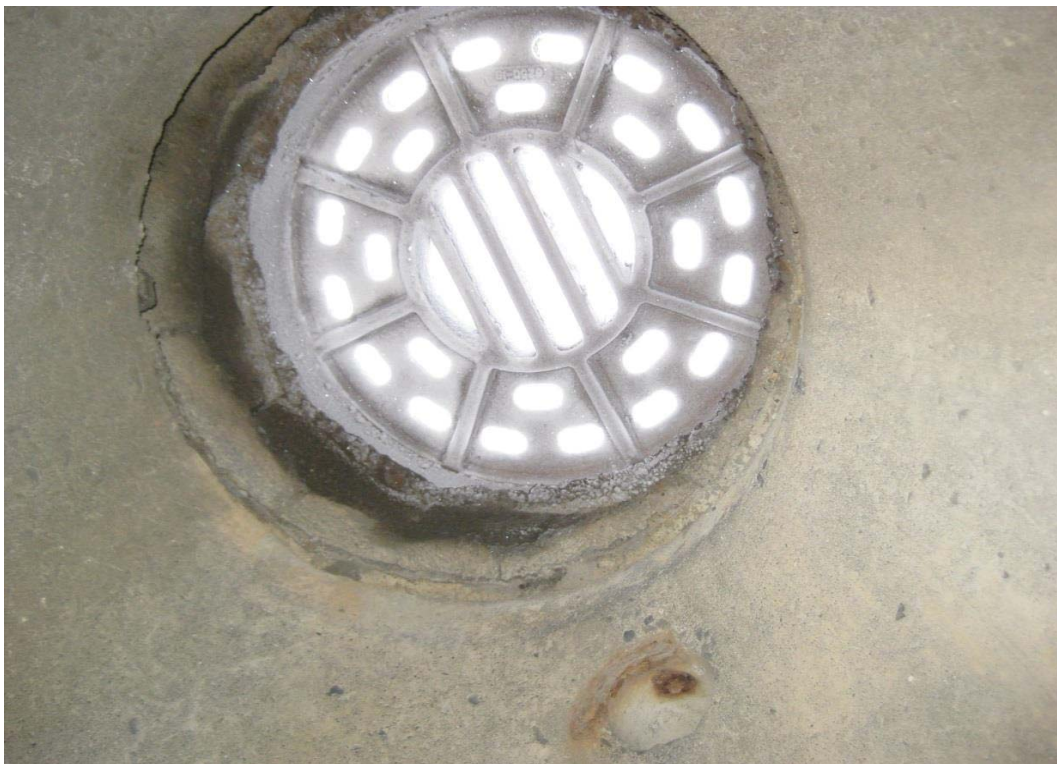
Photo 8

View of 12 o'clock position. 46" torch cut hole with moderate surface rust on the edges. View is looking up at cast iron manhole cover. This manhole is at the bend in the drain. No significant deficiency.

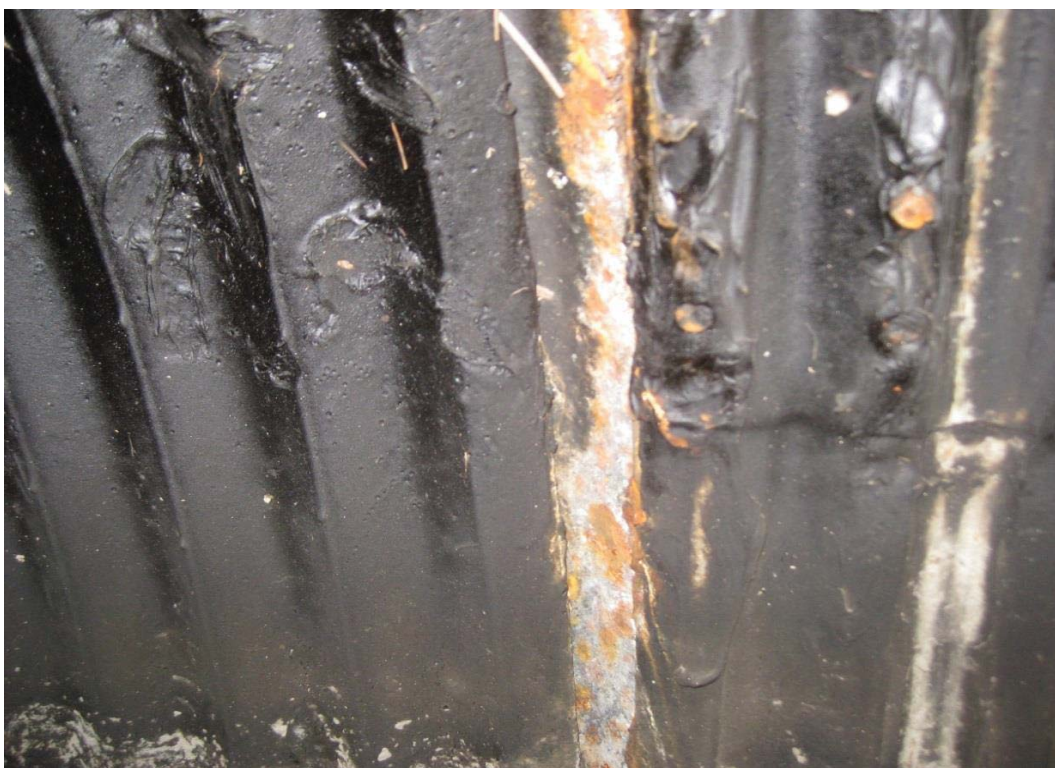
Photo 9

Drain A - 139'  
 Seam at 3 o'clock with gap to 2" and offset up to 1". Moderate corrosion.

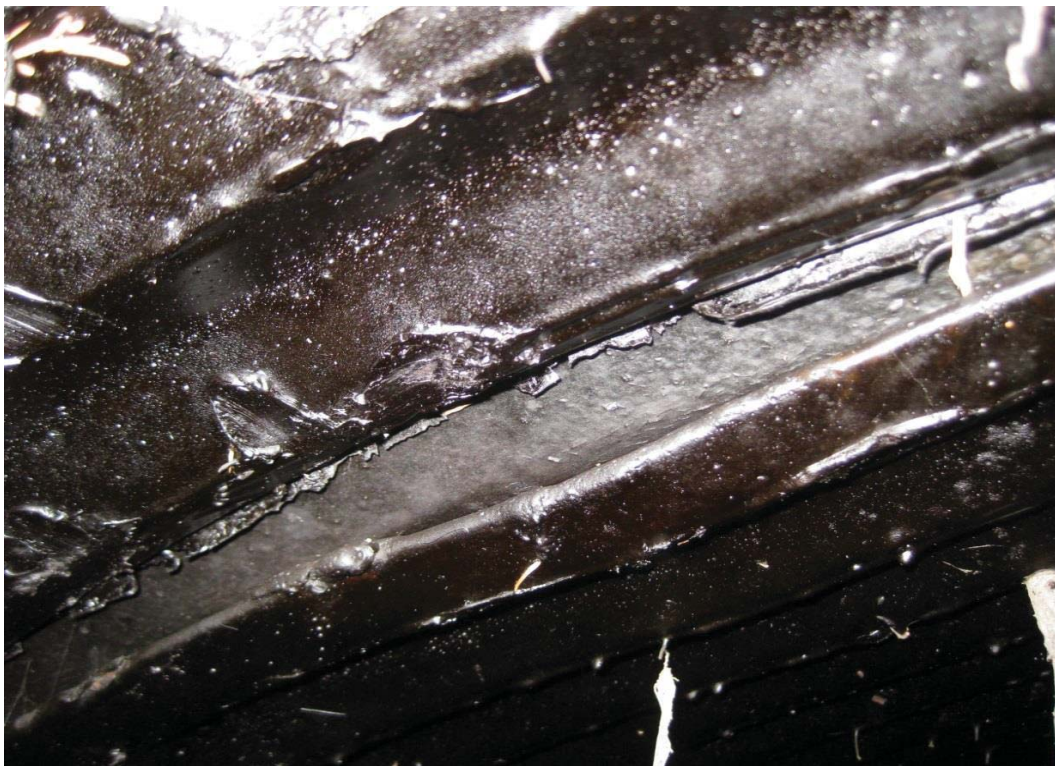
Photo 10

Drain A - 160'  
 Seam at 11 o'clock with gap to 1" and offset up to 1". Minor surface rust on edge.

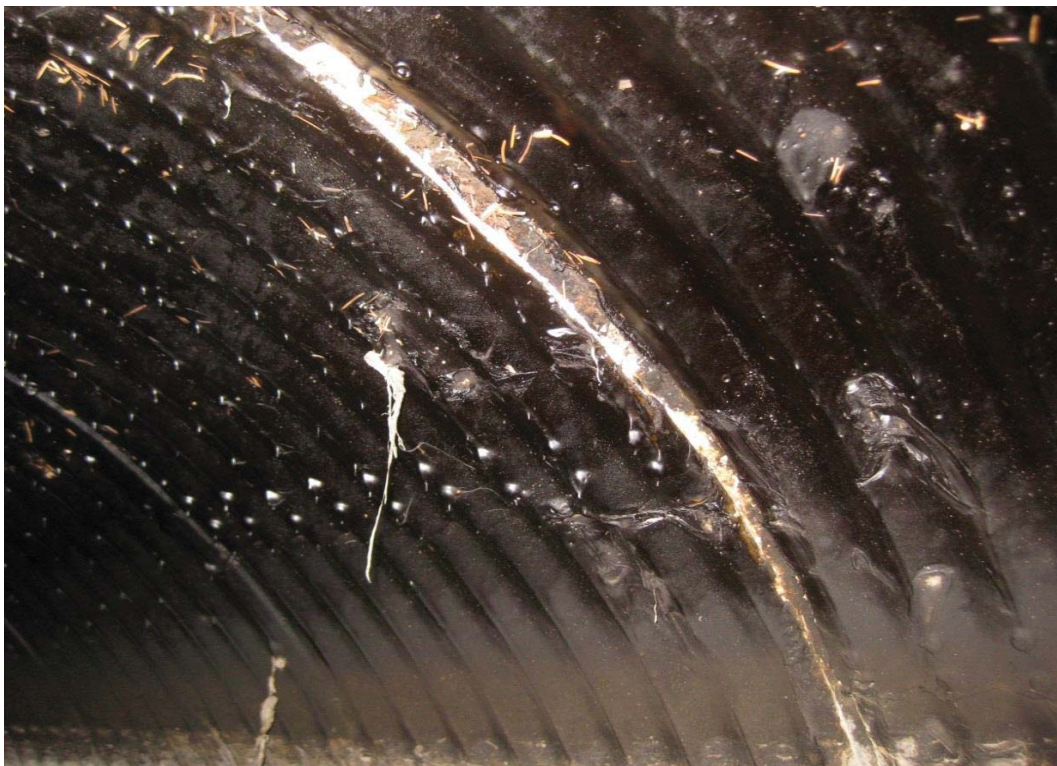
Photo 12

Drain A - 184'  
Seam at 11 o'clock looking upstream with gap to 1" and offset up to 1/2".

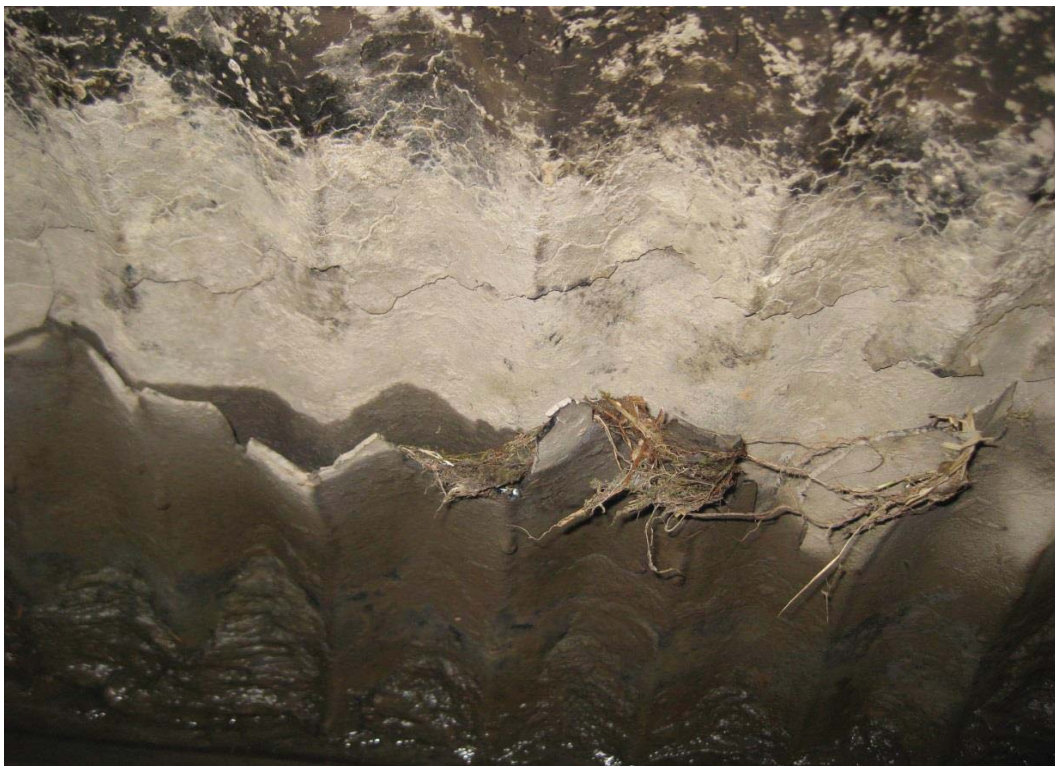
Photo 14

Drain A - 218'

Seam at 3 o'clock. Coating is peeling from 2:30 to 3 o'clock between 215' and 218'.

The coating in Drain A at 218' and 510' should be replaced. This is a low priority.

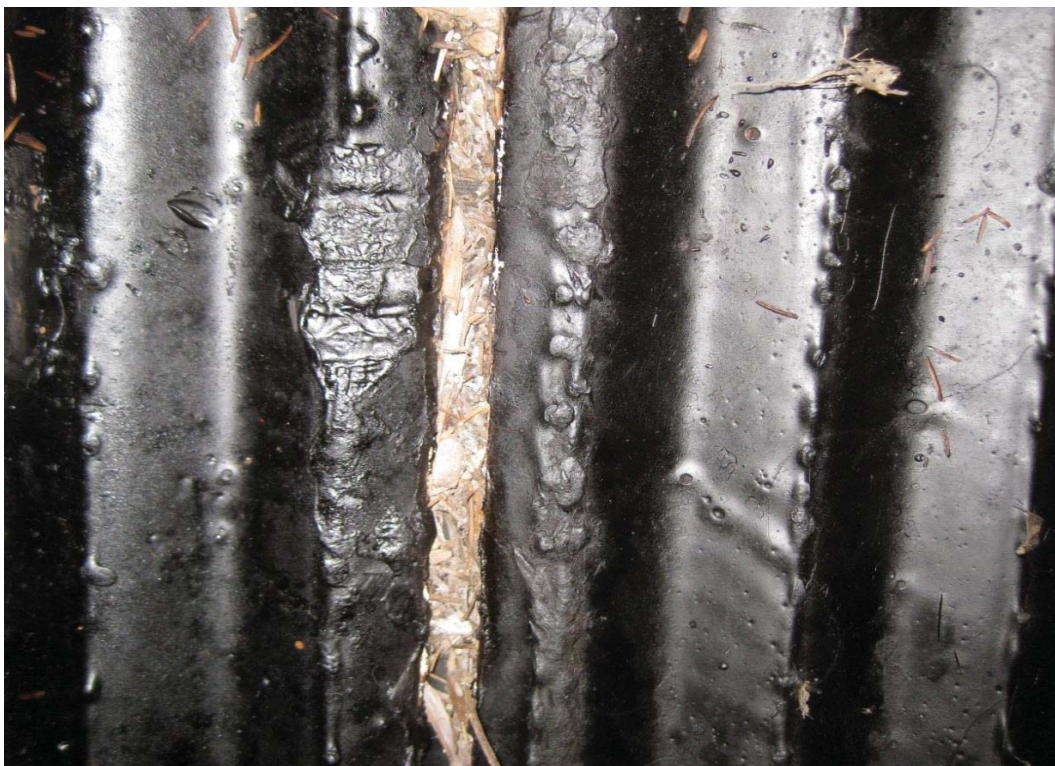
Photo 15

Drain A - 225'  
Seam at 12 o'clock with gap to 1" and offset up to 1/2".

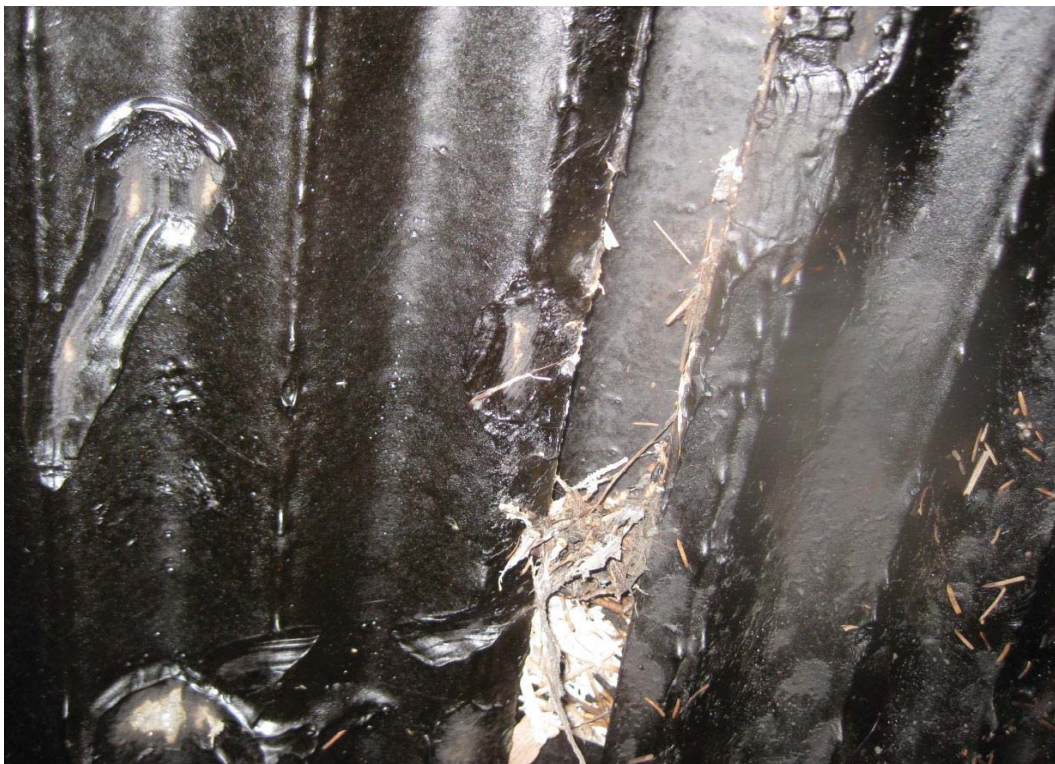
Photo 16

Drain A - 247'  
Seam at 3 o'clock with gap to 1-1/2". No offset or corrosion.

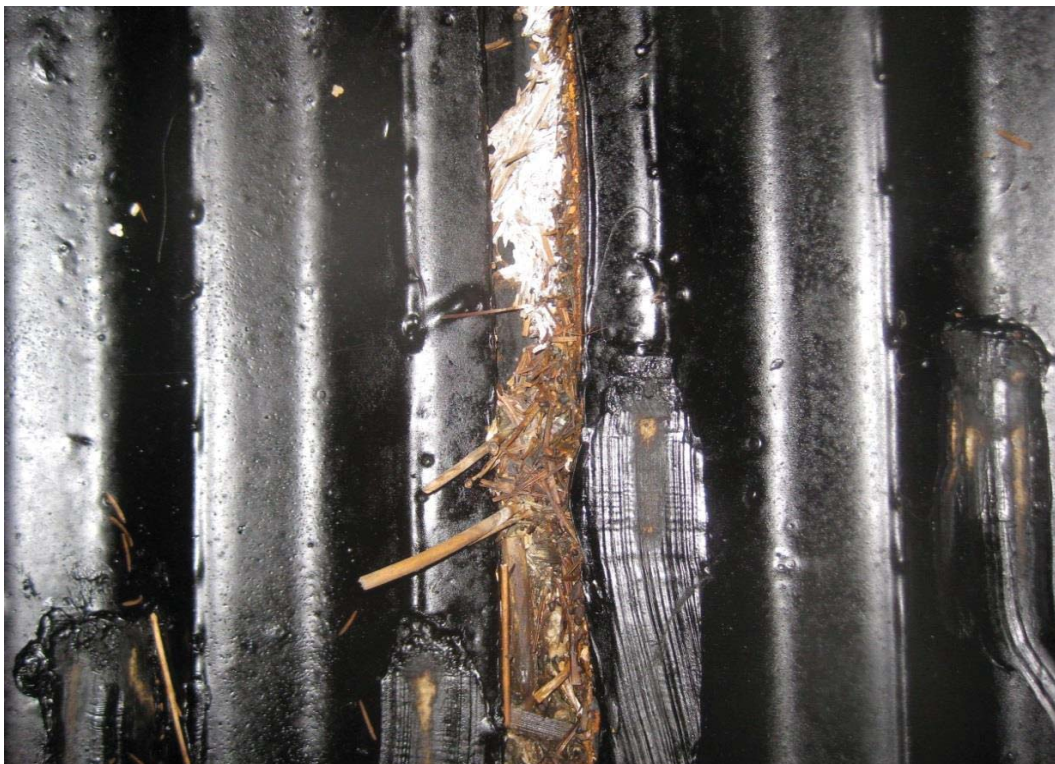
Photo 18

Drain A - 266'  
Seam at 12 o'clock with gap to 1". Minor corrosion.

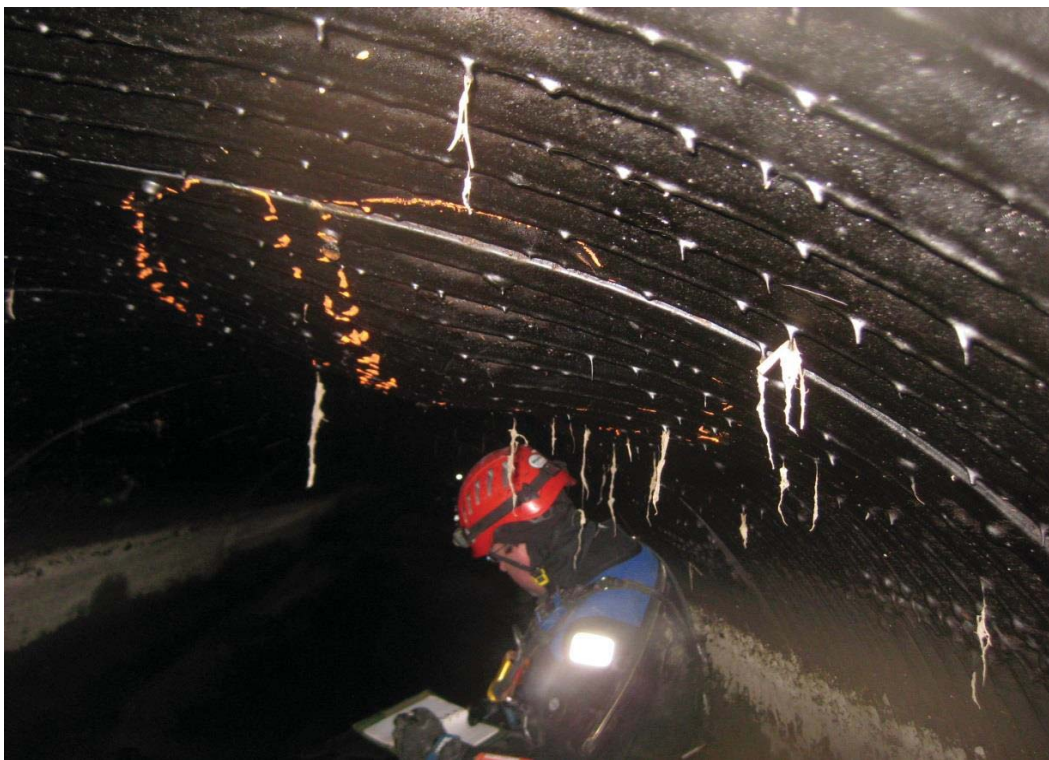
Photo 19

The pipe walls are generally in good condition. The areas of interest related to the walls are in Drain A at 282' where a 2' x 4' area is caved or pressed in 3-1/2" (Photo 19), Drain A at 288' where a 2' x 2' area is pressed in 2" (Photo 20), and Drain A at 497' where a 3' x 2' area is pressed in 2" (Photo 34). There is a horizontal void behind the wall in Drain B at 484' that is 12" deep.

Drain A - 282'  
There is a 2' x 4' area that is caved in 3-1/2".

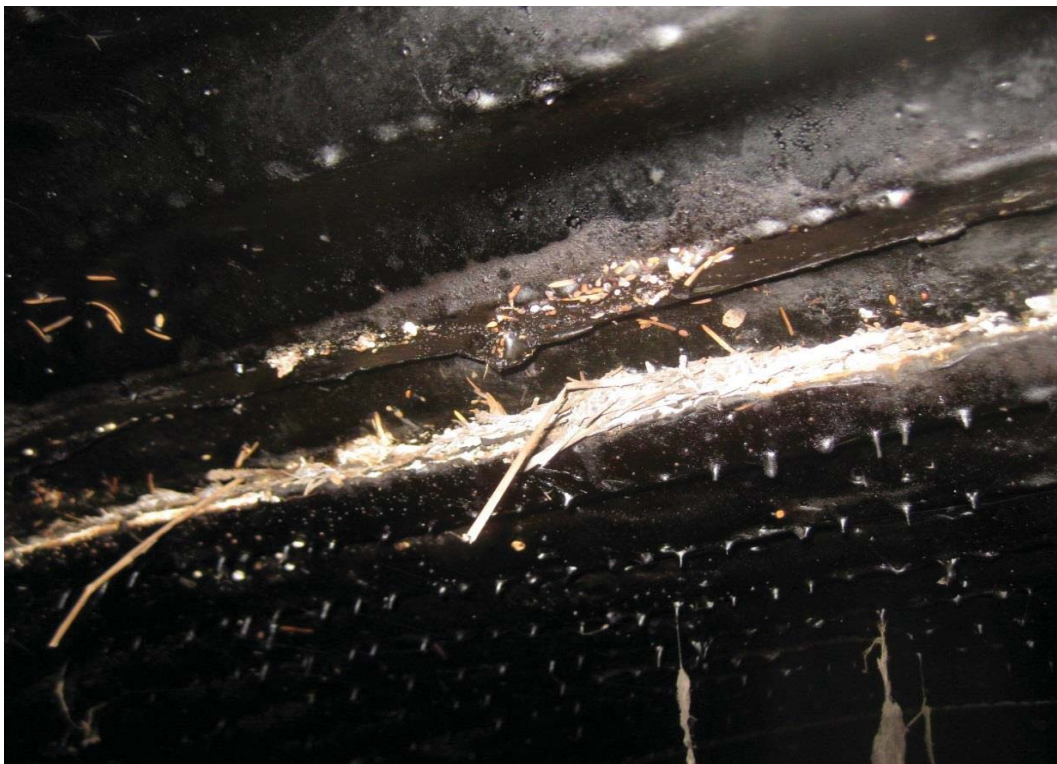
Photo 20

Drain A - 288'  
Seam at 12 o'clock with gap to 1" and an offset of 2". There is a 2' square area that is caved or pressed in 2".

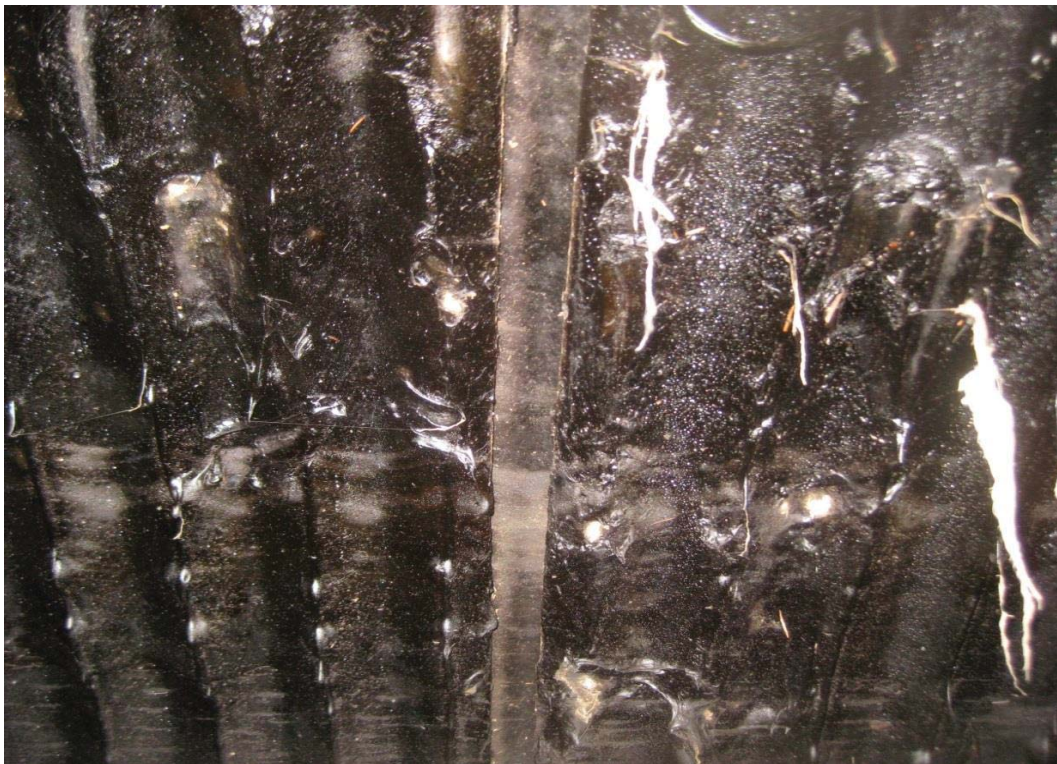
Photo 23

Drain A - 333'

Seam at 9 o'clock with gap to 1-1/4" and an offset of 1/4" and an offset up to 1/2". Moderate corrosion.

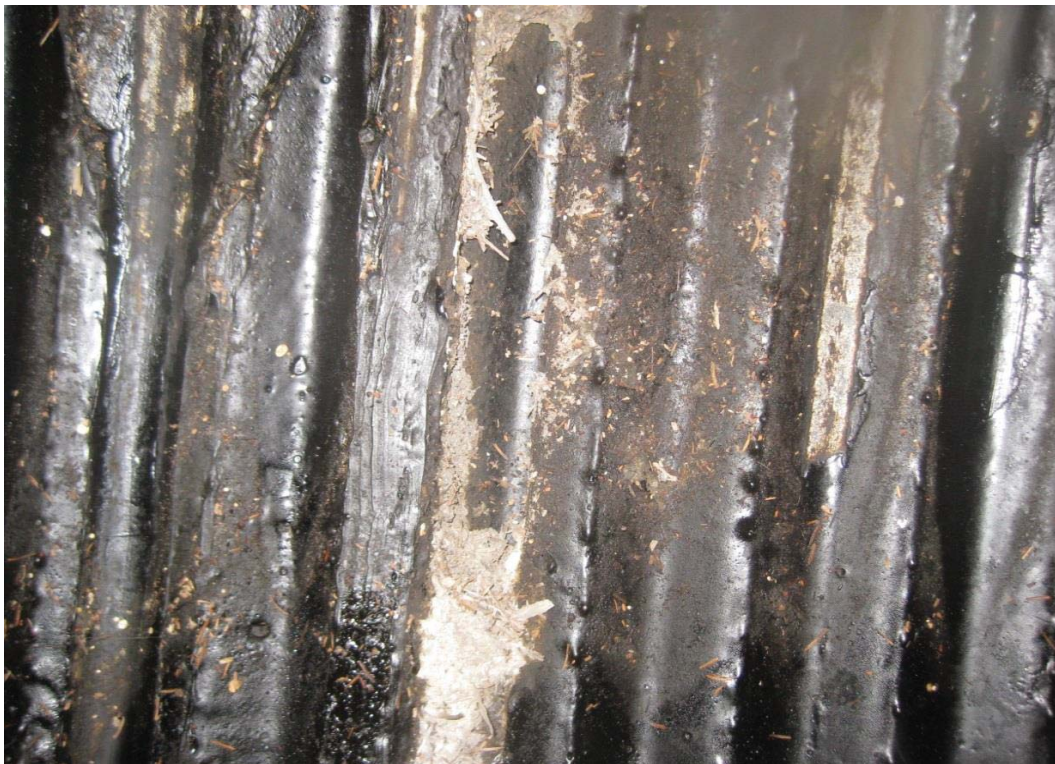
Photo 27

Drain A - 380'  
Seam at 12 o'clock with gap to 2" and an offset up to 1/2".

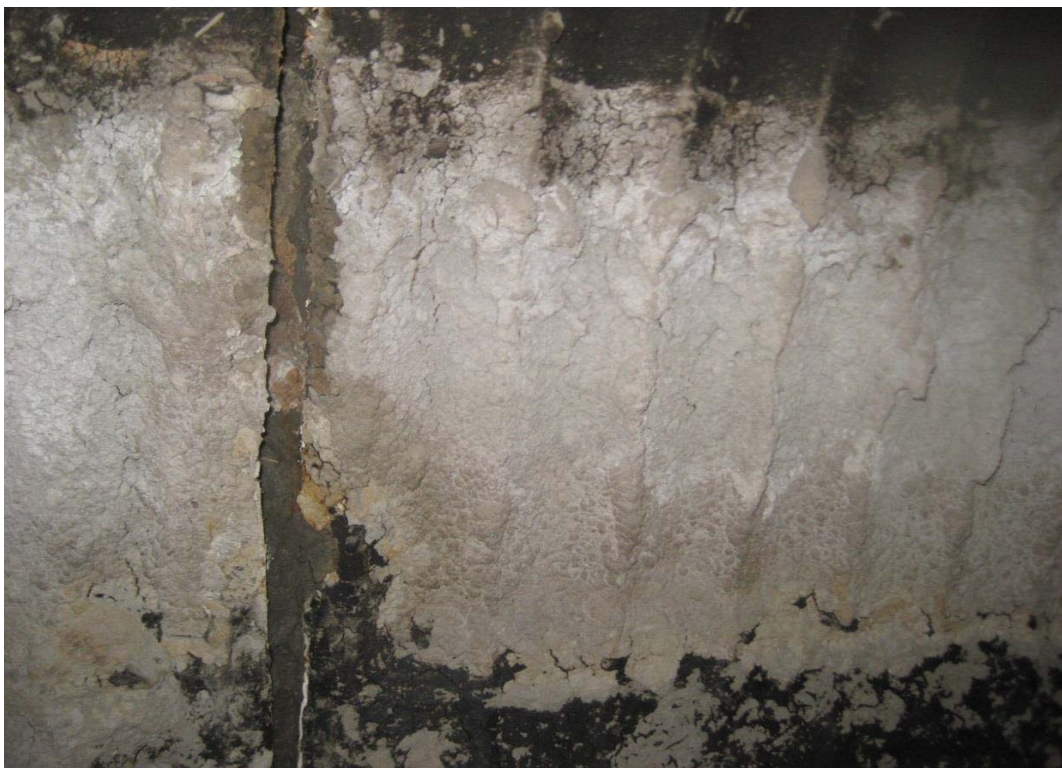
Photo 29

Drain A - 402'  
 Seam at 9 o'clock with gap to 1-1/2" and an offset of 1". Moderate edge corrosion.

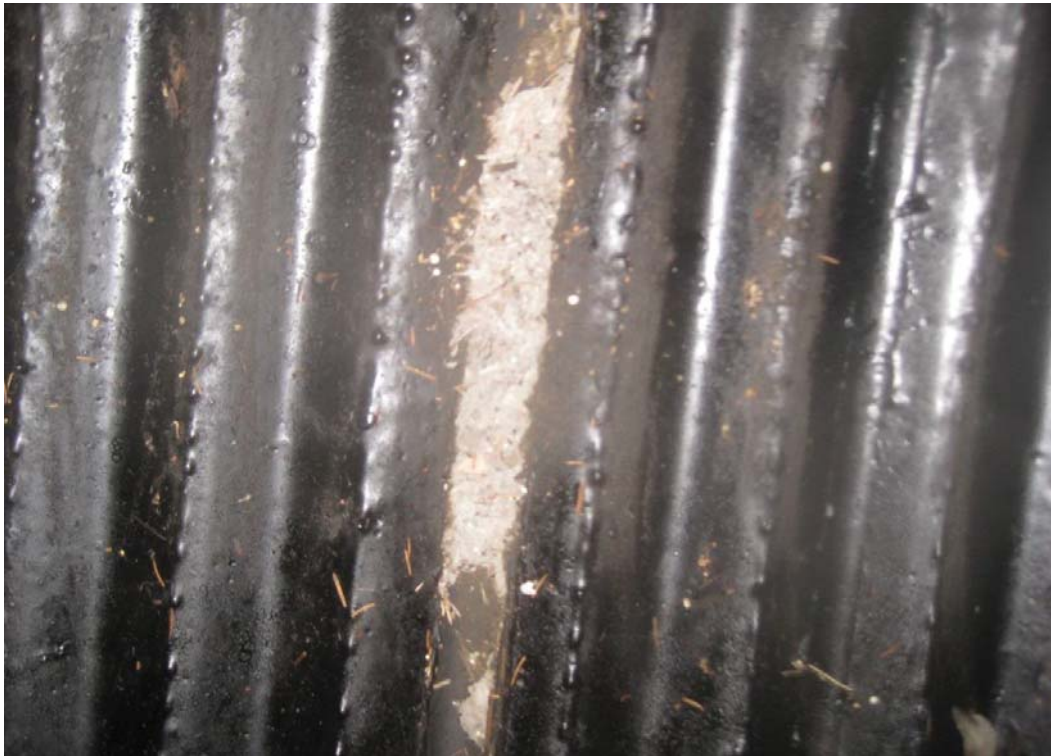
Photo 30

Drain A - 425'  
 Seam at 12 o'clock with gap to 1-1/2" and an offset of 1/2". Minor corrosion along edges.

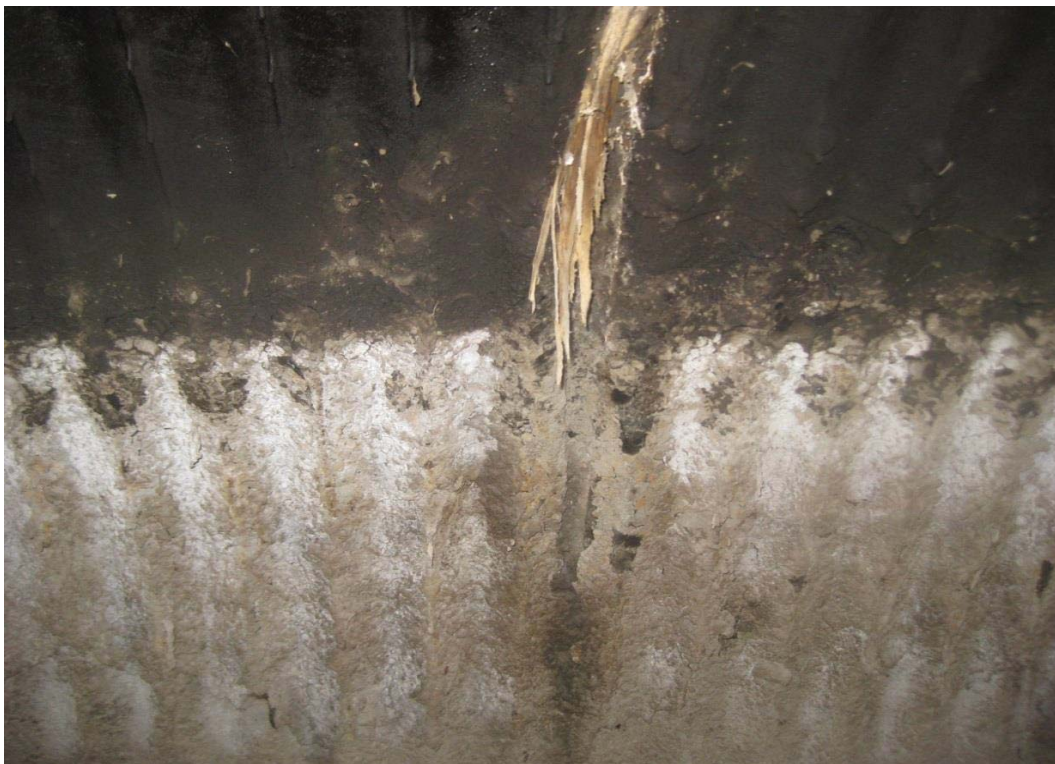
Photo 32

Drain A - 466'  
Seam at 9 o'clock with gap to 1-1/2" and an offset of 1". Moderate corrosion.

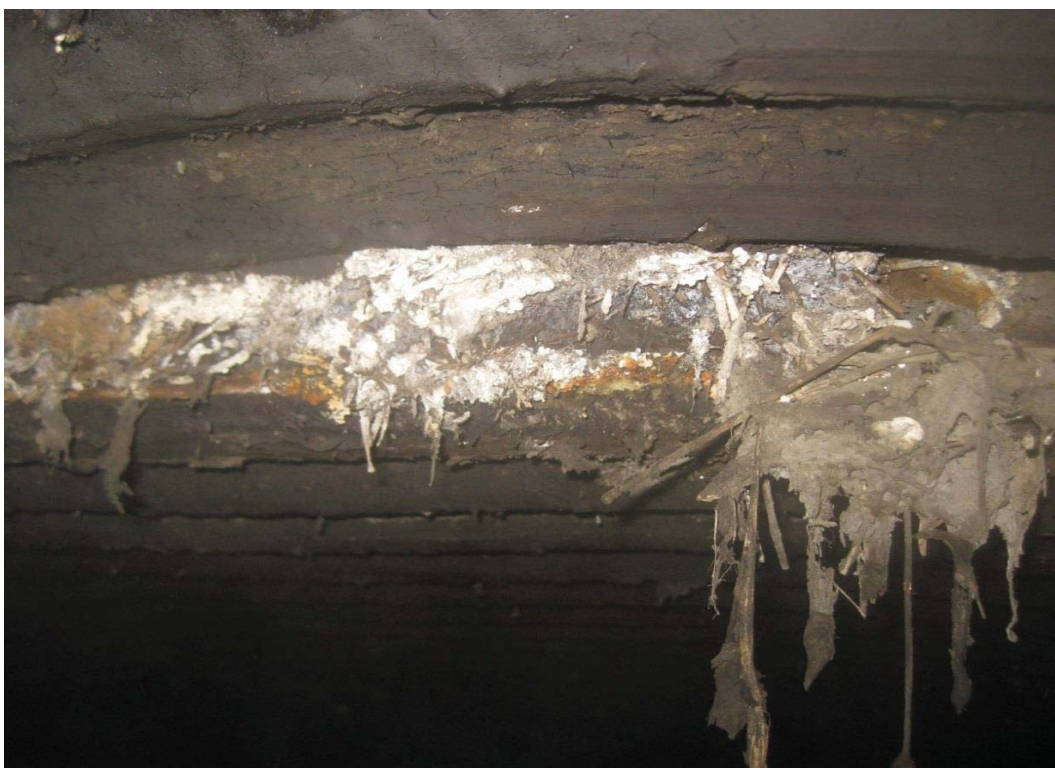
Photo 33

Drain A - 487'  
Seam at 12 o'clock with gap to 1" and an offset of 1-1/2".

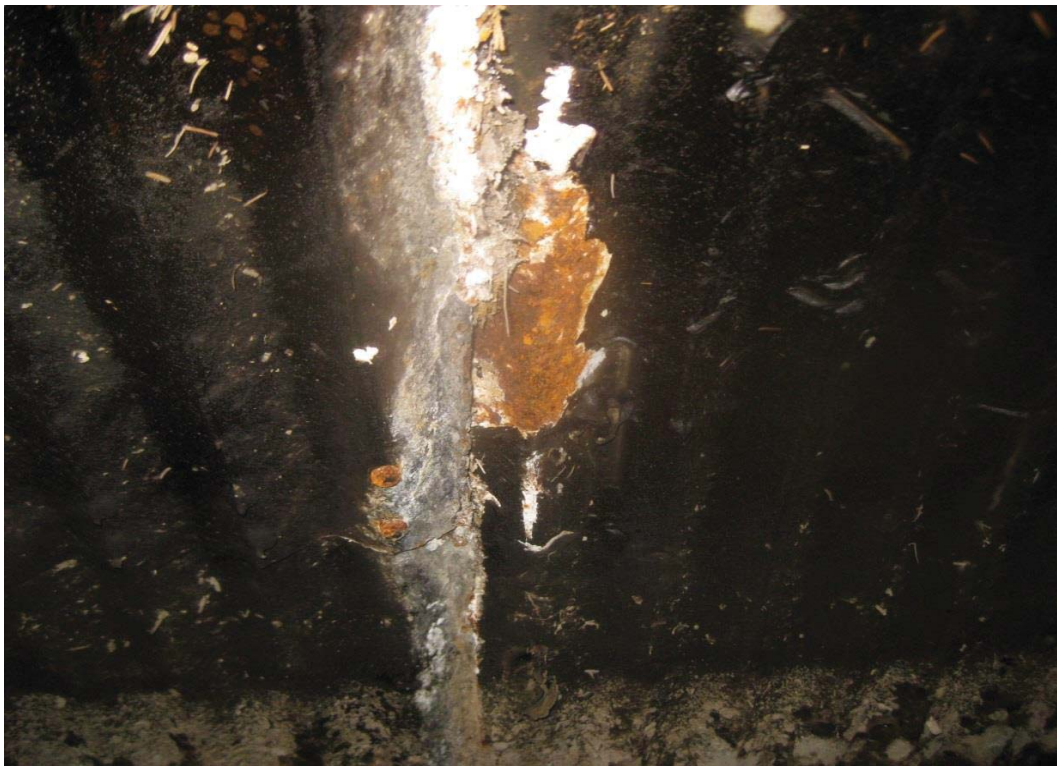
Photo 37

Drain A - 510'

Seam at 12 o'clock looking upstream with gap to 1" and an offset of 1-1/2". Moderate corrosion.

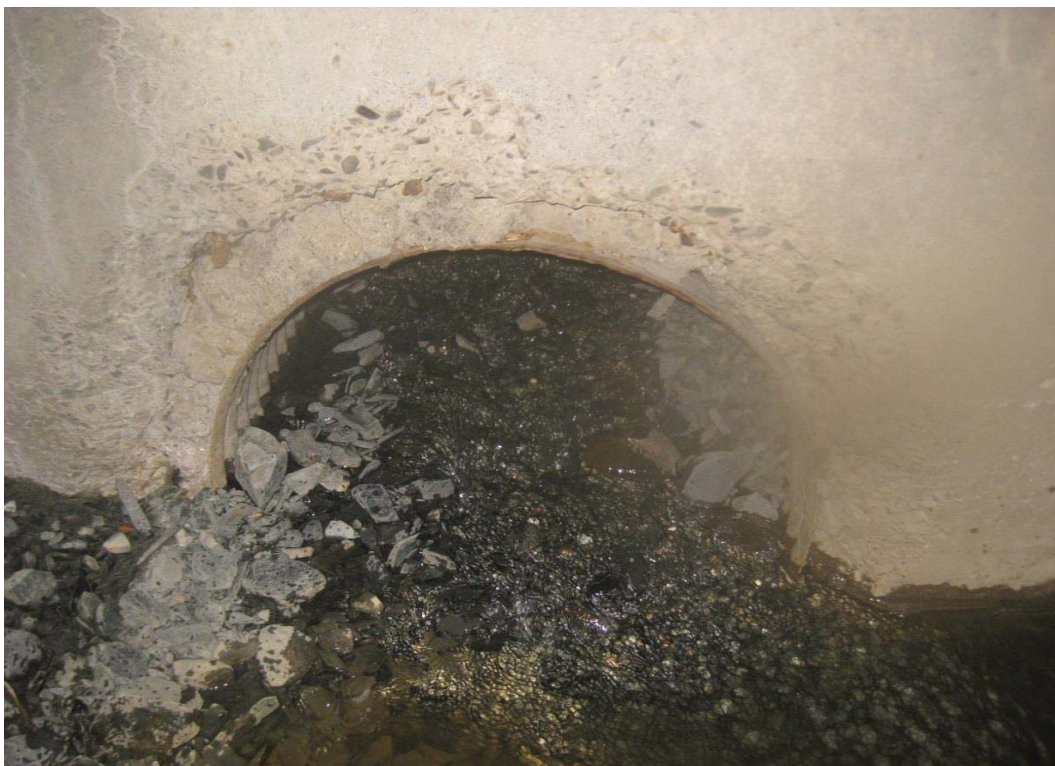
Photo 39

Drain A - 519'

Storm drain entering at 3 o'clock. Water from Drains A and B flow through this drain that runs along Marine Drive. Rock in drain pipe to 14" deep.

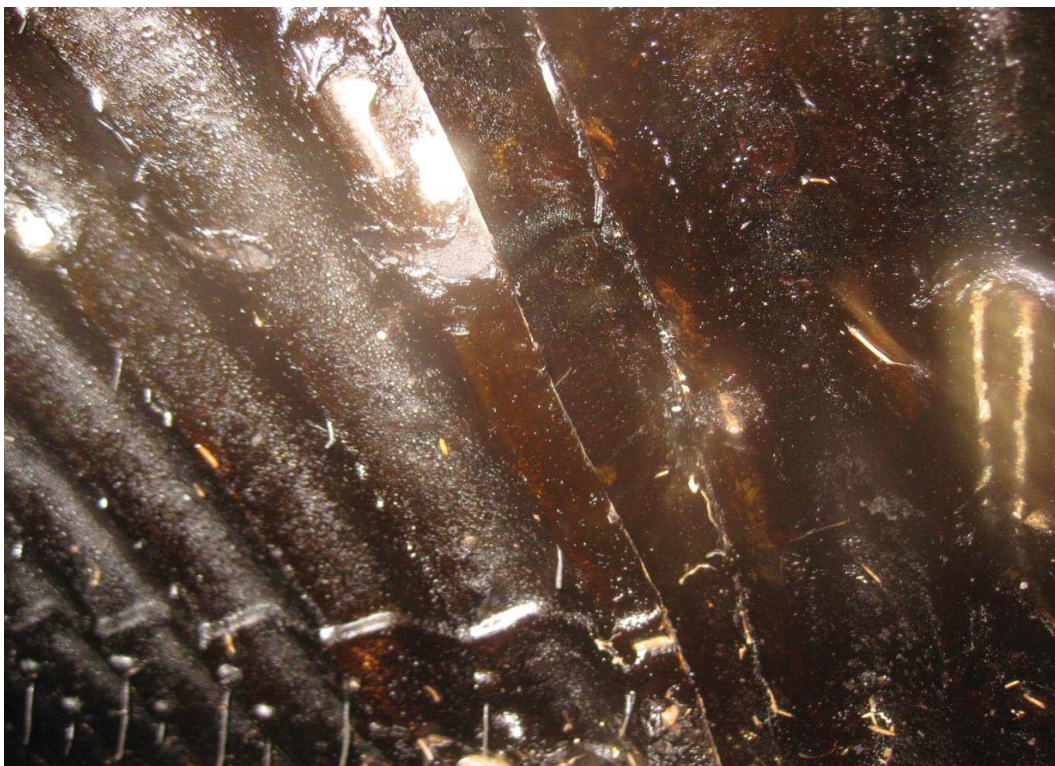
Photo 41

Drain A - 541'  
Seam at 9 o'clock looking upstream with gap to 1-1/2" and an offset of 2".

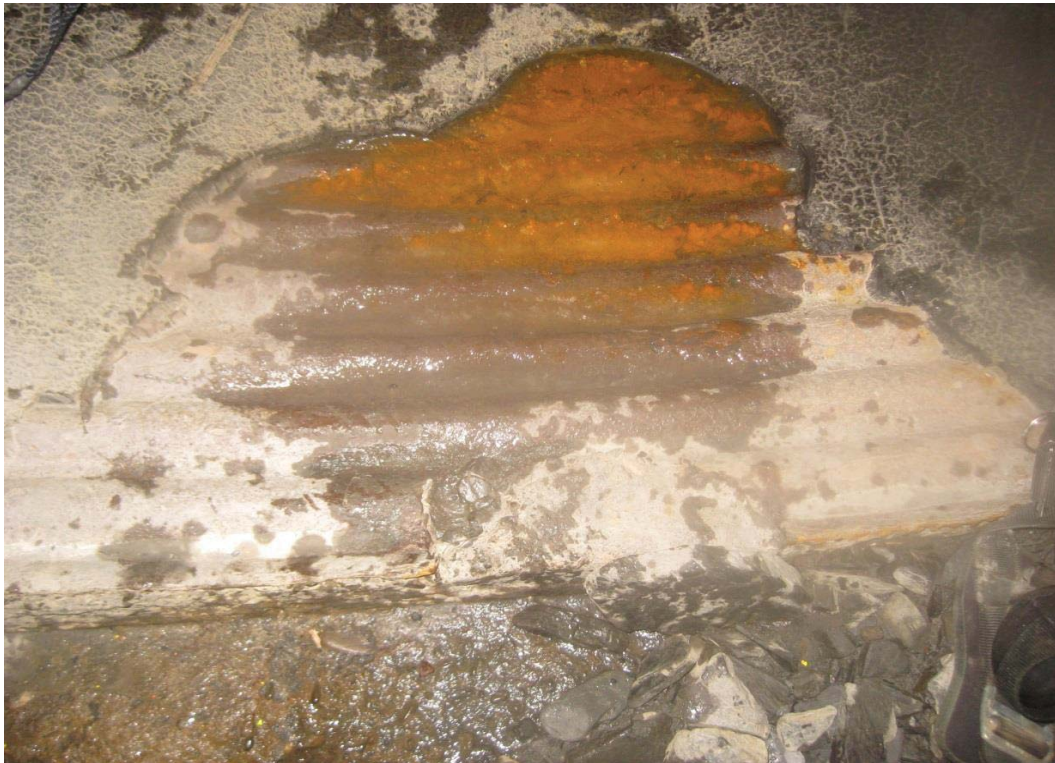
Photo 42

Drain A - 521'  
2' x 2' area of failed coating at 6 o'clock with moderate surface rust.

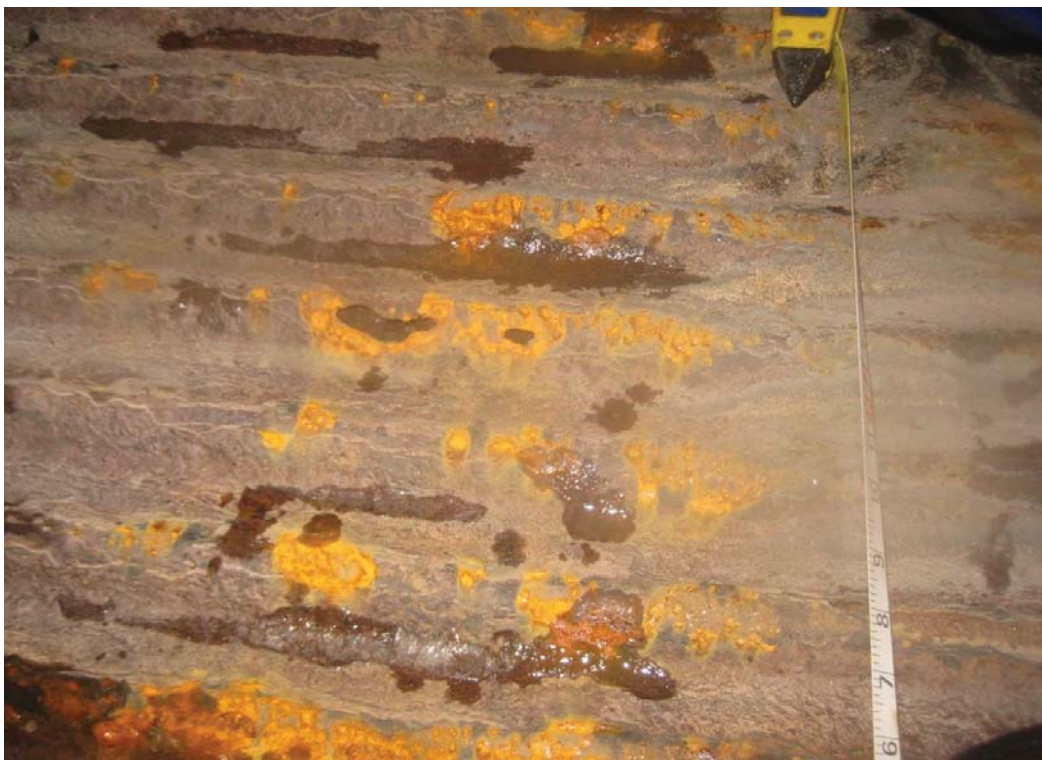
Photo 43

Drain A - 542'  
Hole in drain 1/2" x 2" at 6 o'clock with heavy corrosion.

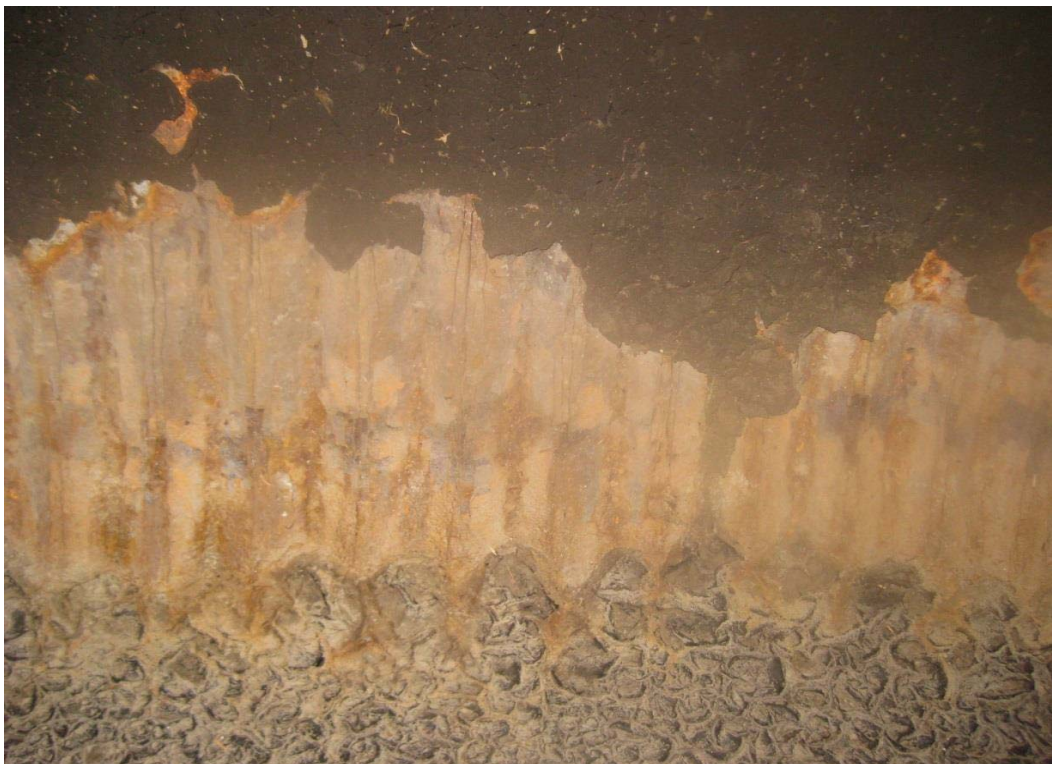
Photo 43

Drain A - 560'  
2' coating failure with heavy corrosion to end of drain at 9 o'clock and 3 o'clock.
