## **KODIAK STORM DRAIN INSPECTION REPORT**

**PREPARED FOR DOWL HKM**

**KODIAK, AK**

Inspection Date(s): February 12-13, 2014

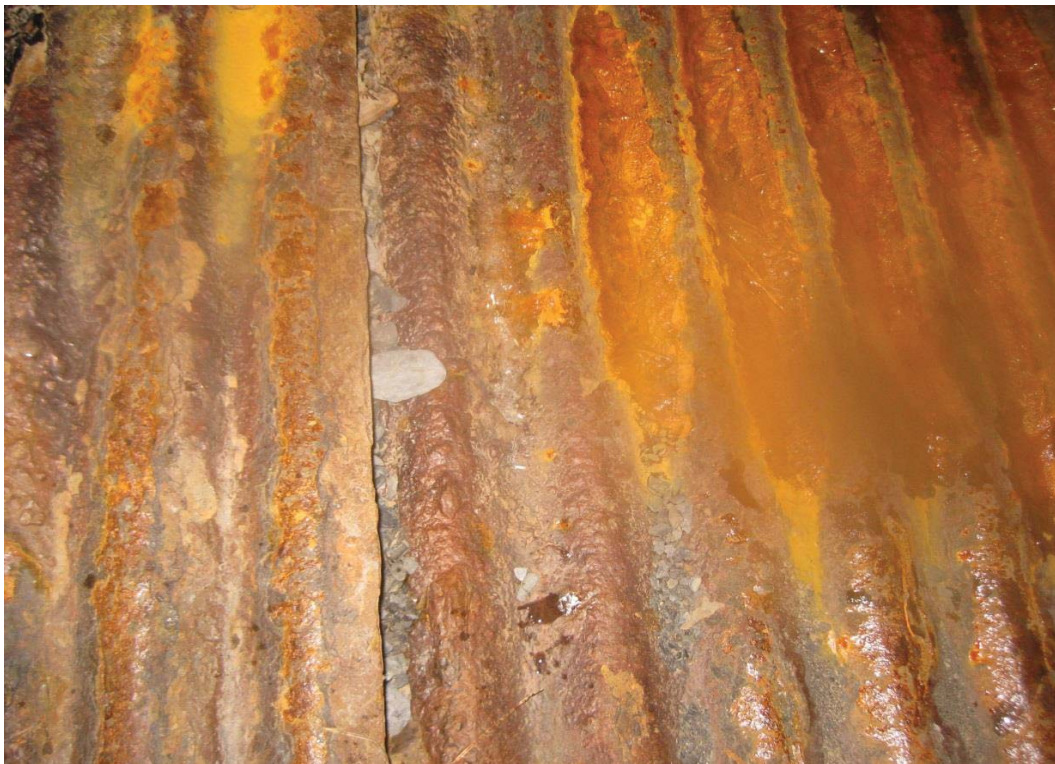
Photo 44

Drain A - 561'  
Seam at 6 o'clock with gap to 1" and an offset of 2". Heavy corrosion.

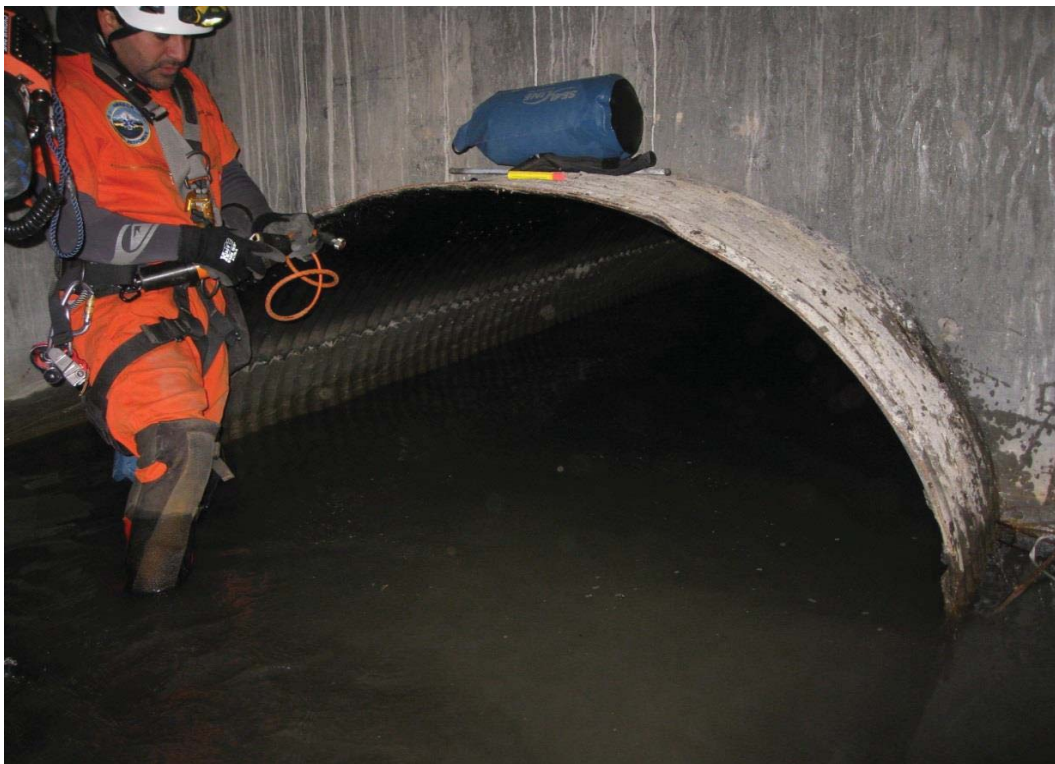
Photo 45

Drain B - 0'  
Ultrasonic testing location at entrance to Drain B. Some damage to coating on torch cut edge.  
Sandy soil in bottom.

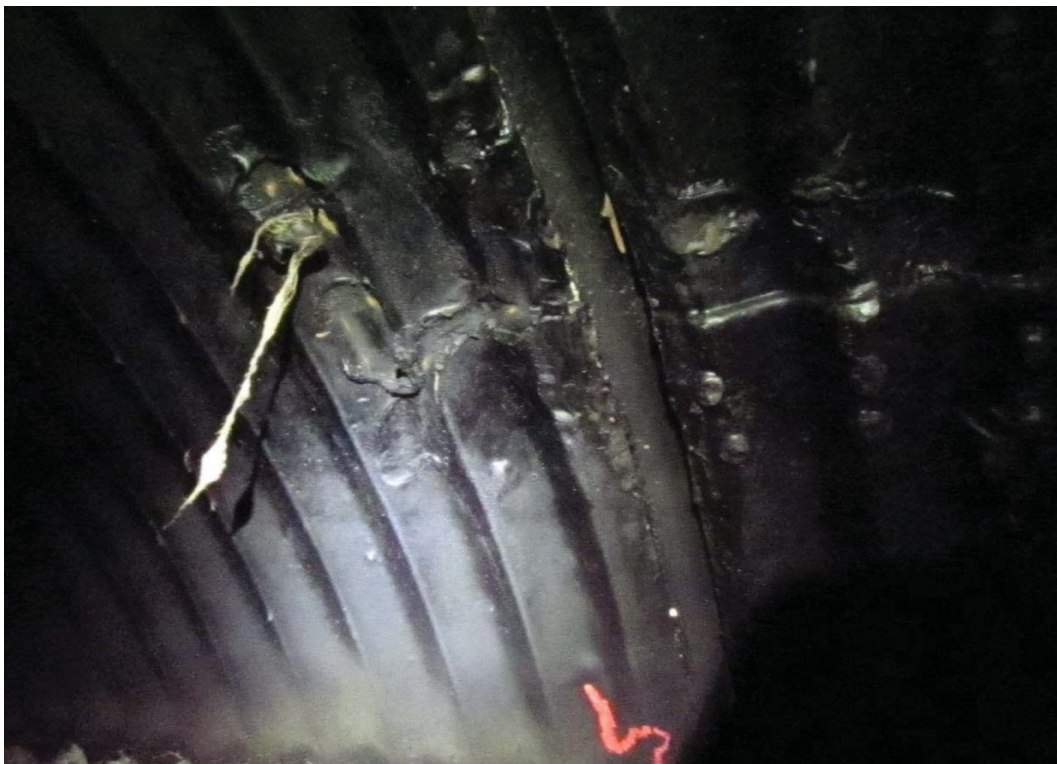
Photo 47

Drain B - 7'  
Seam at 3 o'clock with gap to 1-1/2".

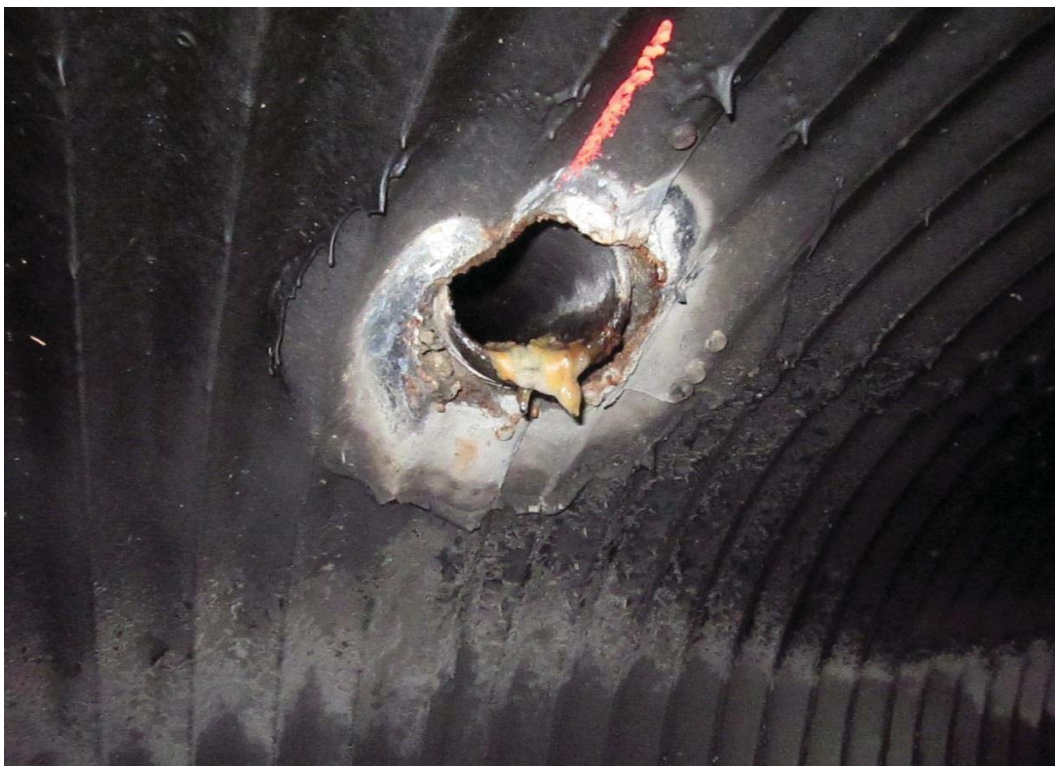
Photo 48

Drain B - 19'

4" drain pipe at 11 o'clock. Coating is broken with moderate corrosion around the torch cut hole.

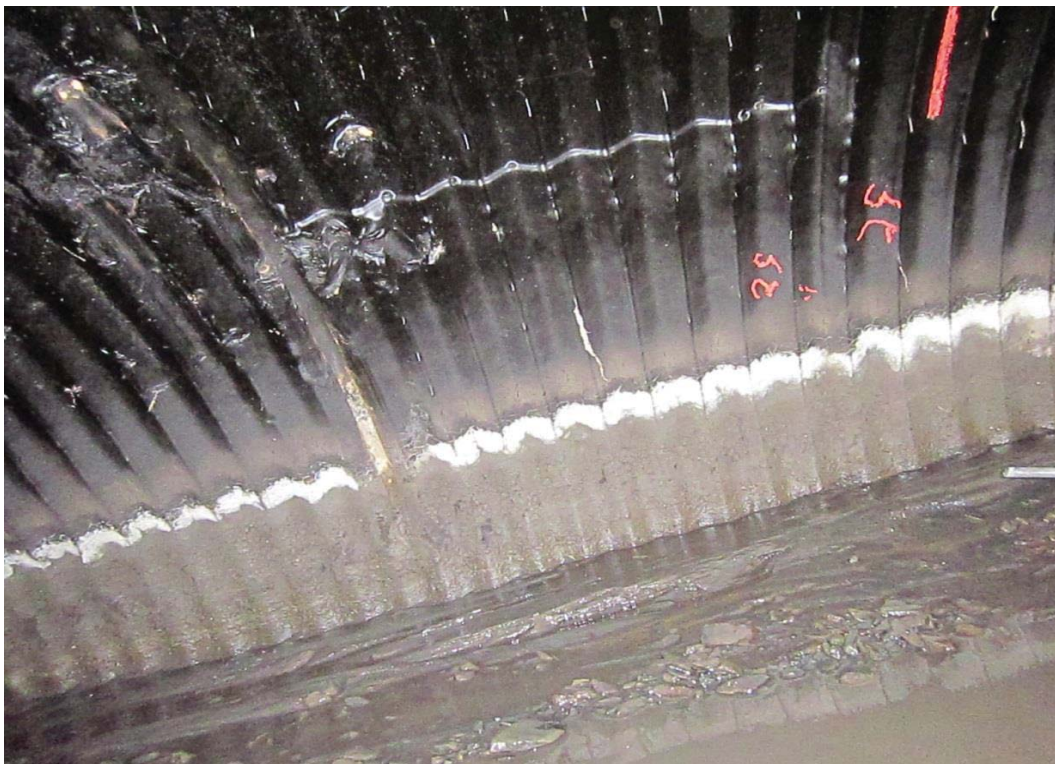
Photo 49

Drain B - 25'

View of ultrasonic testing location. Seam with gap to 1-1/2". In some spots, the coating below the water line is cracked and easy to remove, above the water line coating is in good condition.

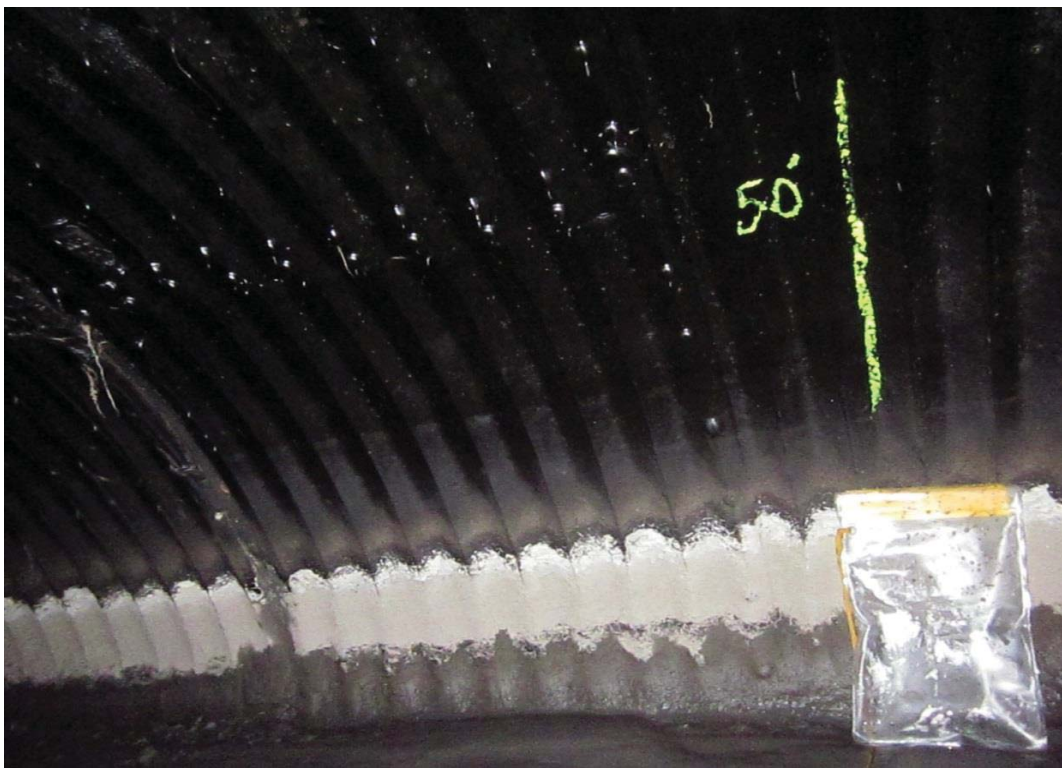
Photo 50

Drain B - 50'  
View of ultrasonic testing location. Seam with gap to 1".

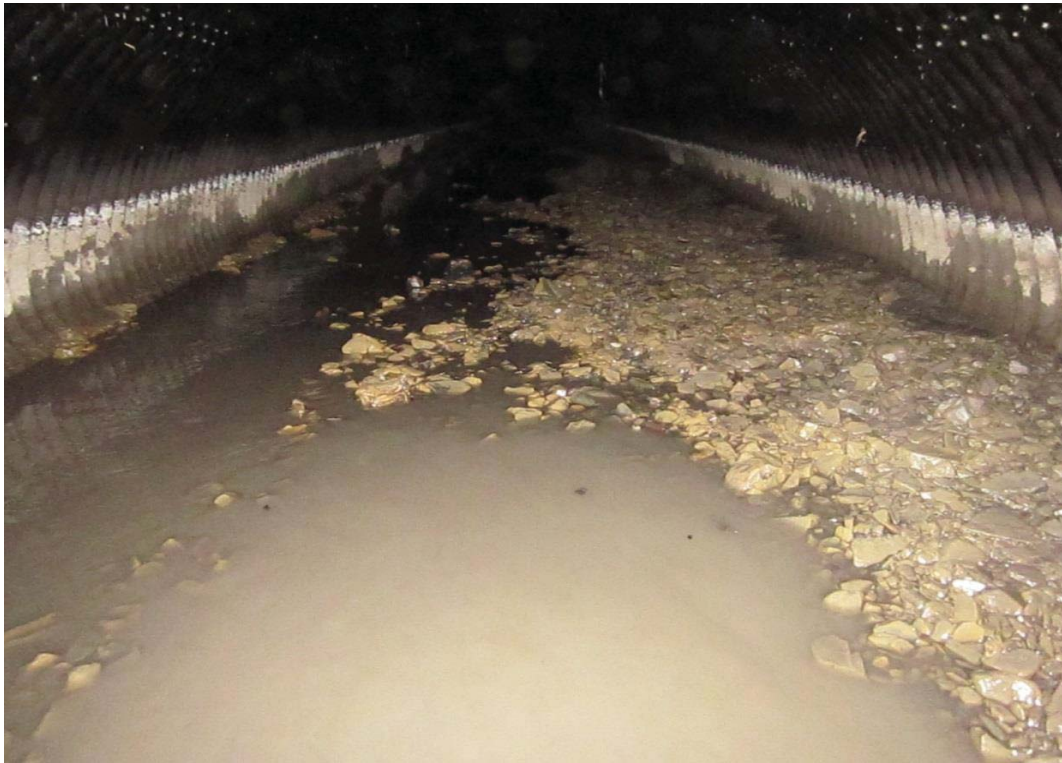
Photo 51

Drain B - 50'  
View downstream from culvert. Up to 1' of sand and rock deposits.

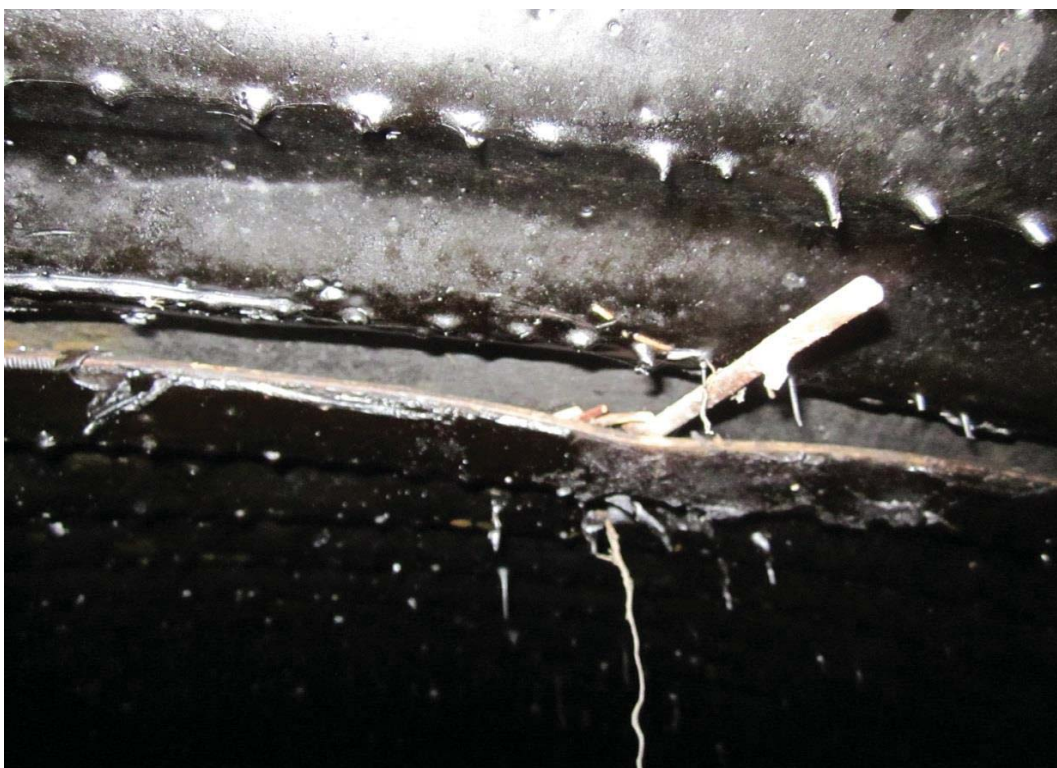
Photo 52

Drain B - 70'  
Seam with gap to 1" and opening of 7".

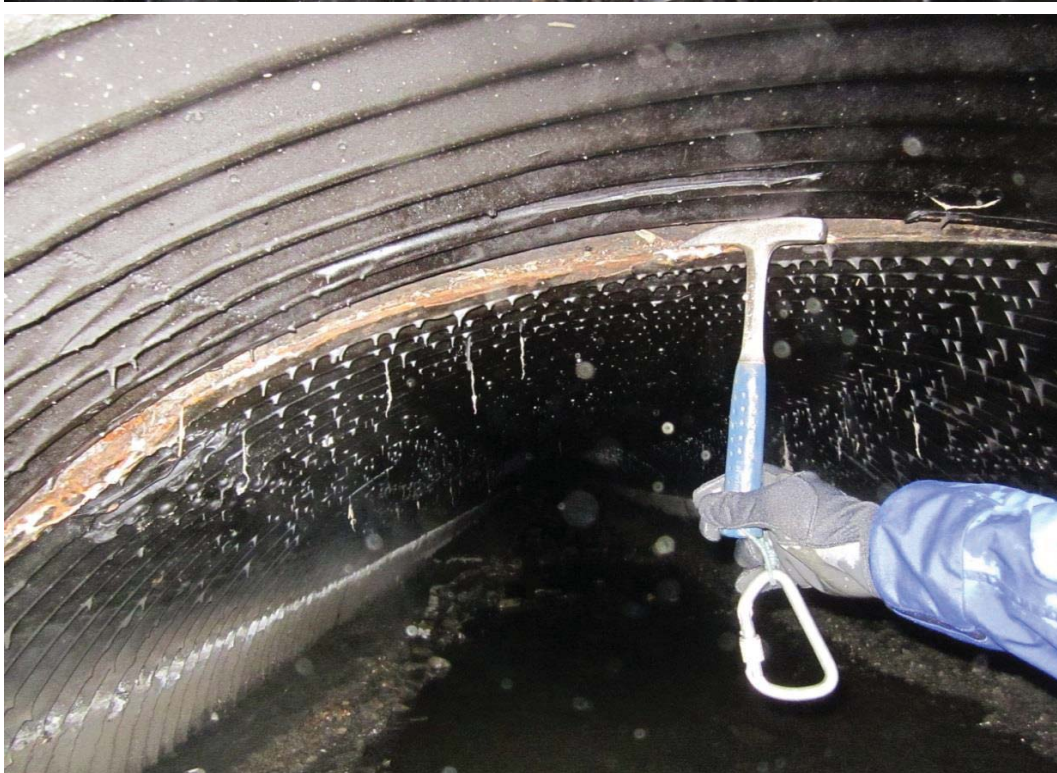
Photo 54

Drain B - 135'

Broken seam looking upstream. Moderate corrosion with coating damage on edge.

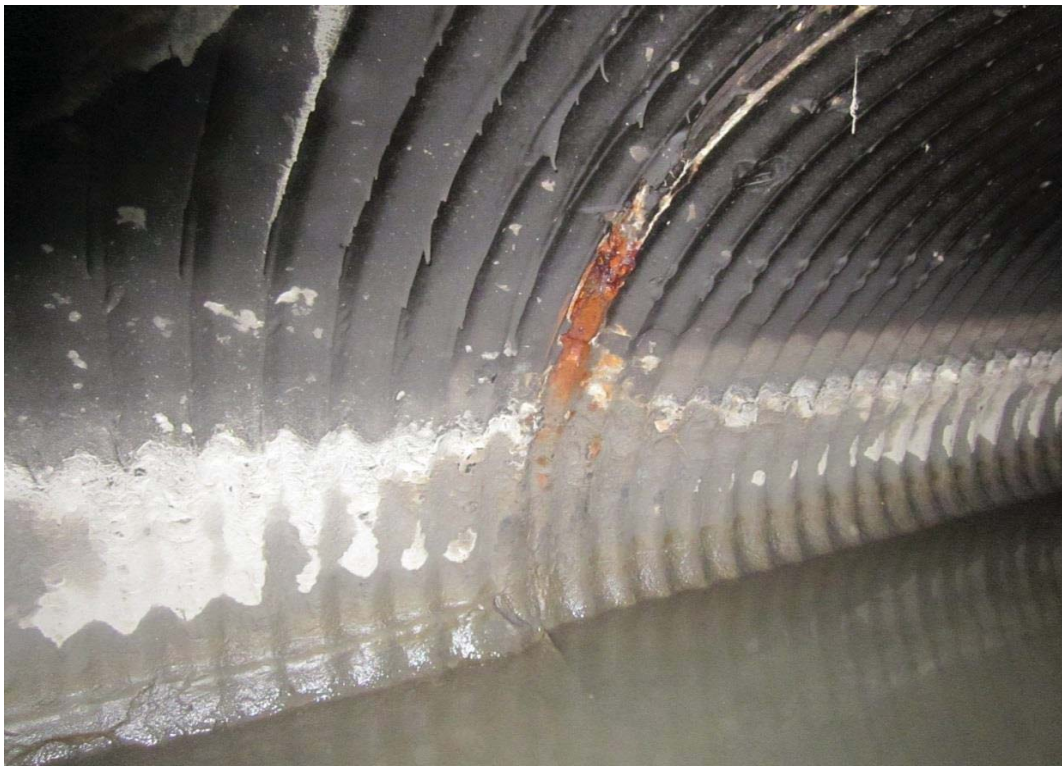
Photo 58

Drain B - 142'  
Seam open to 3/4" with minor surface rust and coating damage.

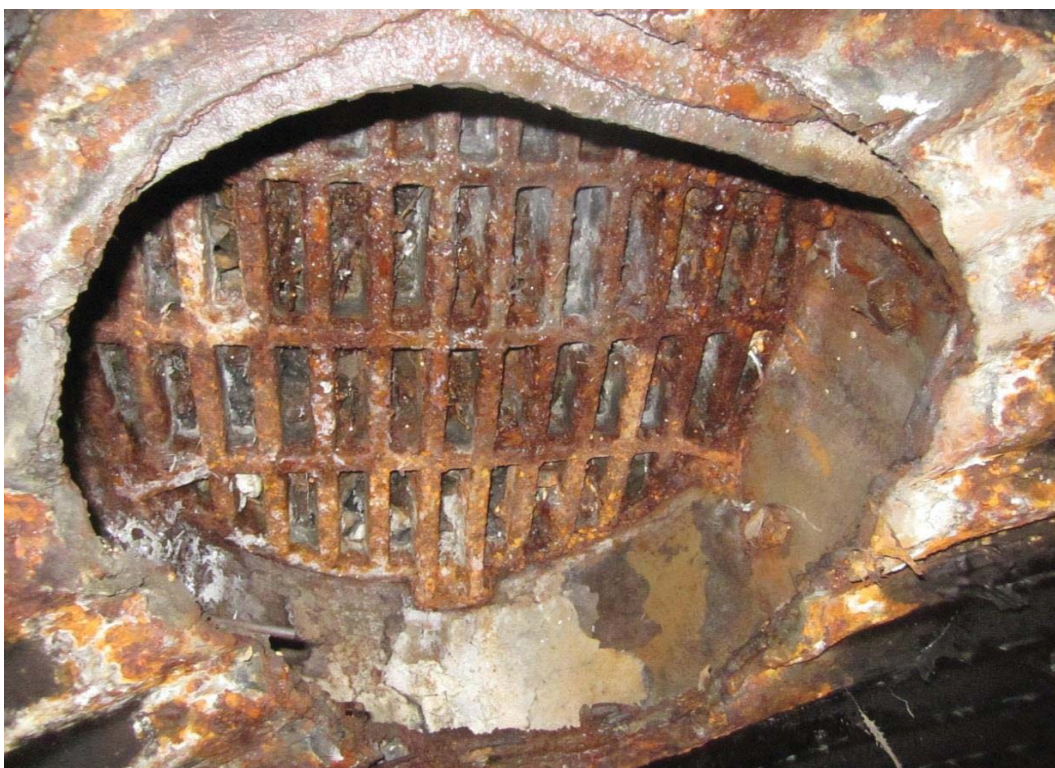
Photo 60

Drain B - 160'

24" cast iron grate. 17" torch cut hole with coating damage and heavy rust. 2" fill on grate. Drain does not show deformation.

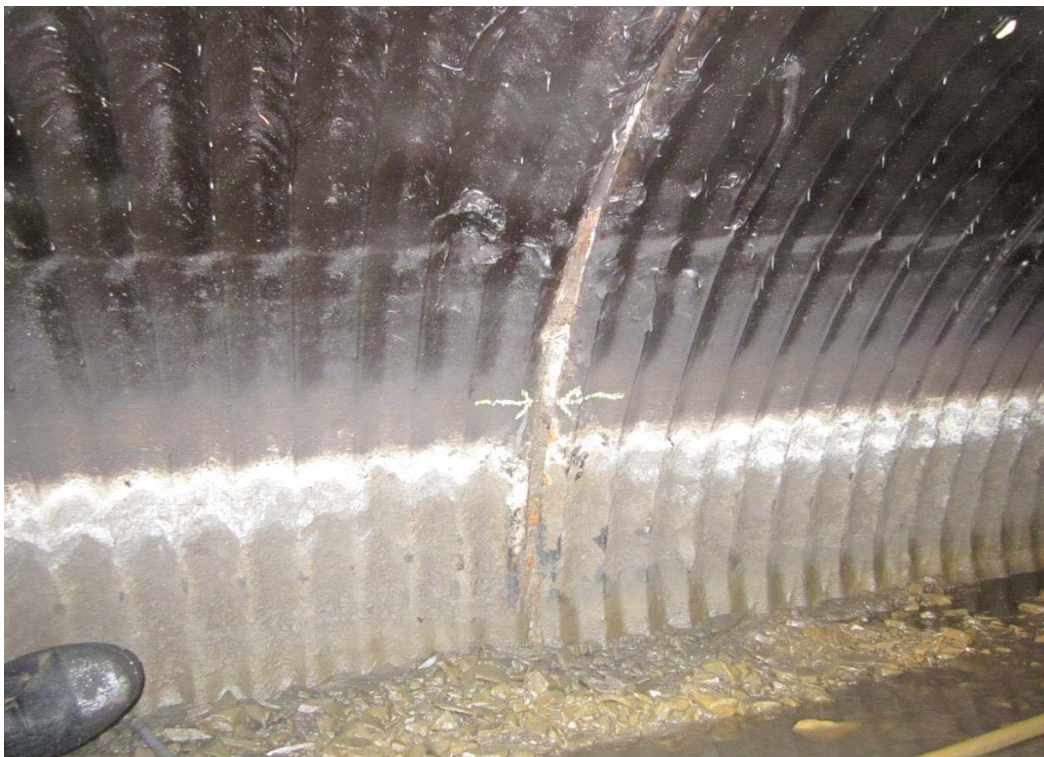
Photo 61

Drain B - 180'

Seam open to 1-1/2" with offset of 1-1/2". Minor surface rust and coating damage.

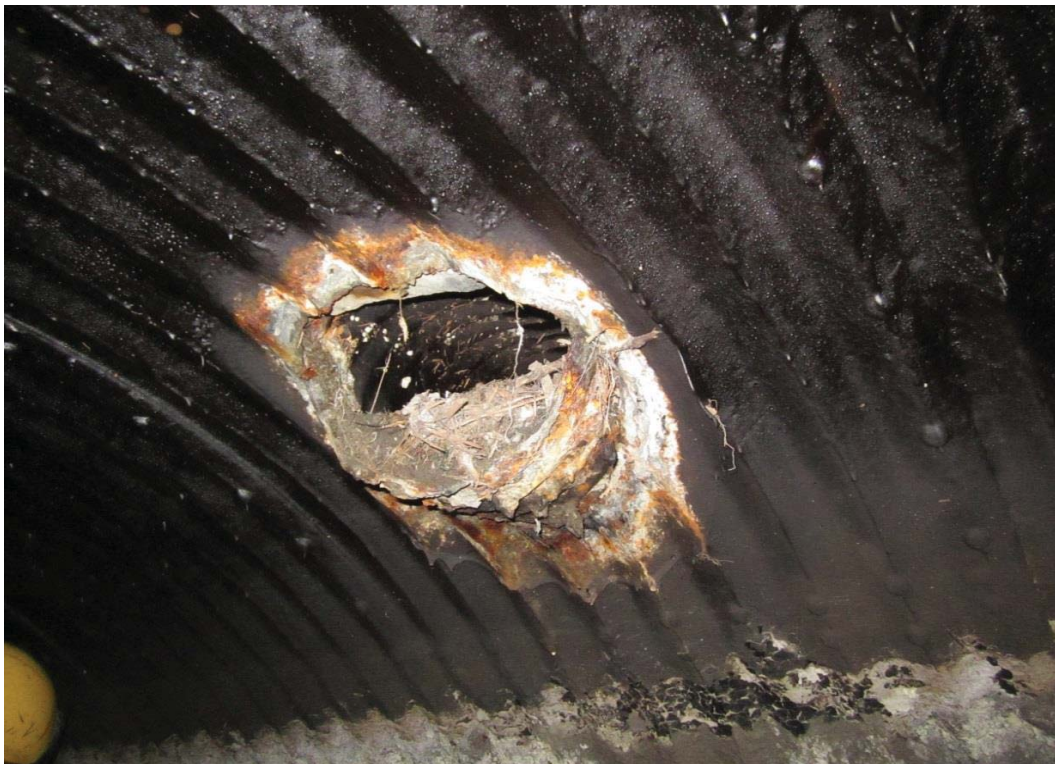
Photo 62

Drain B - 185'

8" corrugated pipe enters at 10 o'clock. Torch cut hole with coating damage and moderate surface rust. Pipe is 1/3 full of debris and not draining.

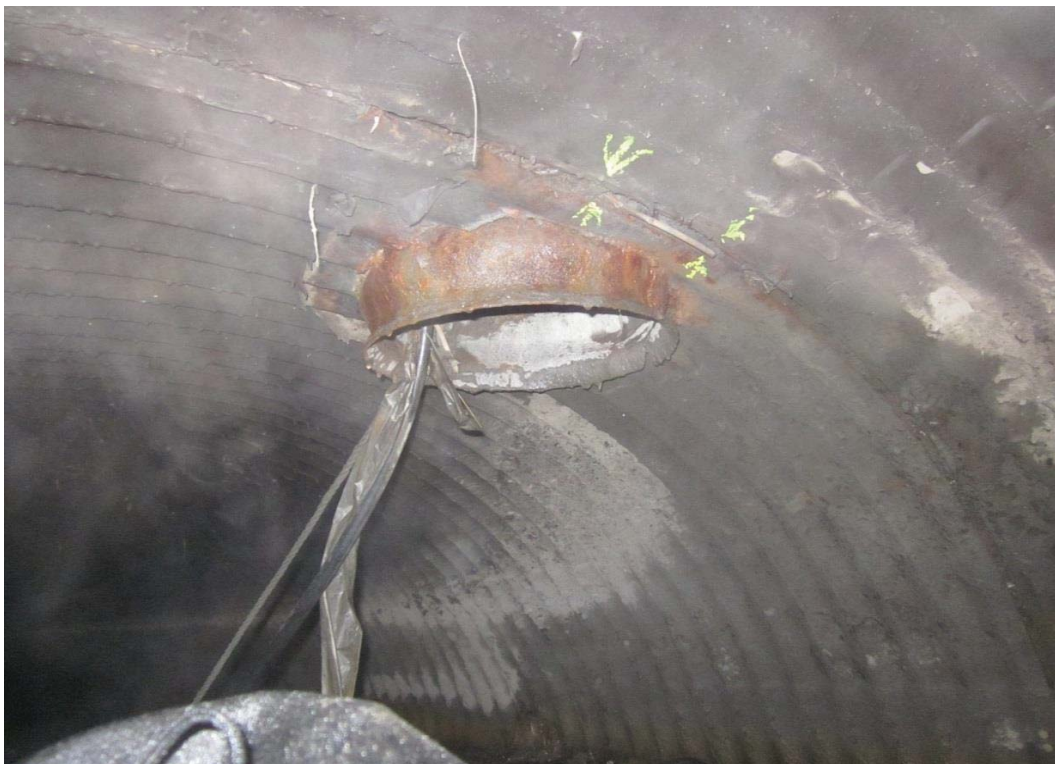
Photo 63

Drain B - 210'

Seam open to 1" with minor coating damage. 2" downstream from seam a 12" corrugated pipe is located at 1 o'clock. The pipe is in a torch cut hole with coating damage and moderate rust.

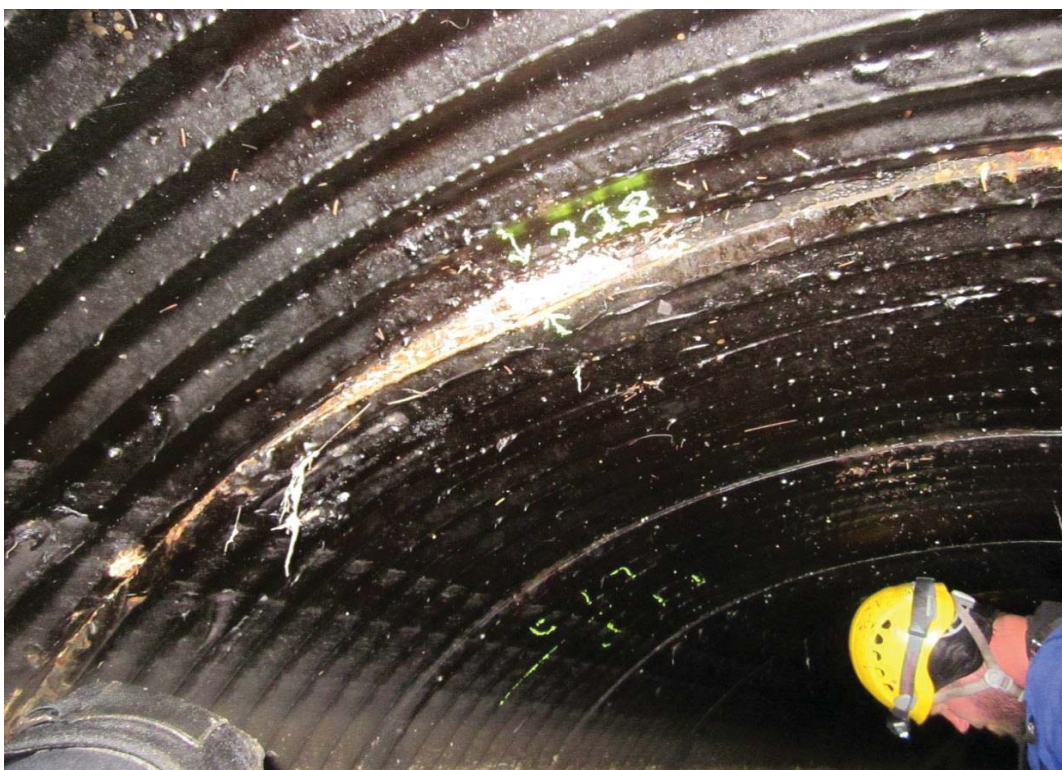
Photo 64

Drain B - 228'  
 Seam at 12 o'clock open to 1-1/2" with offset of 1-1/4". Minor coating damage on edge with surface rust.

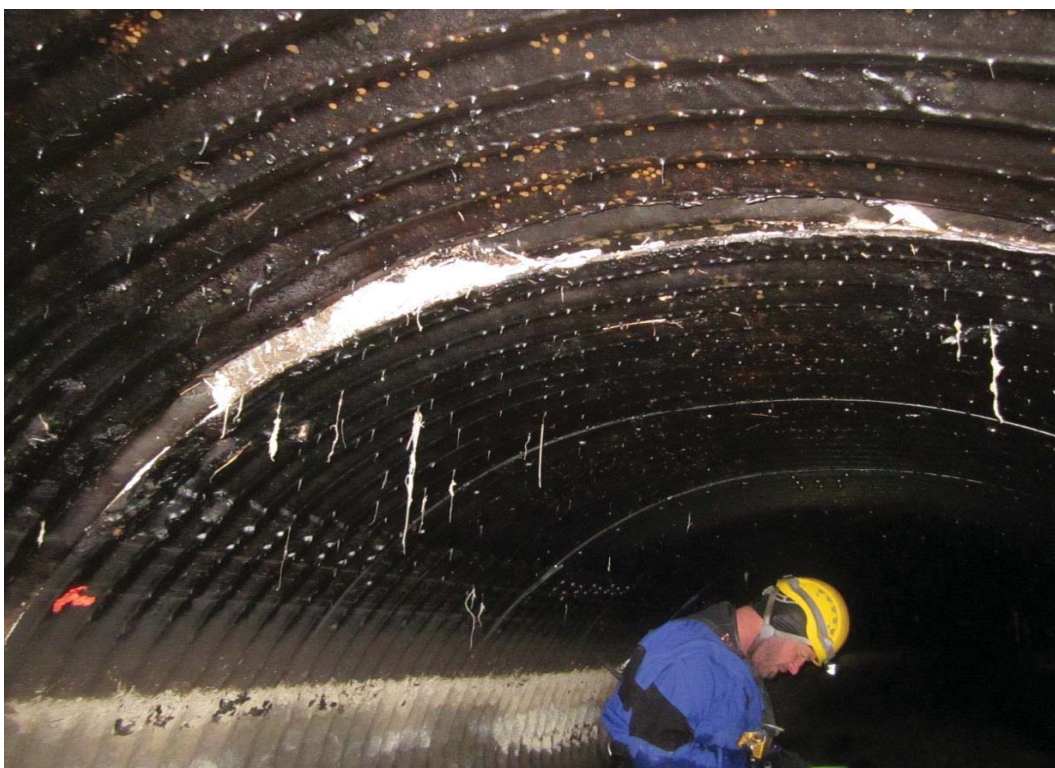
Photo 66

Drain B - 268'  
Seam with gap open to 2" with offset of 1" at crown.

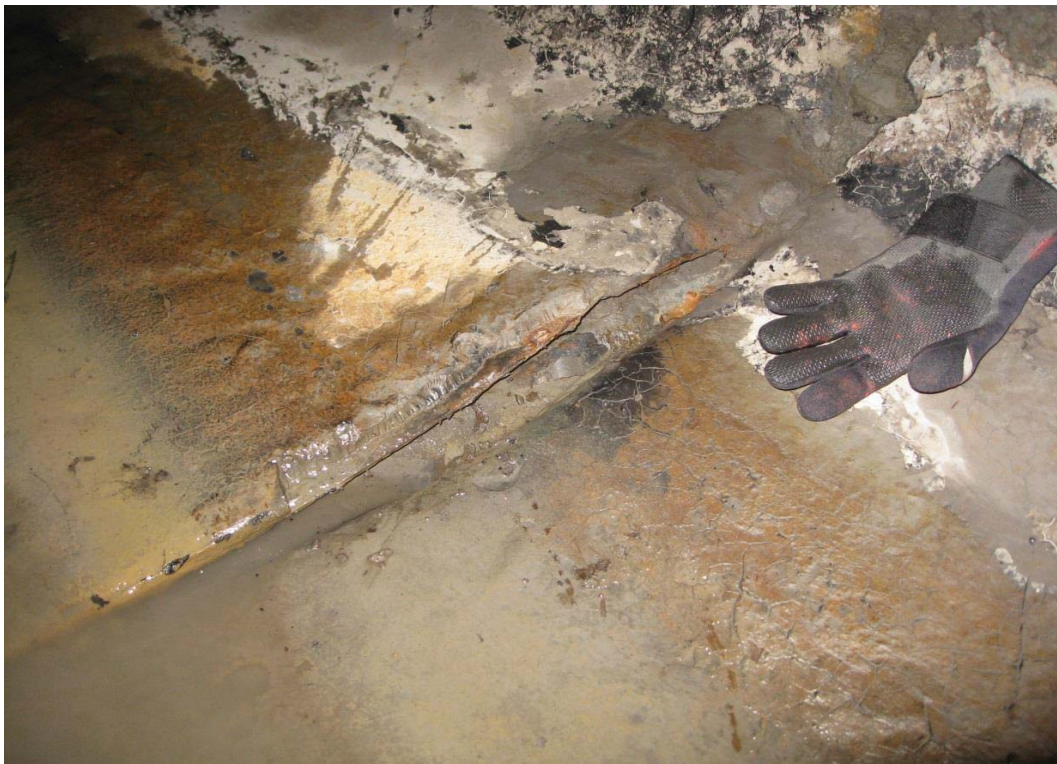
Photo 70

Drain B - 336'

Seam with apparent leakage. Floor sounds unsupported from 300' to 475'. No gap for probe. There is fine silt to 3" deep. Photo is of 7 o'clock position.

The hollow sounding bottom of both drains should be investigated by drilling 3-5 small 1/8" pilot holes in each 175' section and probing with a light welding wire. The holes should be sealed with epoxy, silicone or with self sealing sheet metal screws. This recommendation is a moderate to high priority.

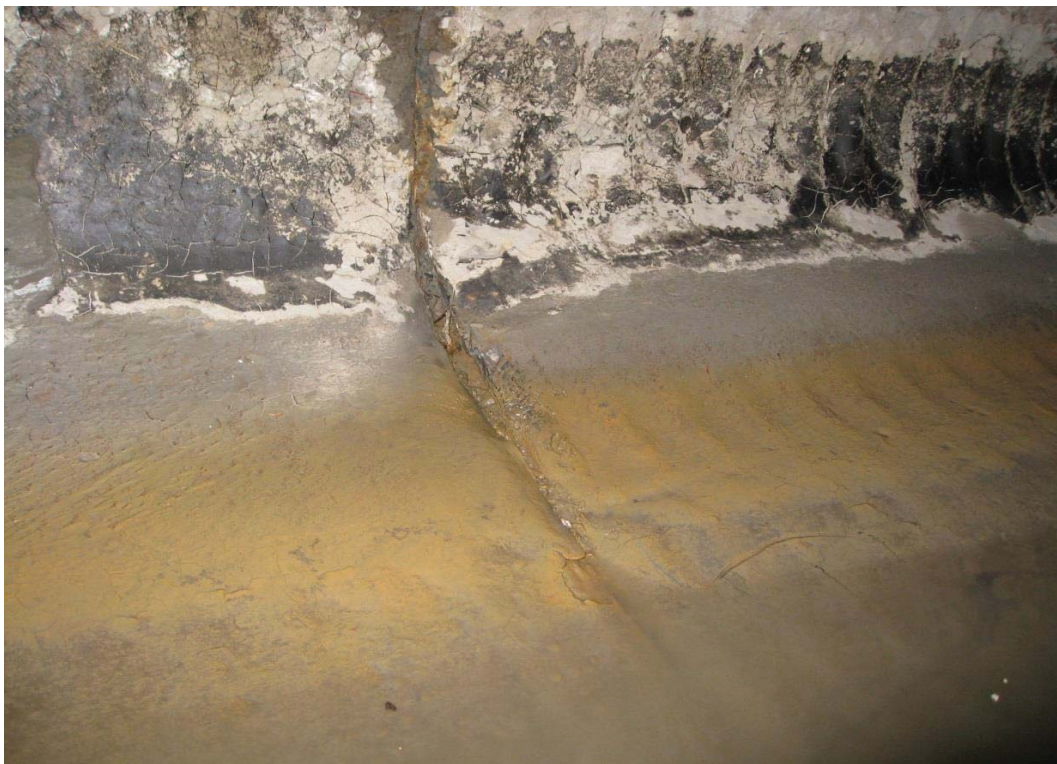
Photo 71

Drain B - 400'

Seam at 8 o'clock with vertical gap to 1-1/2" and horizontal gap to 1/2". Solid behind gap, no void.

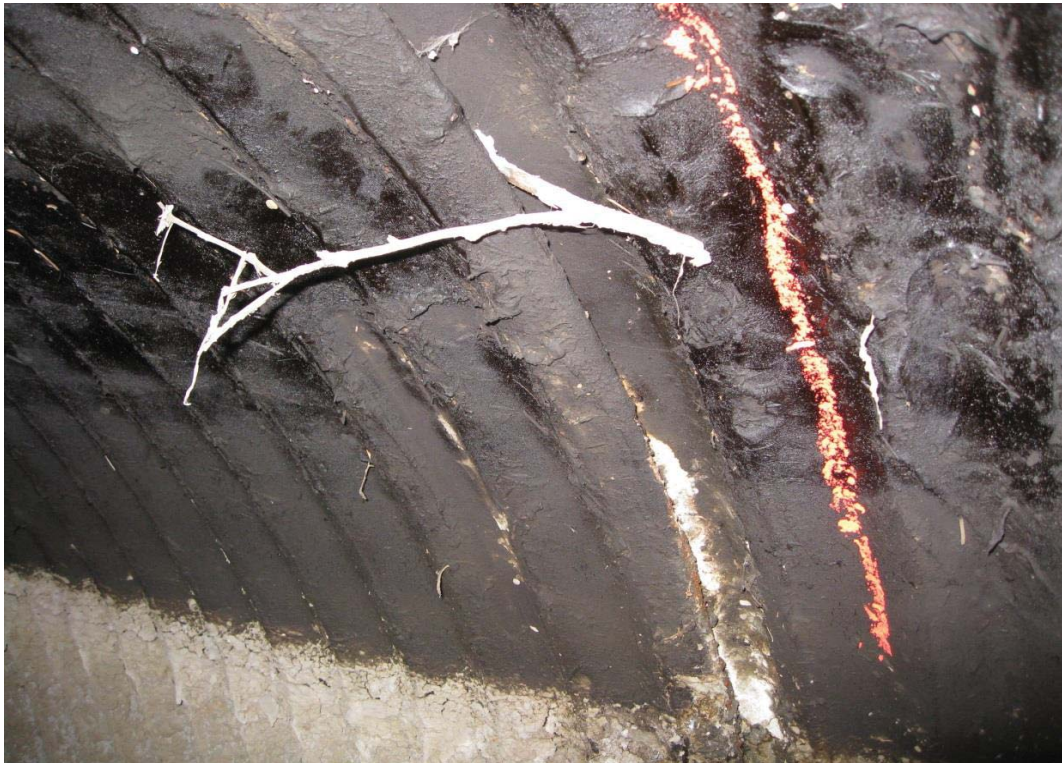
Photo 73

Drain B - 424'  
Seam at 1:30 with vertical gap to 1/2" and horizontal gap to 1".

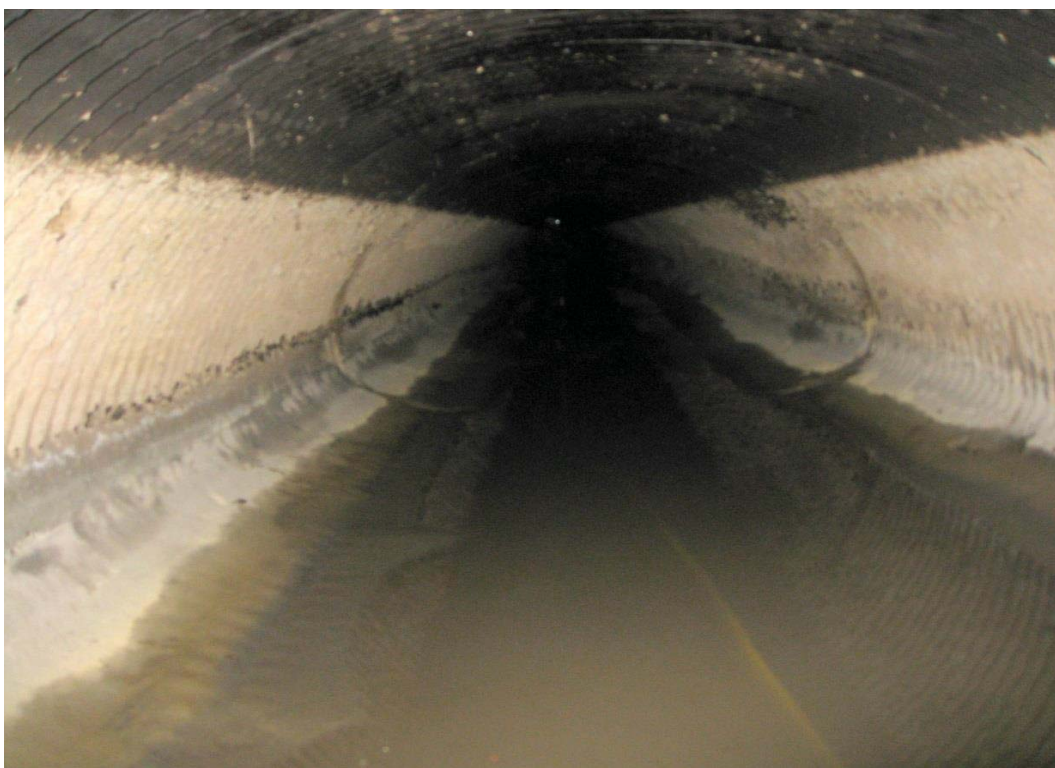
Photo 74

Drain B - 475'

View upstream. Coating is intact. Coating is much thinner and less adhered on bottom and sides going downstream.

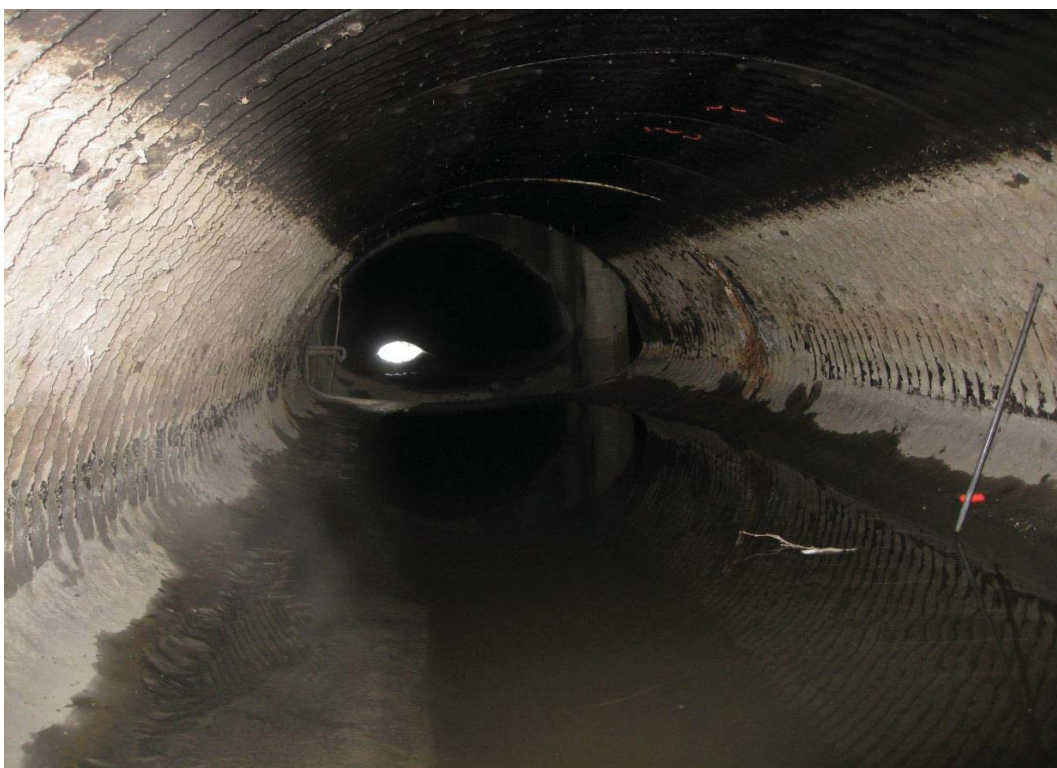
Photo 76

Drain B - 495'  
View downstream. Drain is half full of tidewater. Coating is thin.

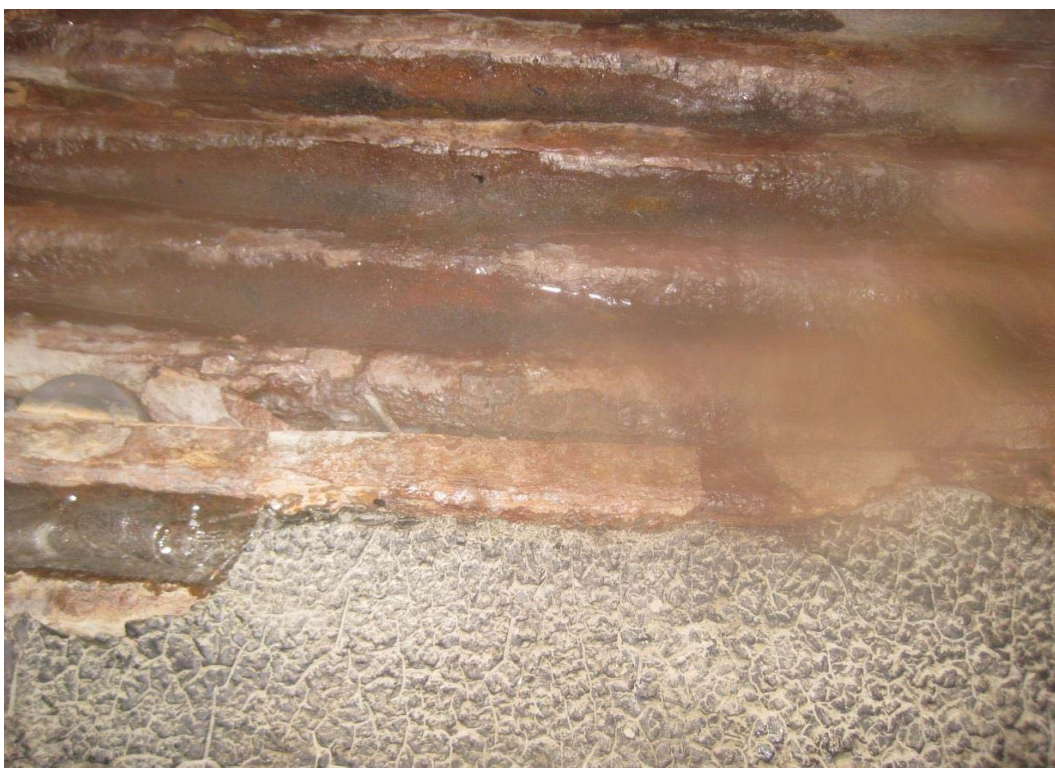
Photo 78

Drain B - 539'

Seam at 6 o'clock with gap to 1" and offset up to 2". Heavy corrosion.

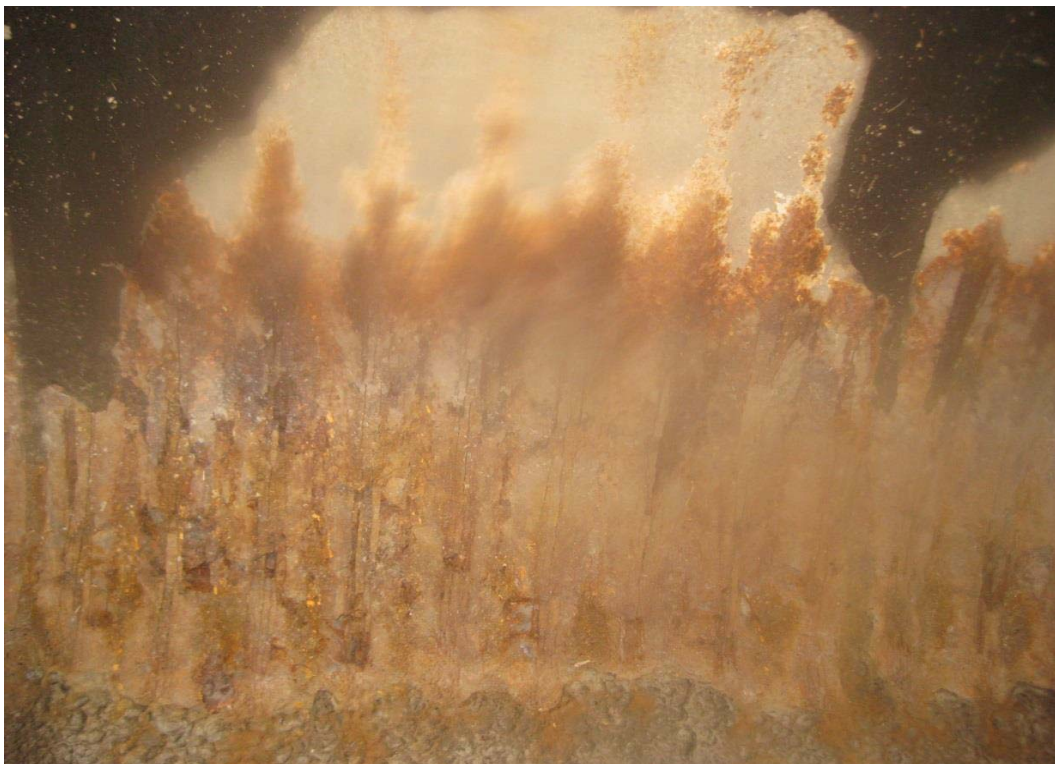
Photo 79

Drain B - 550'

Coating failure with heavy corrosion in a 2' strip to drain exit. No ultrasonic testing at this location due to heavy corrosion and crew fatigue.

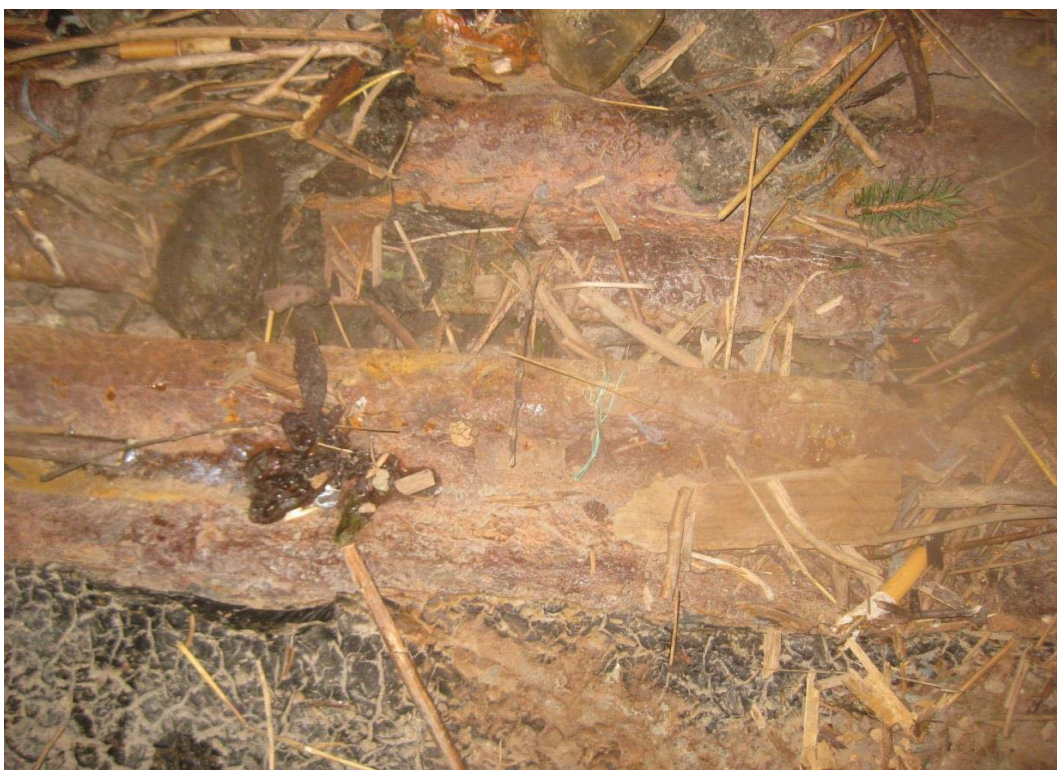
Photo 80

Drain B - 557'  
Seam at 6 o'clock with gap to 1" and offset up to 2". Heavy corrosion.
