**ASSESSMENT OF CONDITION
& RECOMMENDED REPAIR OPTIONS**

**DRAIN (CULVERT) A
DRAIN (CULVERT) B**

**UNDER THE COMMERCIAL AREA
BETWEEN CENTER AVE AND W MARINE WAY
KODIAK, AK**

**MILL CREEK MANAGEMENT
TECHNOLOGIES, INC.
1415 141ST COURT SE
MILL CREEK, WA 98012**

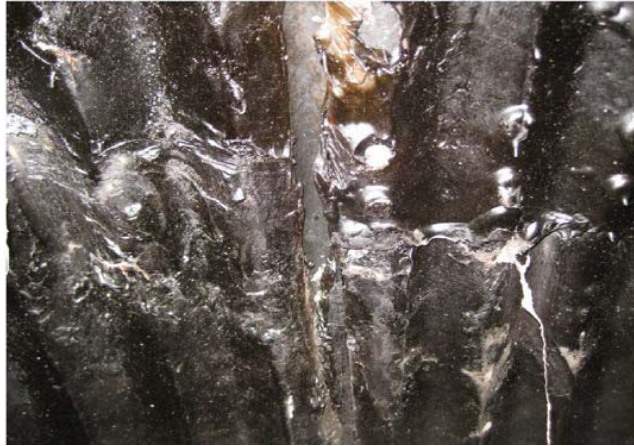
Photo 1 - Drain A - Separated joint showing no corrosion or signs of leakage

3. Many of the joints have separations of up to 1" but in all but three cases show no signs of infiltration or exfiltration. The exposed metal at these joints appears to be in pristine condition with very few exceptions. These joints need to be cleaned and treated with naval jelly where there is minor rust, then sealed with caulking and coated with a bituminous or coal tar epoxy coating to prevent future leaking and/or corrosion.

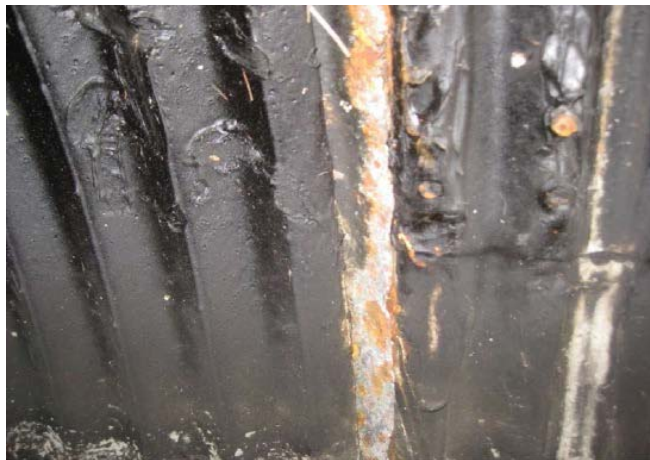
Photo 2 - Drain A – Separated joint showing minor incipient corrosion

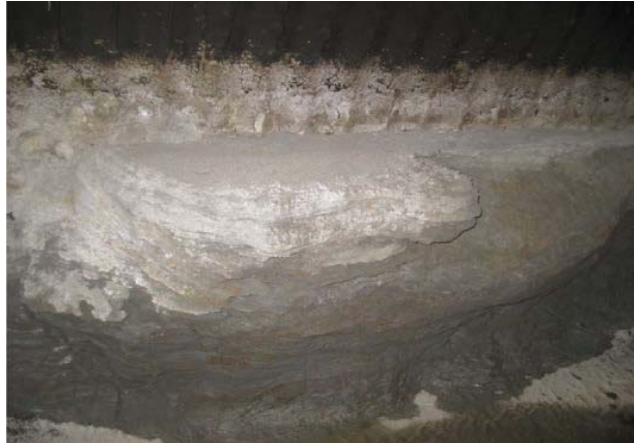
1. There are deposits about 10" deep in the inverts of both culverts that consist mostly of heavy silt, sand, some gravel (See Appendix photo 3). About 180 ft of culvert B has a layer of small rocks mixed with silt (See Appendix photo 8). These deposits prevented inspection of the culvert inverts. While it is likely that the inverts are in excellent condition based on what the culverts look like at water's edge, it is recommended that they be sample-inspected to confirm their condition.
2. If the inverts are in good condition, the deposits should be left in place (especially the rocky deposits), as they will provide protection against abrasion caused by sand and silt carried down the pipe by seasonal flows.

Photo 3 - Drain A – typical 10" deep silt/sand deposit

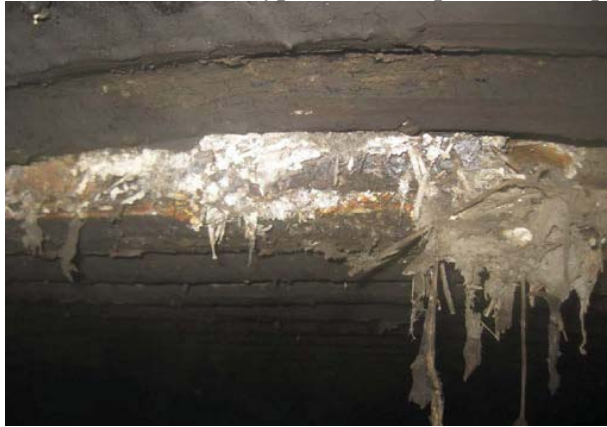
Photo 4 - Drain A – Joint with 1" separation and 1-1/2" offset

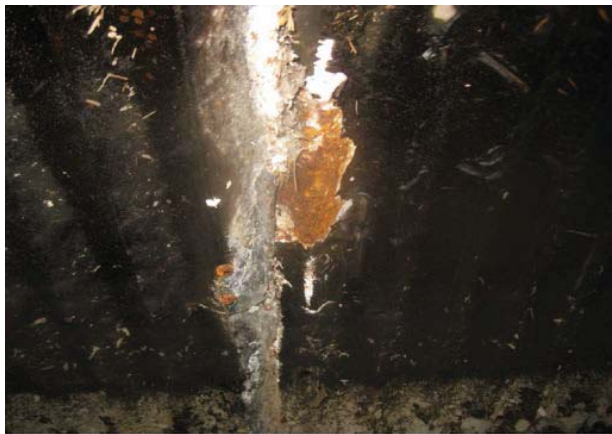
Appendix photo 13) or where the coating was pulled apart when the joints separated, allowing exposed steel to become mildly corroded (See Appendix photo 5).

Photo 5 - Drain A – occasional flaking off of coating with minor Corrosion

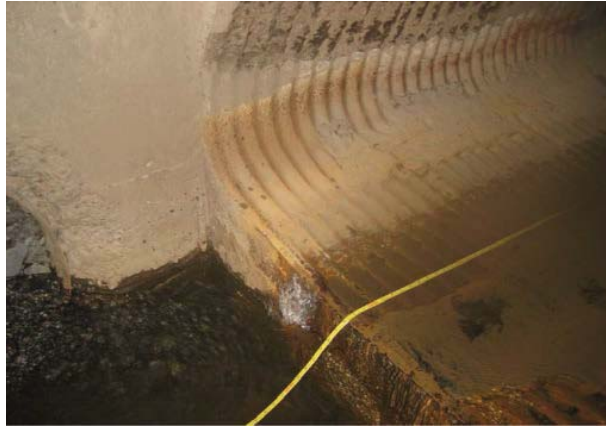
Photo 6 - Drain A – Outlet steel is exposed and needs to be cleaned and recoated

4. The areas inside both pipes where there is some serious but limited-scope corrosion (mostly around the inlet flame-cut manhole/pipe openings and the outlets) need to be cleaned carefully by wire brushing, repaired with an epoxy-resin coating and finished with a thick bituminous coating like the original coating.

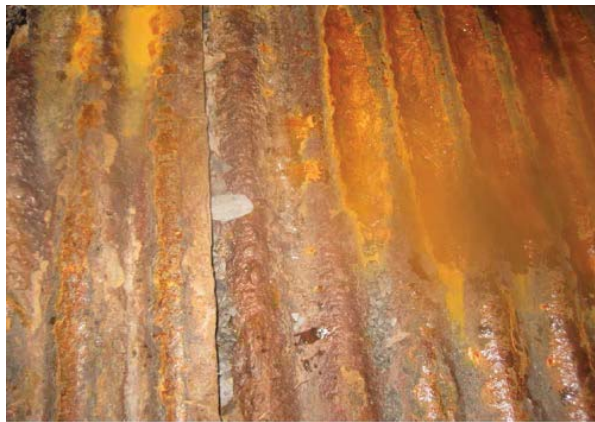
Photo 7 - Drain A - Corroded outlet where coating is missing

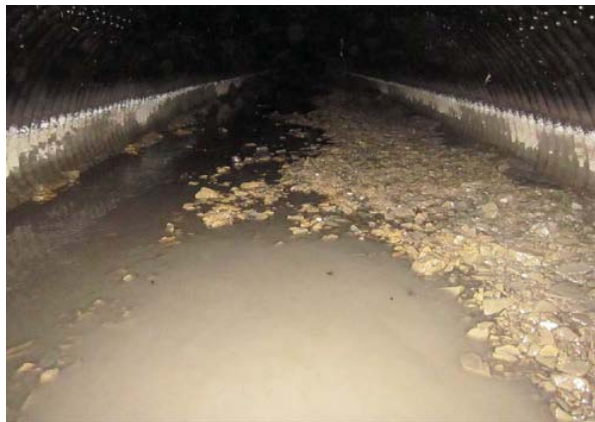
Photo 8 - Drain B – Rocky invert debris

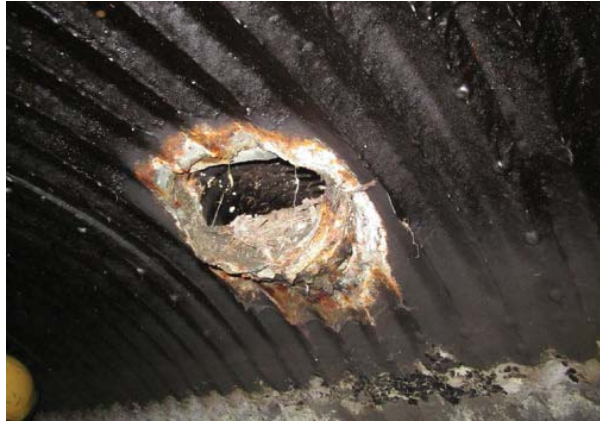
3. There is an element of weather severity in seasonal freeze/thaw cycles that would be expected to affect the inlet and outlet areas of the pipes. This seems to be the case for our culverts: corrosion is present in all of the inlet and outlet areas where severe weather conditions have caused peeling up of the bituminous coating and allowed corrosion of the underlying steel (See Appendix photos 6 & 7). Pipe deterioration is also present in areas where inlet openings exposed to severe weather were burned into the pipe crowns using a welding torch and the bituminous coating was not restored following the cutting (See Appendix photos 9 & 11). All of these corroded areas can be repaired and recoated to reestablish pipe longevity.

Photo 9 - Drain B - Flame cut inlet opening

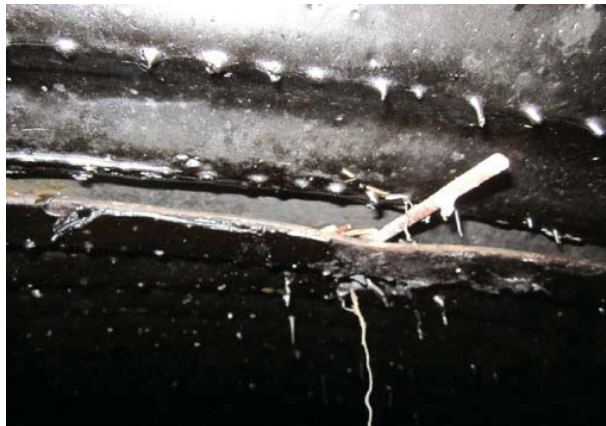
Photo 10 - Drain B – Separated joint with 1” offset

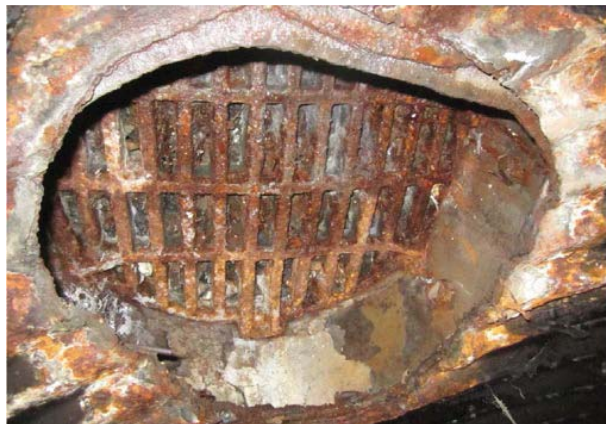
Photo 11 - Drain B – Flame cut manhole opening with serious Corrosion needs to be cleaned and recoated

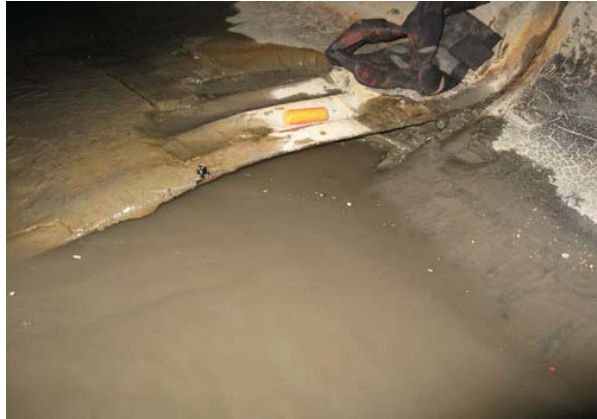
larger with time and undermine the structural integrity of the pipe. The inspection found a continuous void of unknown depth between 300 ft and 475 ft and one 12" deep horizontal void at 484 ft under the invert of Drain B. Both defective areas need to be grouted with cementitious grout to prevent potential future enlargement.

Photo 12 - Drain B – 12" horizontal void that needs to be filled

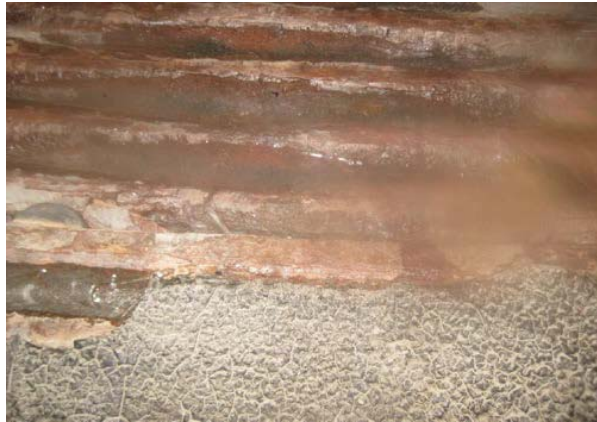
4. Reliability and permanence of the protective coatings (both metallic and bituminous) depend heavily on how the coatings were applied, how thick they are, how well the receiving pipe surfaces were prepared prior to application and how many holidays (defects) are present following application and. In our case the coatings appear to be well adhered throughout (with minor exceptions noted above). There are a few areas where coating adhesion has failed (See

Photo 13 - Drain B – outlet has lost some coating and is corroded. Needs to be cleaned and recoated

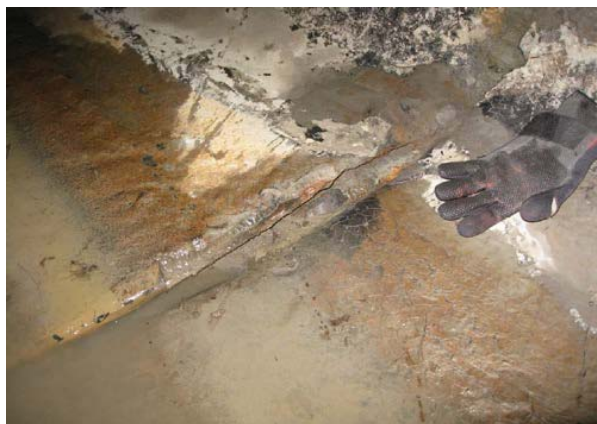
8. Three joints in a 40 ft section of Drain B have infiltrating joints (See Appendix Photo 14). One of the joints is leaking at an estimated rate of 2 gpm. All three joints are leaking from the 7 o'clock position and are close to or within the segment of drain where a continuous void was detected. These joints probably have voids behind them where soil fines have been washed into the pipe and need to be sealed with urethane grout to prevent future void enlargement. The pipe outlet end is encased in a concrete bulkhead but the presence of a long void near that outlet suggests a possibility that there is a void-forming channel flowing under the culvert invert. It needs to be grouted with cementitious grout.

Photo 14 - Drain B – One of two infiltrating joints that needs to be sealed and recoated
