MEMORANDUM

DATE: June 8, 2023
RE: City Manager Report

Baranof Park Tree Assessment

Assessed by Jeremiah Olsen, DBA Jere's Tree Service 5/15/2023

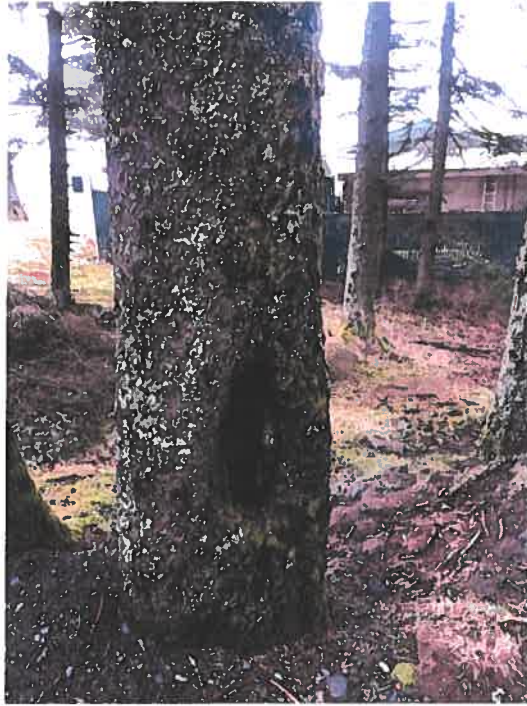
Tree with old wound that has turned to rot and decay, severely compromised

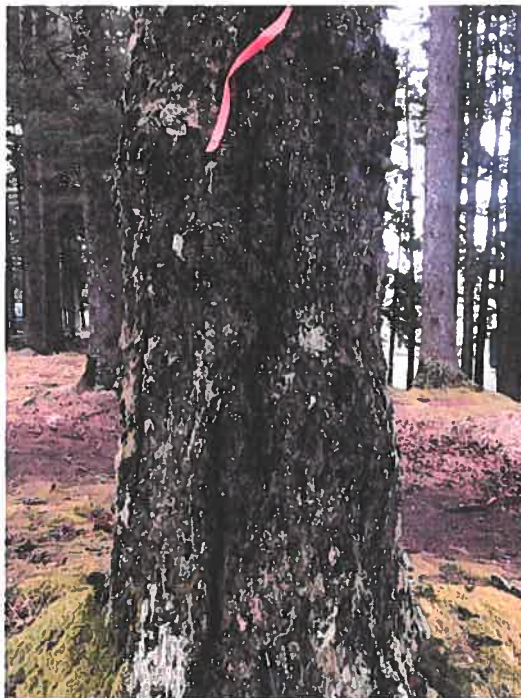
Cracked/spiral grain tree that introduces water which equals decay

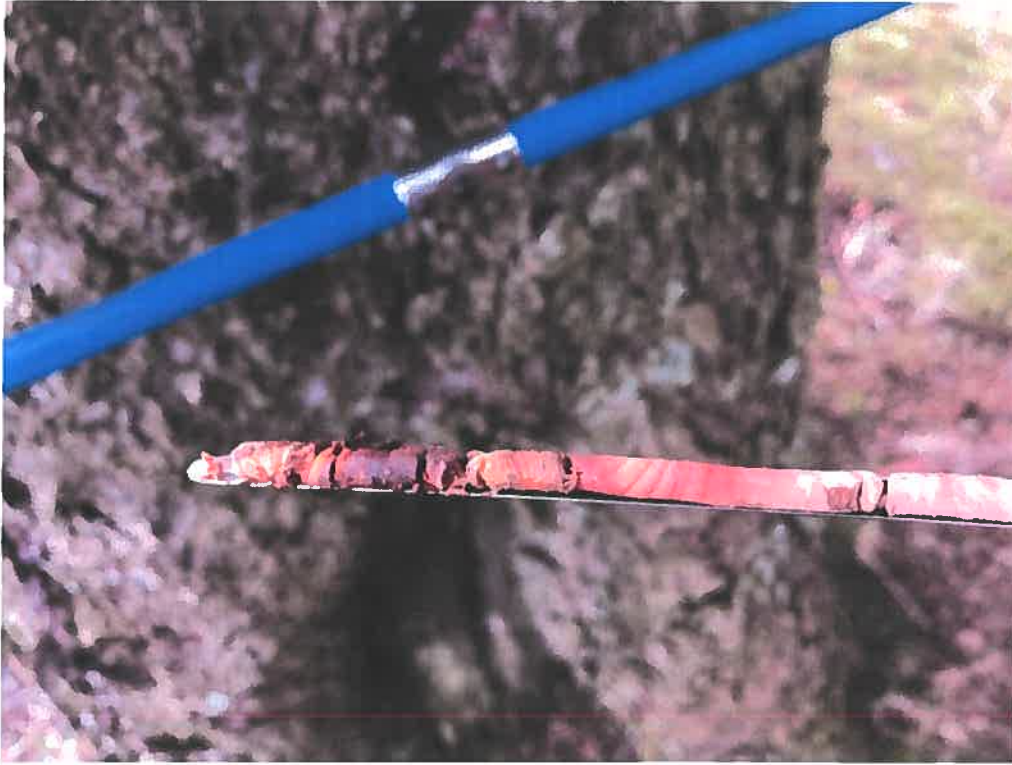
Spruce stump/root rot is irreversible once established and only continues to compromise the health of the tree and will either die standing becoming a snag or becomes susceptible to wind fall. Core samples of were taken to see the extent of the rot inside several of the trees.

Core sample of tree with only small opening in bark but the rot extends over 50% of the inside in tree
