REPORT

AN ENGINEERING ASSESSMENT OF THE CURRENT STABILITY OF THE PILLAR MOUNTAIN SLIDE

KODIAK, ALASKA

November 20, 2013

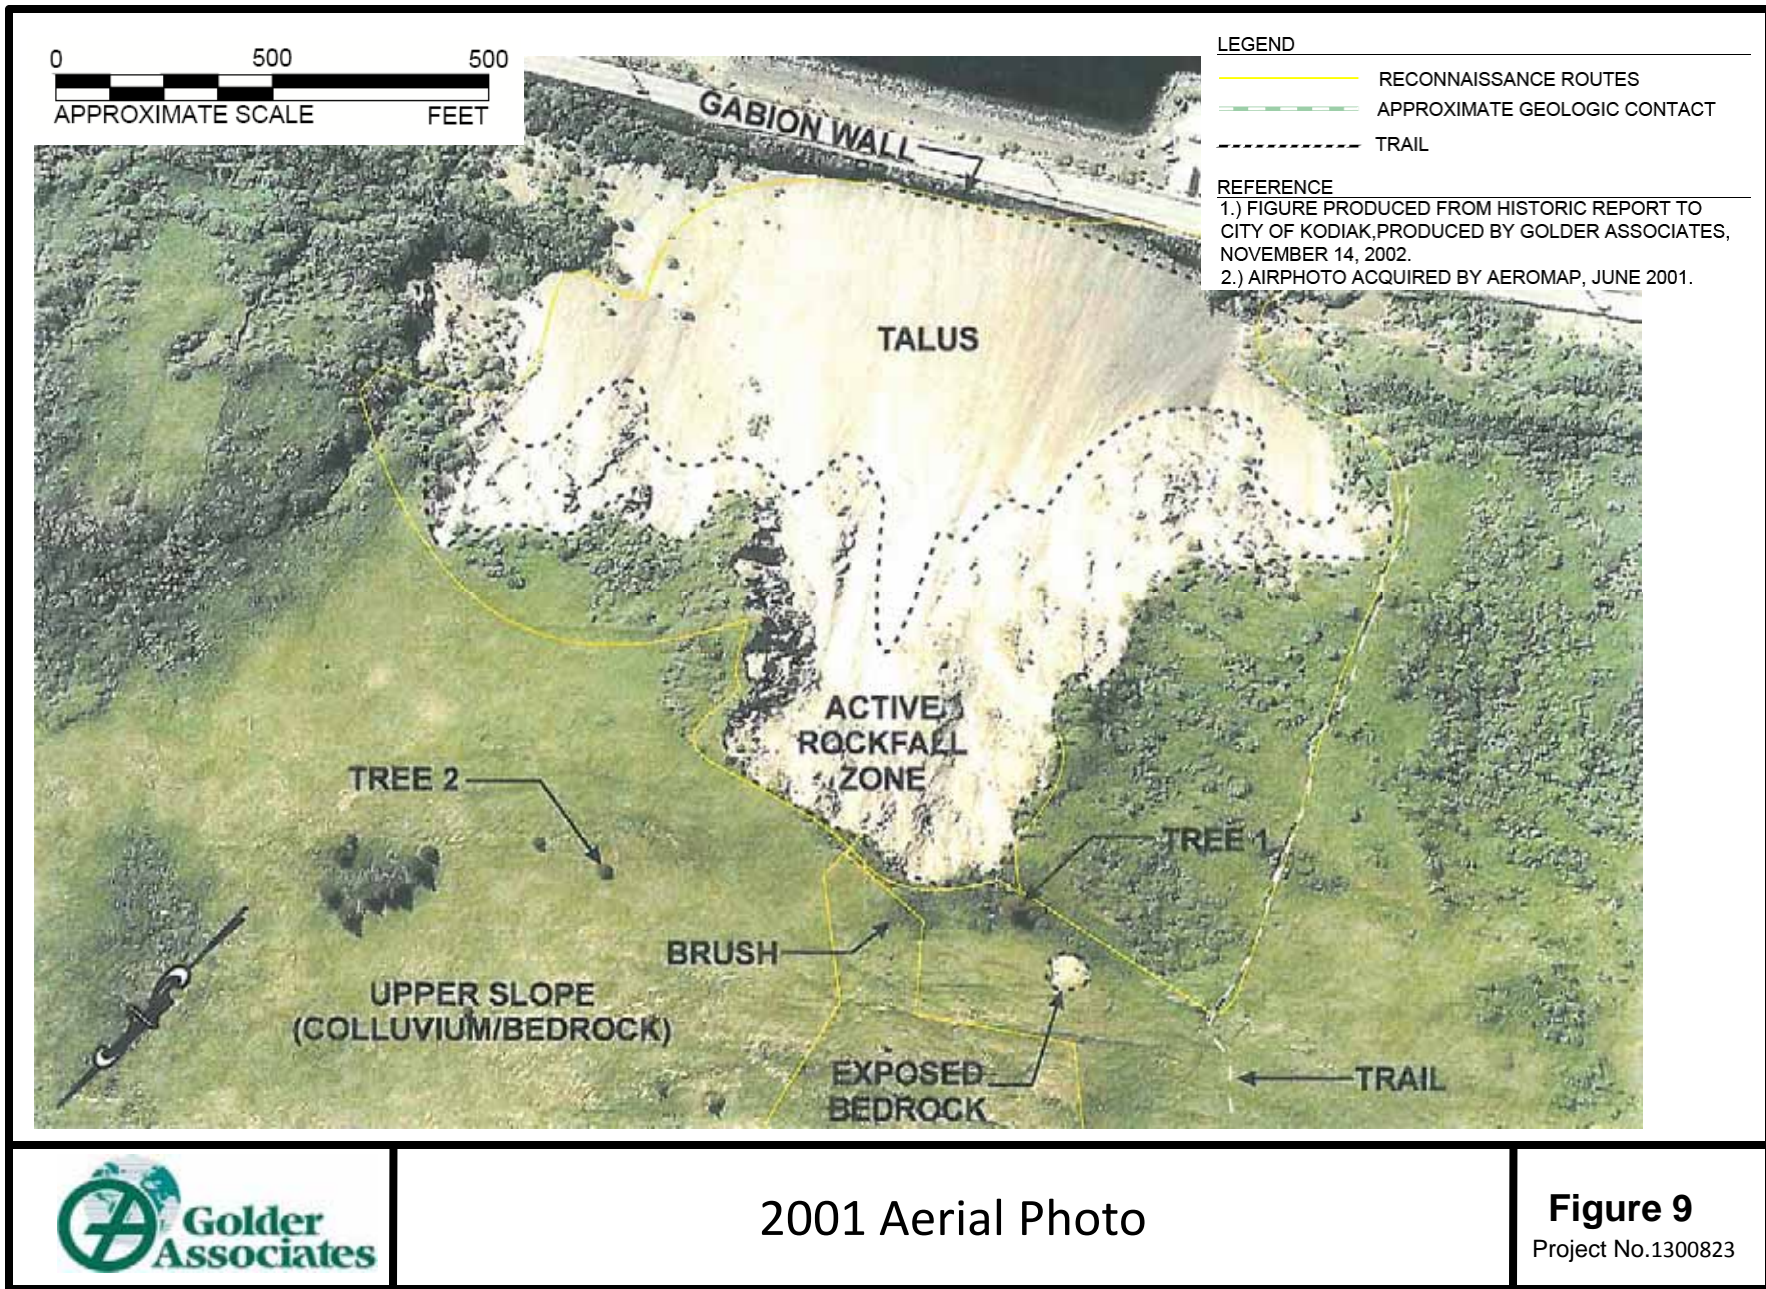
Figure 9
Project No.1300823

The slide area exhibited no significant changes from the conditions observed in 2002. Figure 9 shows a photograph taken in 2001. Figure 10 shows a similar view in LiDAR taken in 2013. Numerous photographs were taken on September 21, 2013. Several are presented as figures which are described as follows:

2001 Aerial Photo

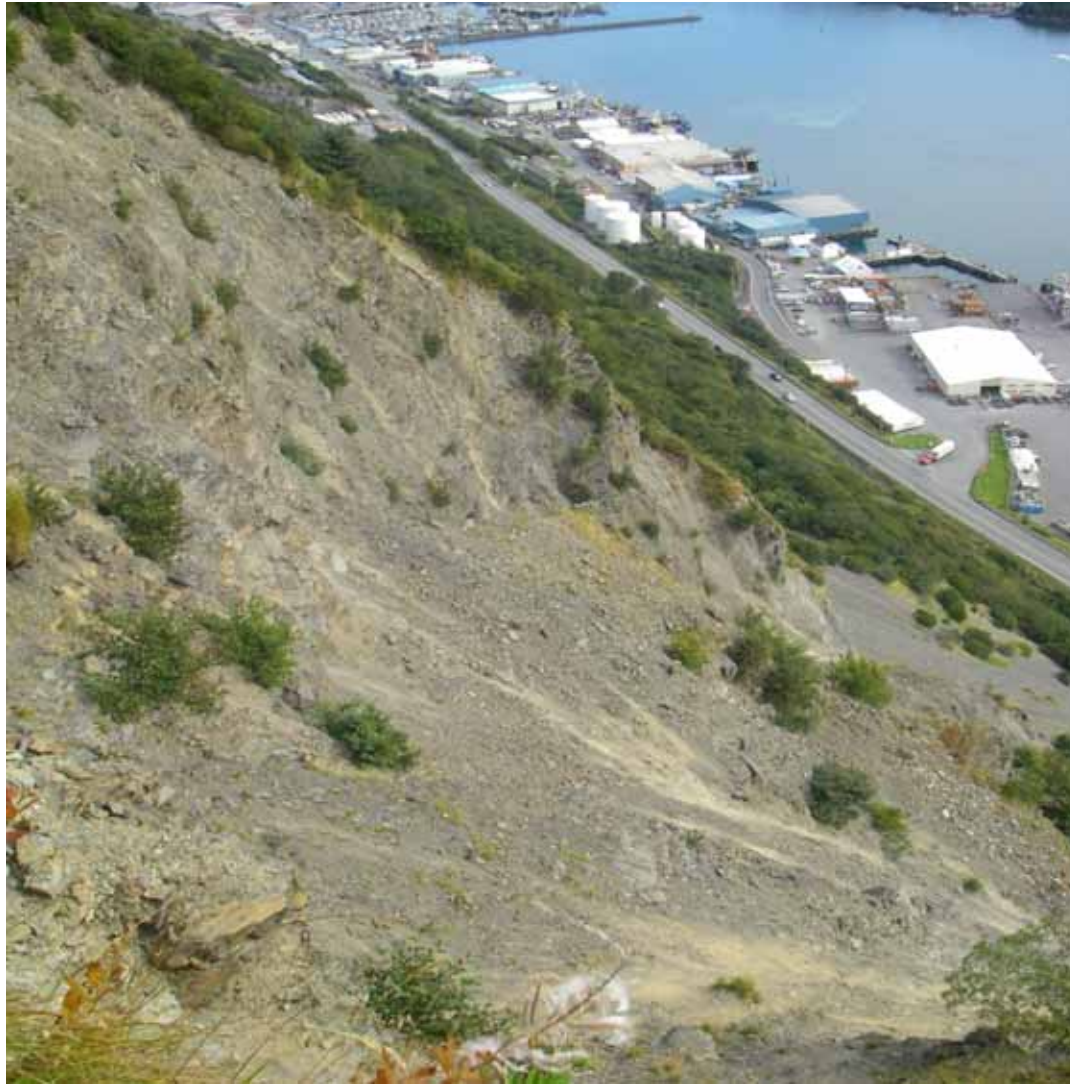
Figure 12
Project No.1300823

View Downslope from Head-scarp
(September 21, 2013)

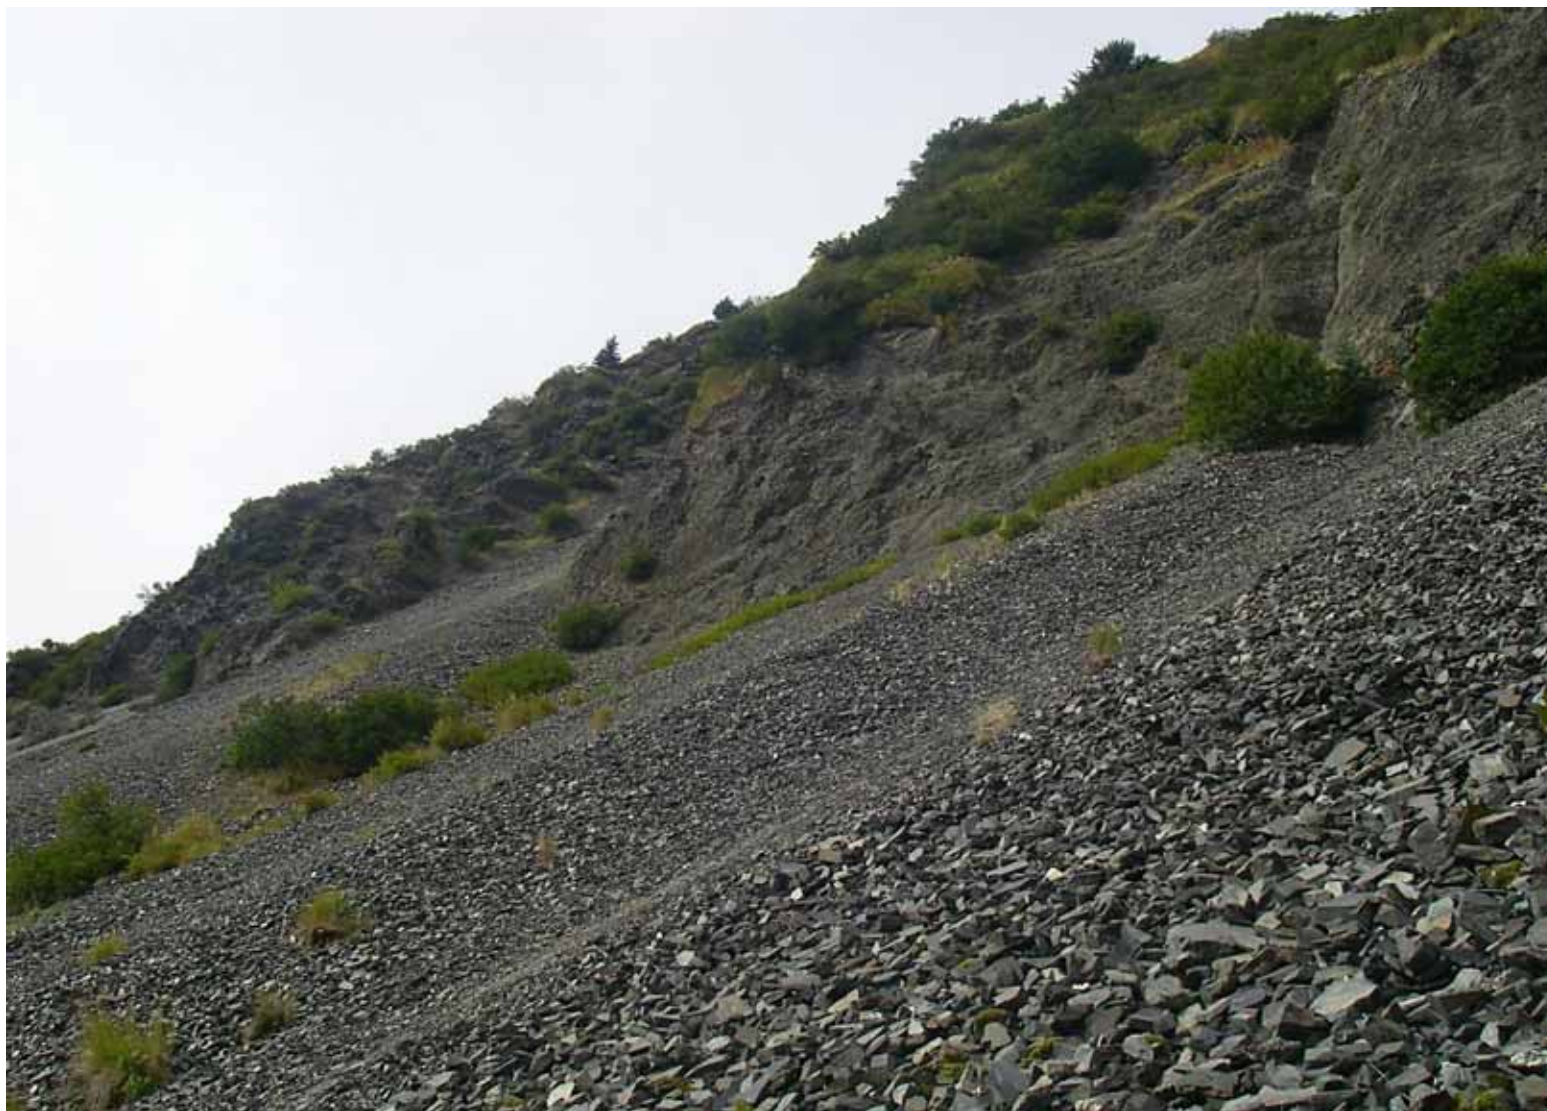
Figure 13
Project No.1300823

View of Northeast Side of Slide Area
(September 21, 2013)

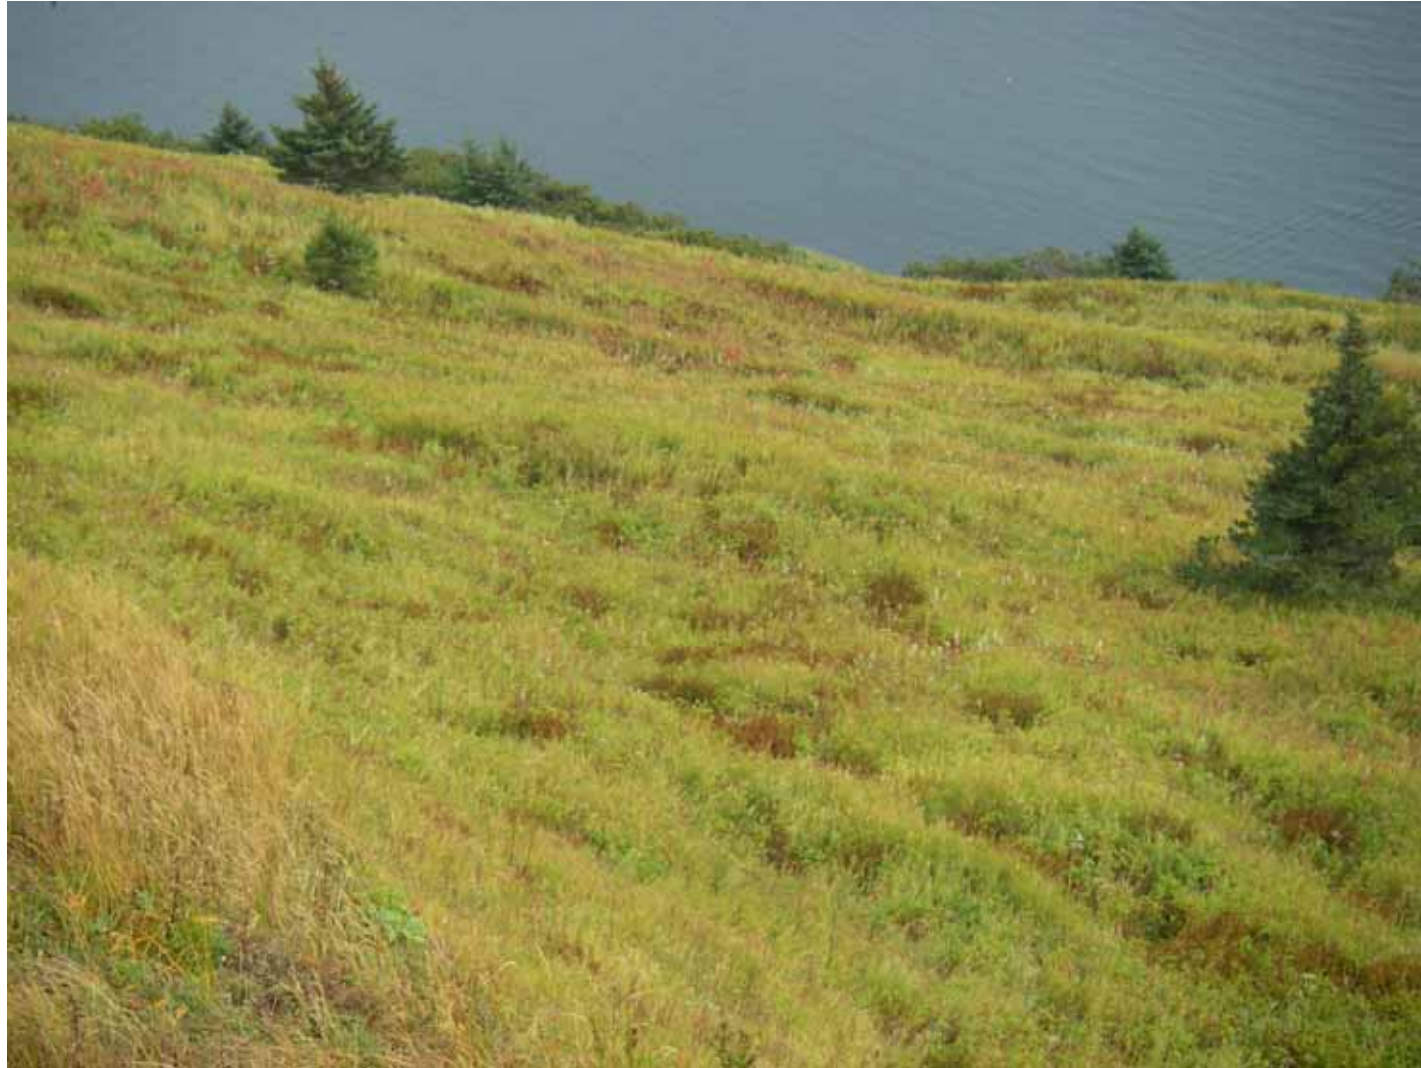
Figure 15
Project No.1300823

View of Upper Slope Terrain Above the Head Scarp
(September 21, 2013)

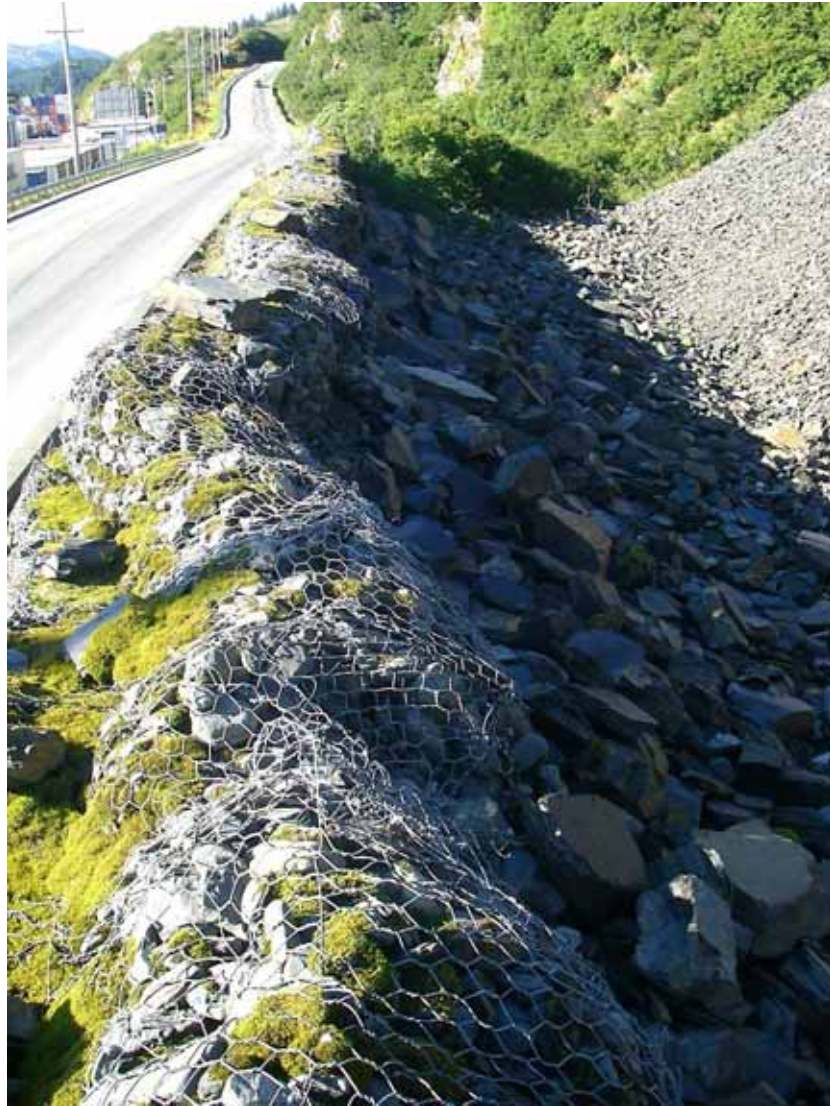
- Figures 16 and 18 show the condition of the gabion wall and the accumulation of talus behind it.
- Figure 17 shows impact craters in the highway pavement and talus under the guard rail across the highway from the gabion wall.
- Figures 19 through 22 show the rock structure in the head scarp above the talus slope.

The highway below the slide is protected from rockfall by a ditch and gabion wall which can be seen in Figure 17. As the figure shows, the gabion wall is distorted in places by apparent rockfall impacts. A couple rocks appeared to have reached the highway and possibly reached the far guardrail as is evident in Figure 18. Some of the largest blocks (See Figure 19.) reached the gabion wall and these are typically tabular and weigh 50-200 pounds. They apparently begin spinning on edge after they fall and thereby achieve greater velocity enroute down the talus cone compared to rocks that fall and slide. The talus is composed of larger blocks, typically in the 10-50 pound range, on the southwest side of the cone, while the northeast side of the cone is typically characterized by blocks in the 1-5 pound range. The talus cone has grown slightly but there are no large blocks ($>0.25 \text{ yd}^3$) evident in the talus accumulations.

Rockfall across Road and Impact Craters on Pavement
(September 21, 2013)

- Repair the damaged gabion baskets.
 - Increase the height of the gabion walls to reduce the chance for rockfall on the highway. This should be done under the supervision of an engineer familiar with rockfall risks.

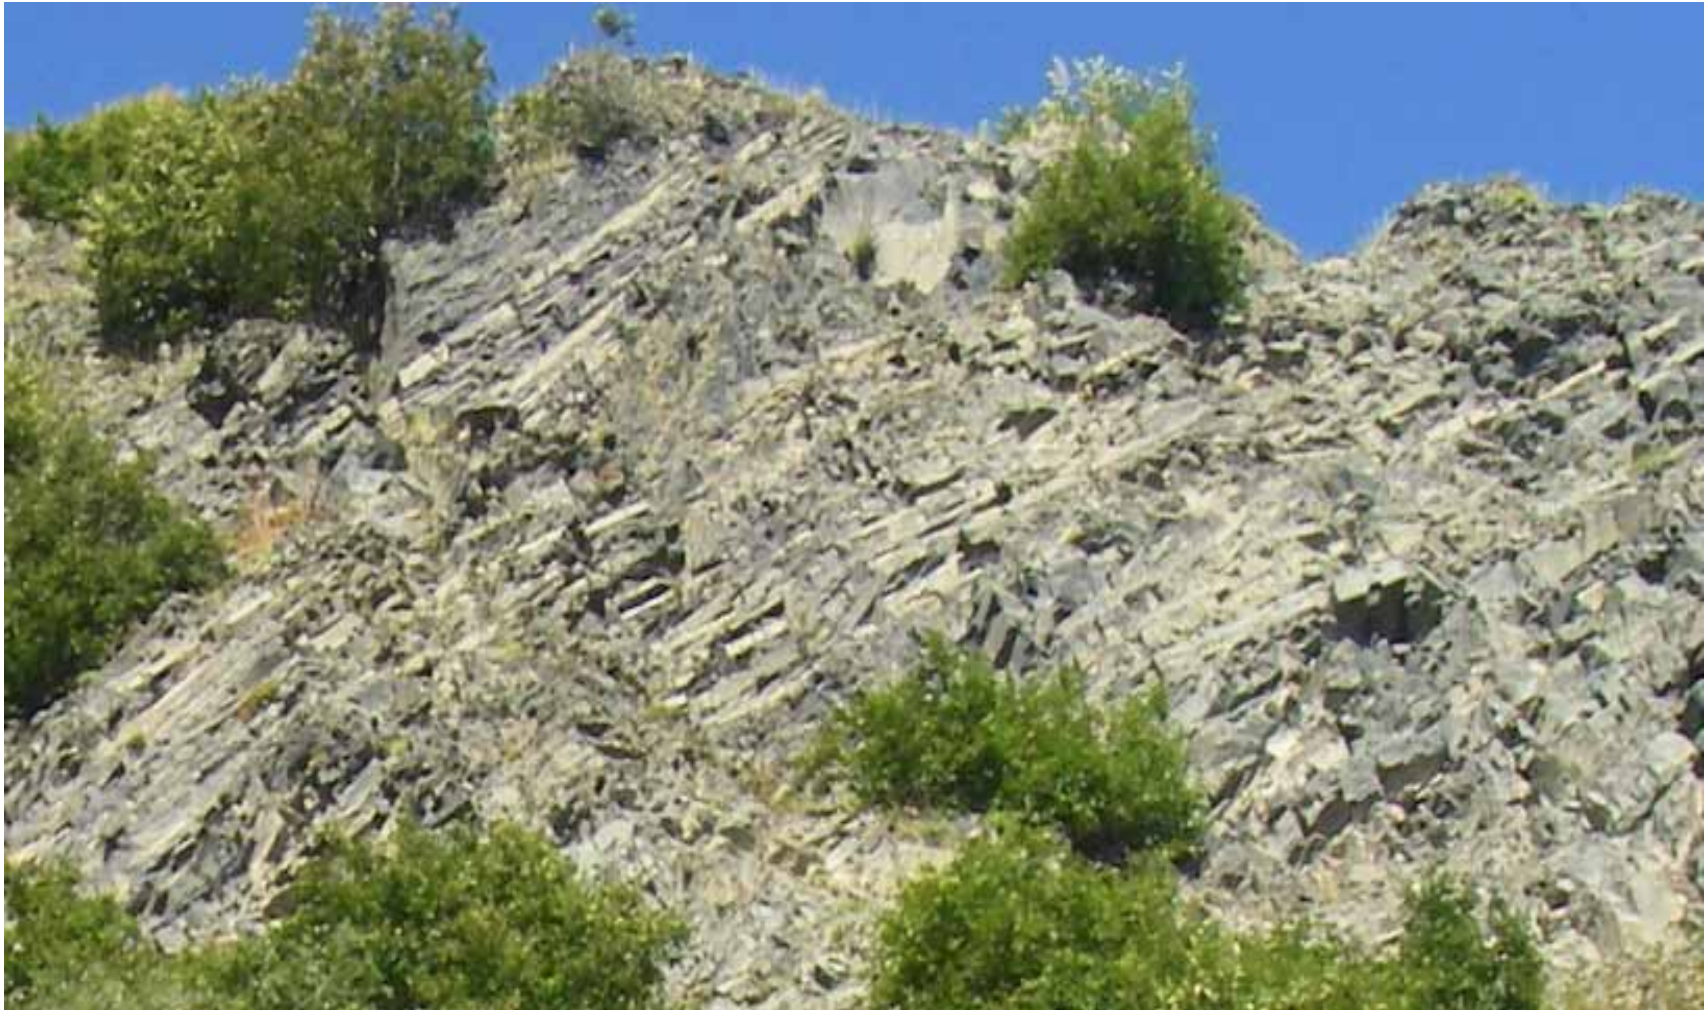
Figure 21
Project No.1300823

Cross Slope View of Head Scarp Rock Structure

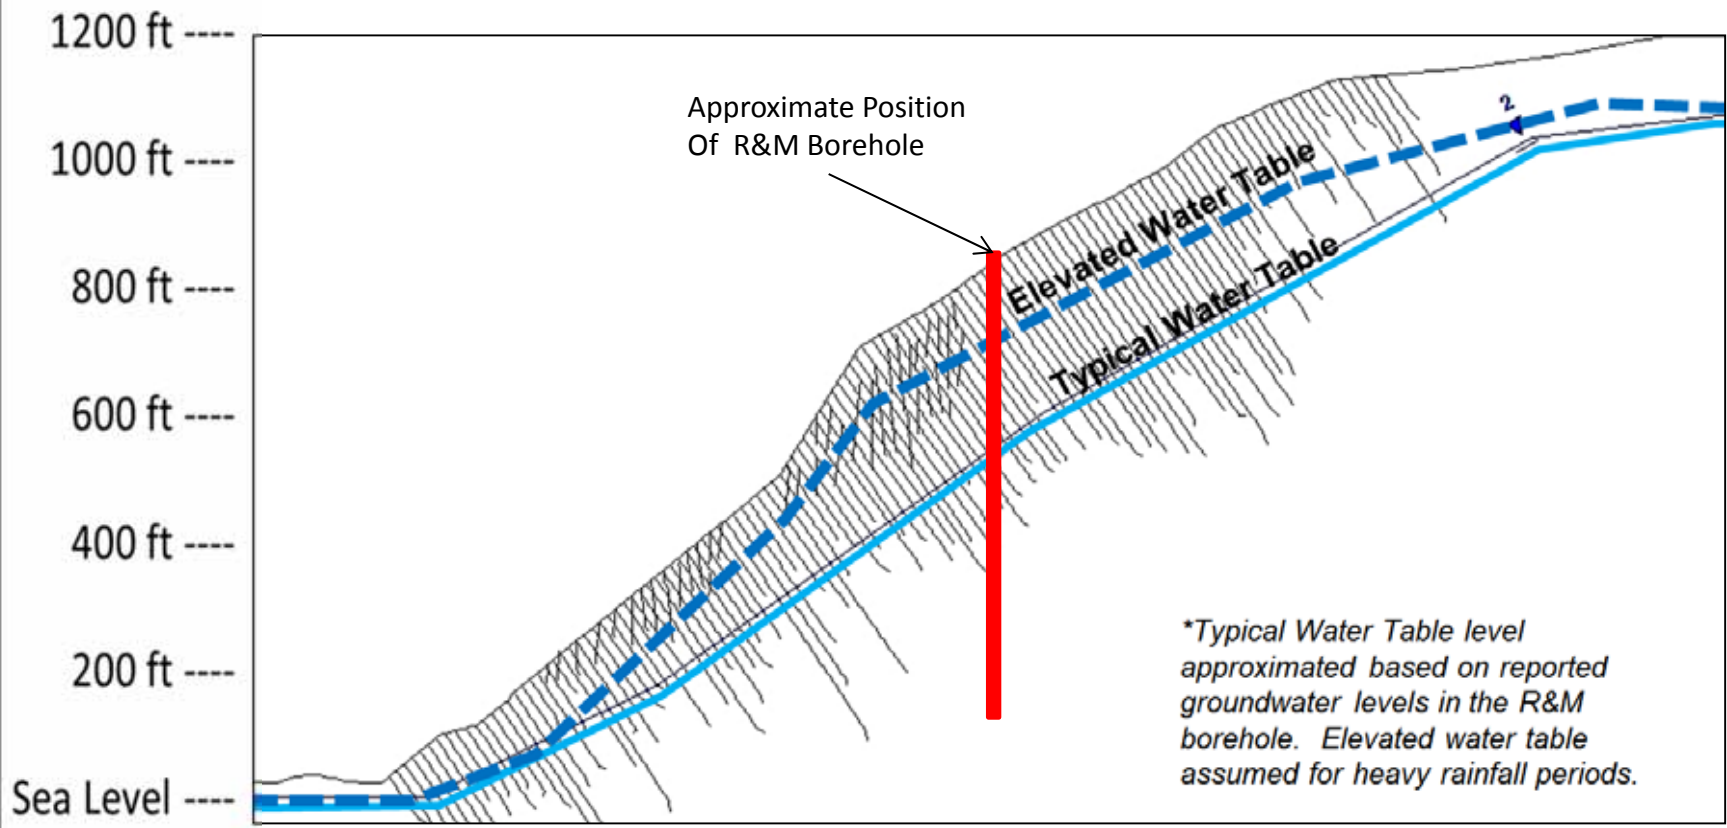
Figure 25
Project No.1300823

The analysis was carried out using typical and elevated water tables similar that that shown in Figure 25 and bedding was assumed to dip into the face approximately 60 degrees. At the toe of slope, additional sub-vertical J1 fractures were also inputted into the model to allow for freedom and dilation near the toe of slope (or in the case of Section 4, at the crest of the head-scarp as shown in Figure 25 and Figure 26). A possible typical water table elevation was estimated based on the water table reported in R&M “Drill hole No.1 1980” (“perched” water table measurements June 14 1980 – 315’ below ground surface, September 1, 1980 – 335’ below ground surface).

Example of Typical and Elevated Water Tables Shown for Section 4

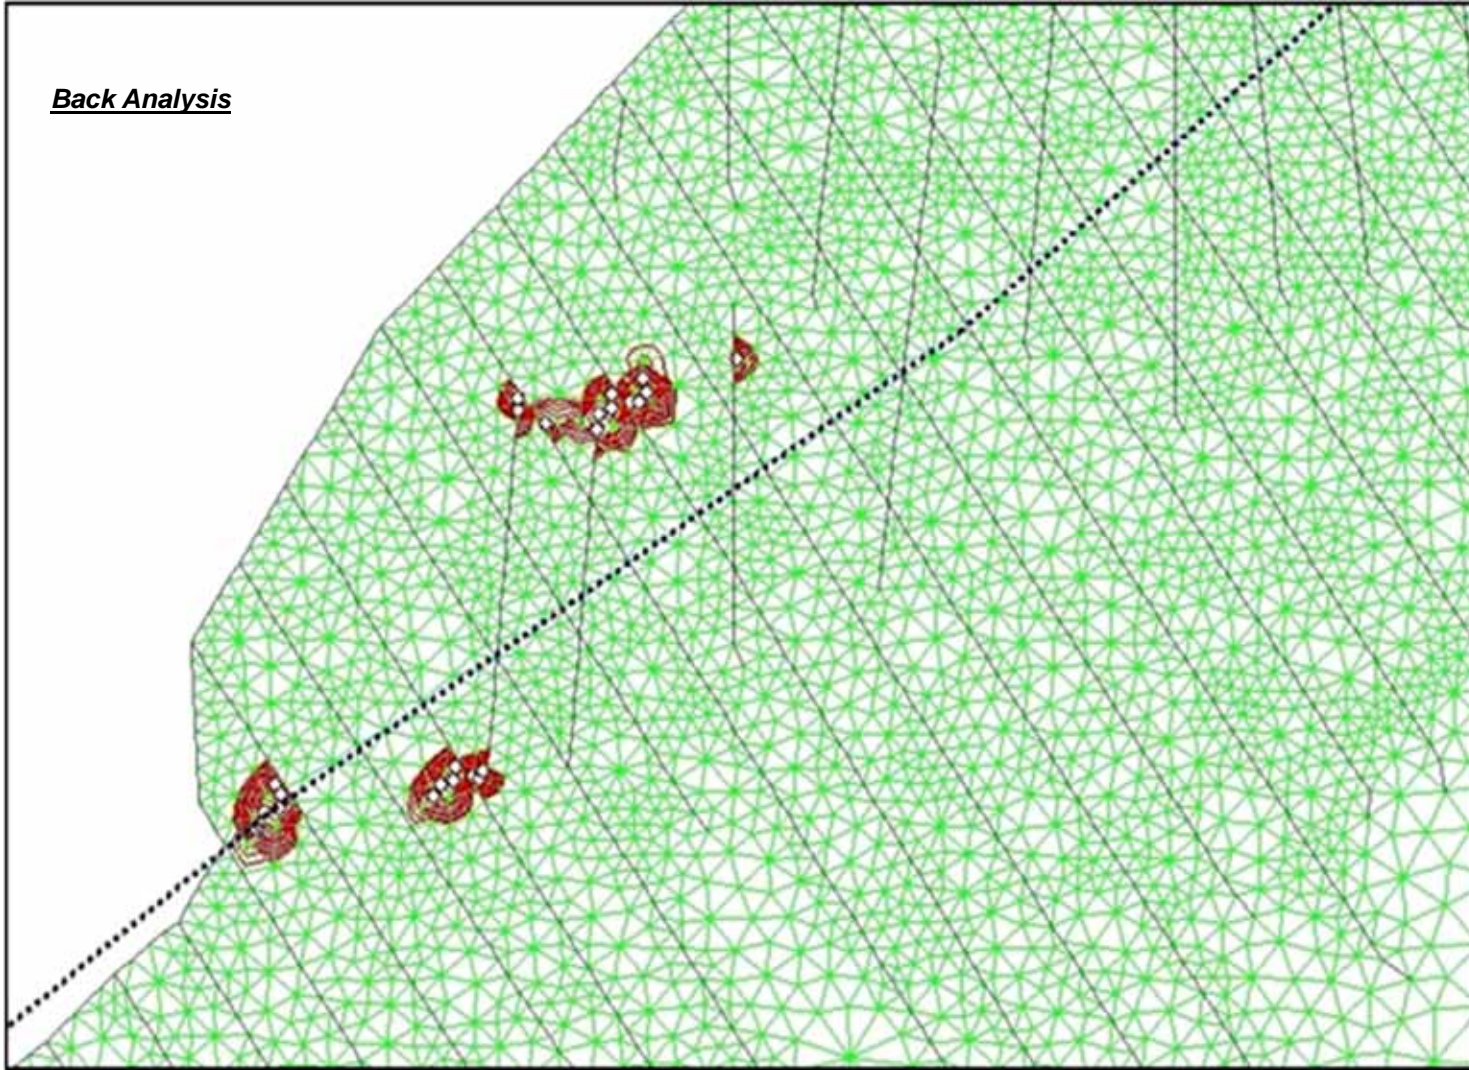
Figure 27
Project No.1300823

Tensile Fracturing/Yielded Element Progression to Failure (1 of 4) for Over Steepened Section 6

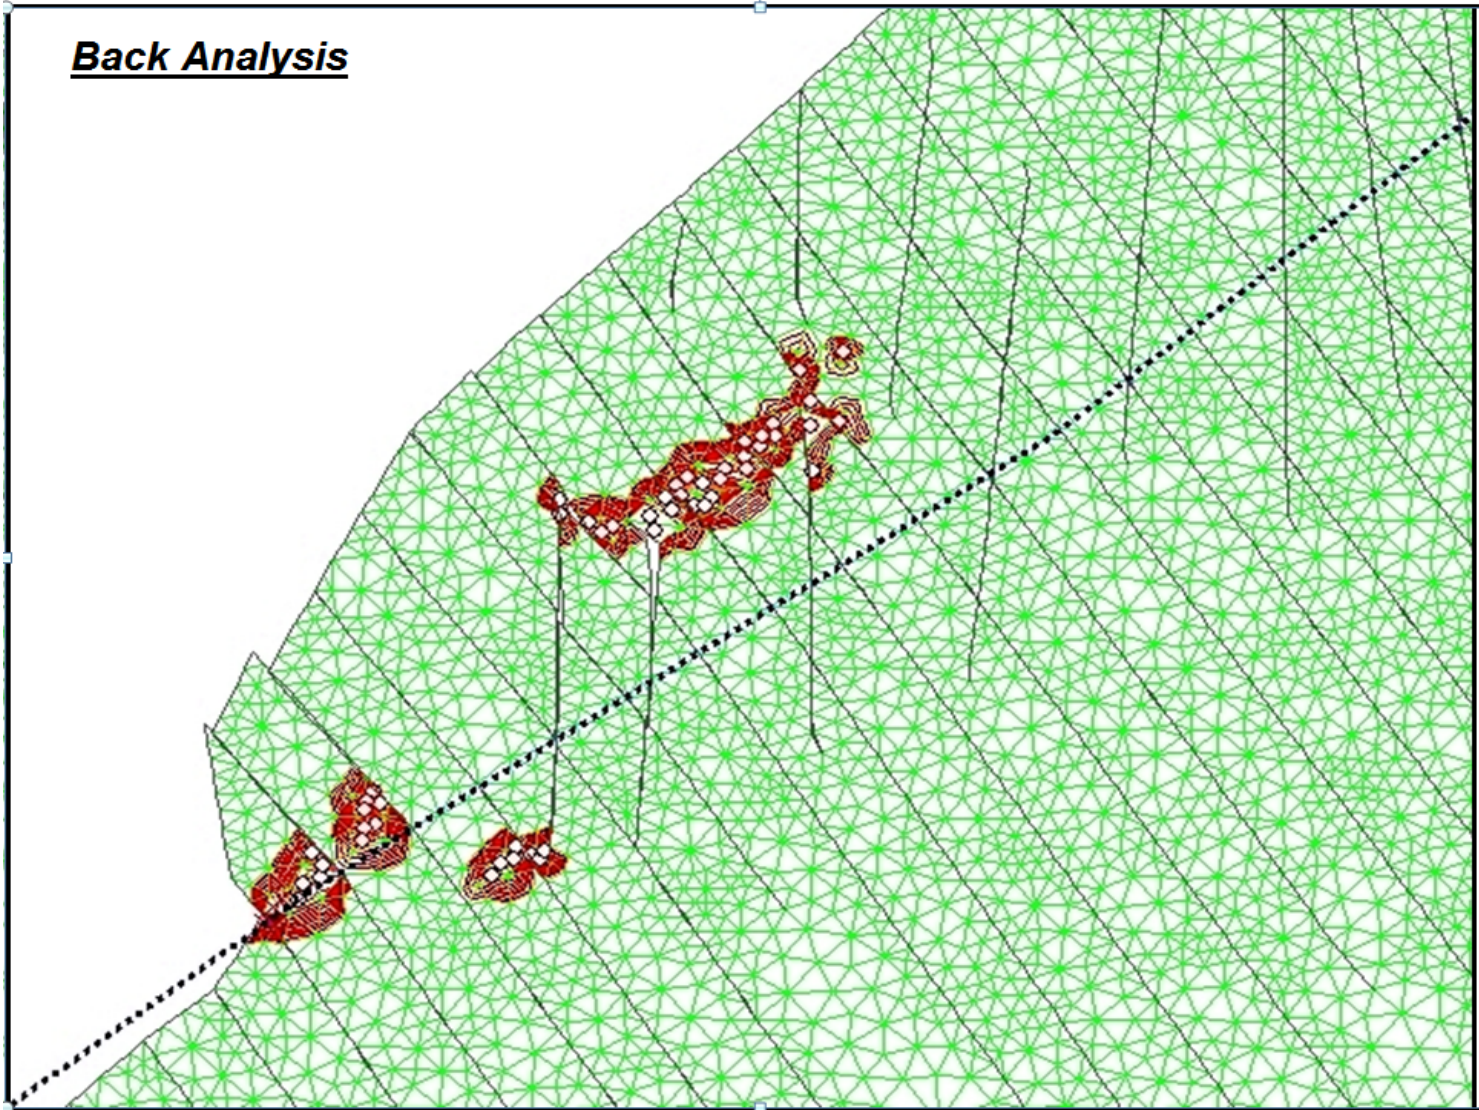
Figure 28
Project No.1300823

Tensile Fracturing/Yielded Element Progression to Failure (2 of 4) for Over Steepened Section 6

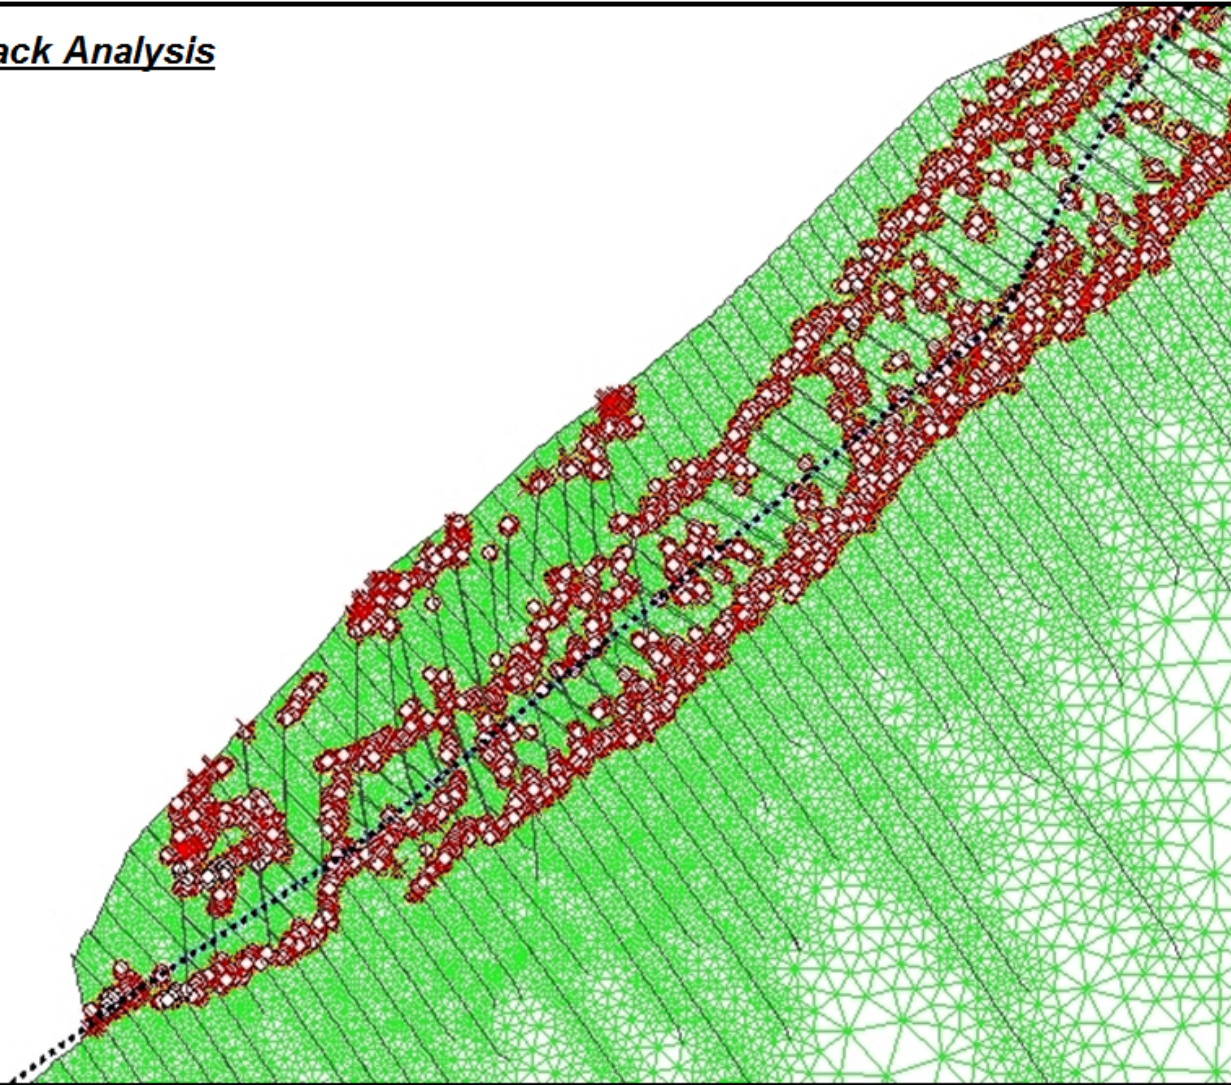
Figure 30
Project No.1300823

Tensile Fracturing/Yielded Element Progression to Failure (4 of 4) for Over Steepened Section 6

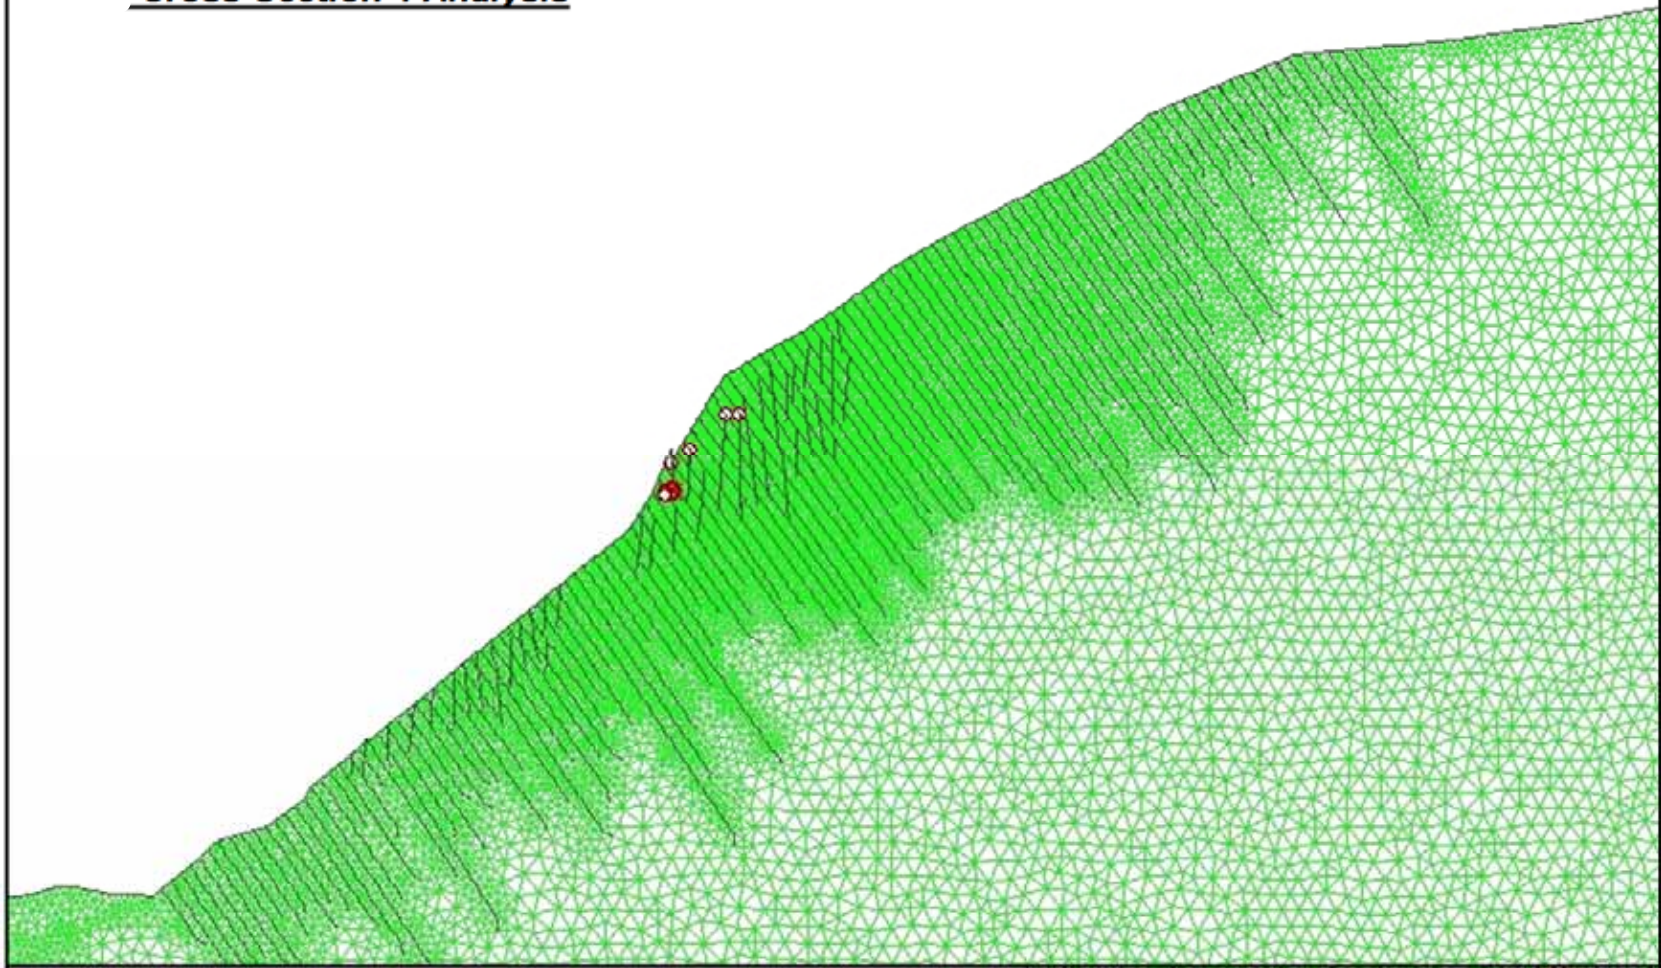
Figure 33
Project No.1300823

Tensile Fracturing/Yielded Element Progression to Failure (1 of 5) for Over Steepened Section 4

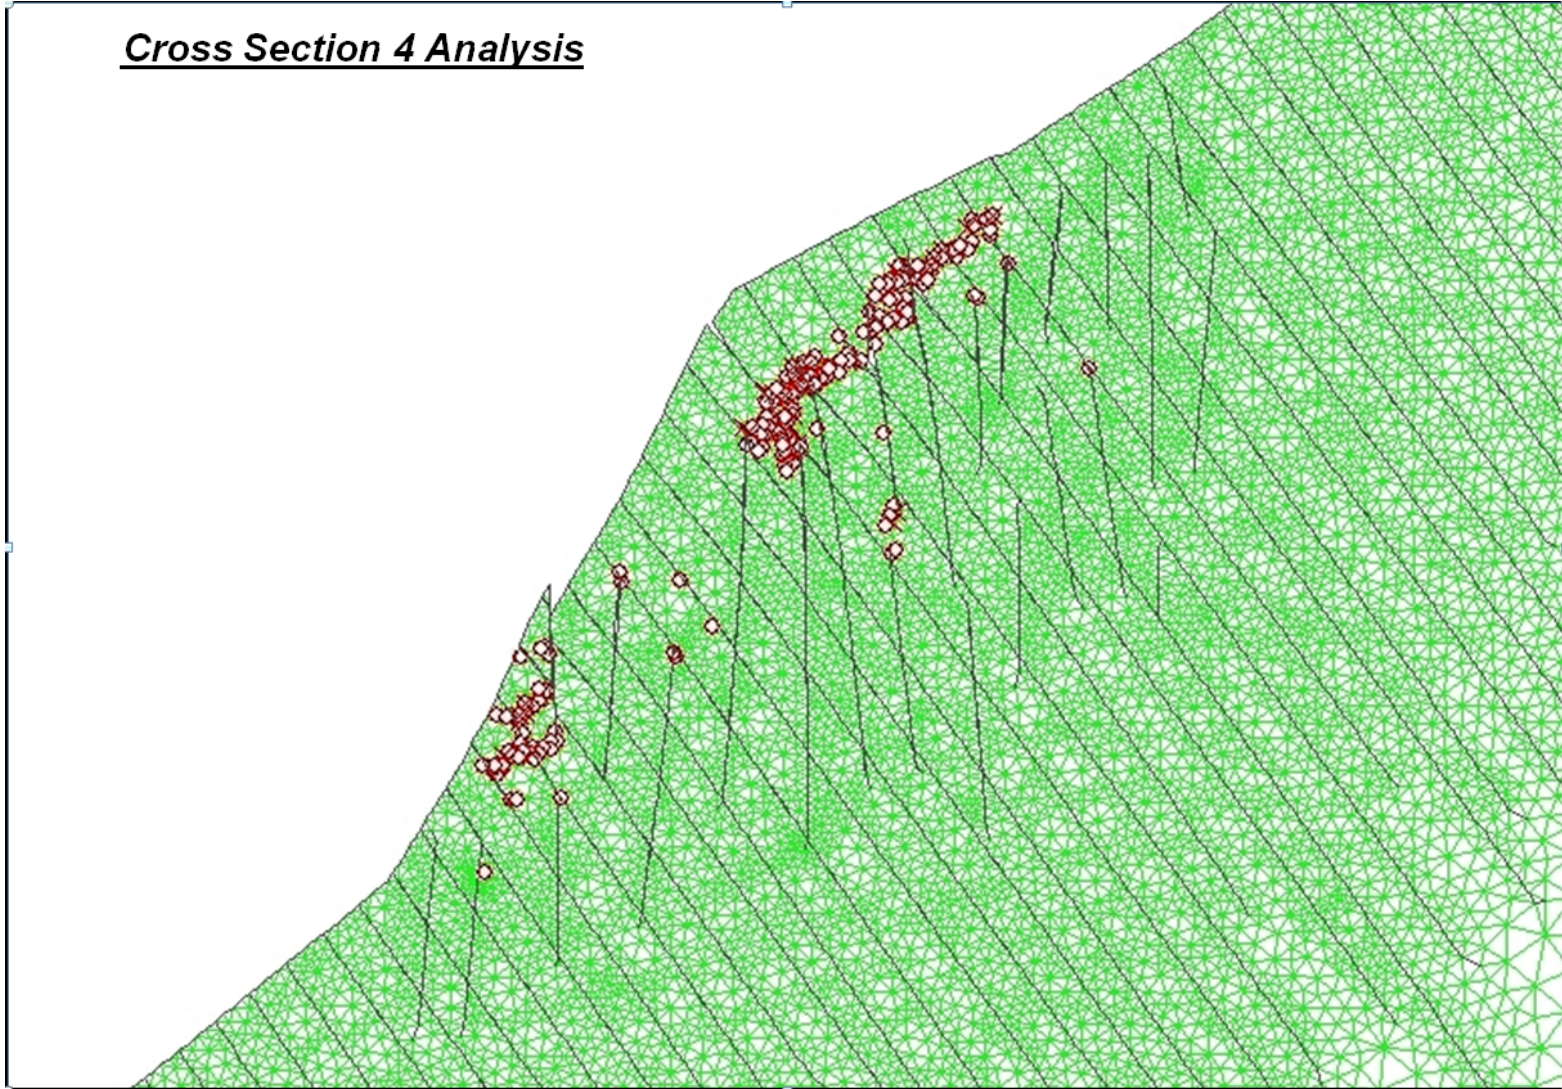
Figure 34
Project No.1300823

Tensile Fracturing/Yielded Element Progression to Failure (1 of 5) for Over Steepened Section 4

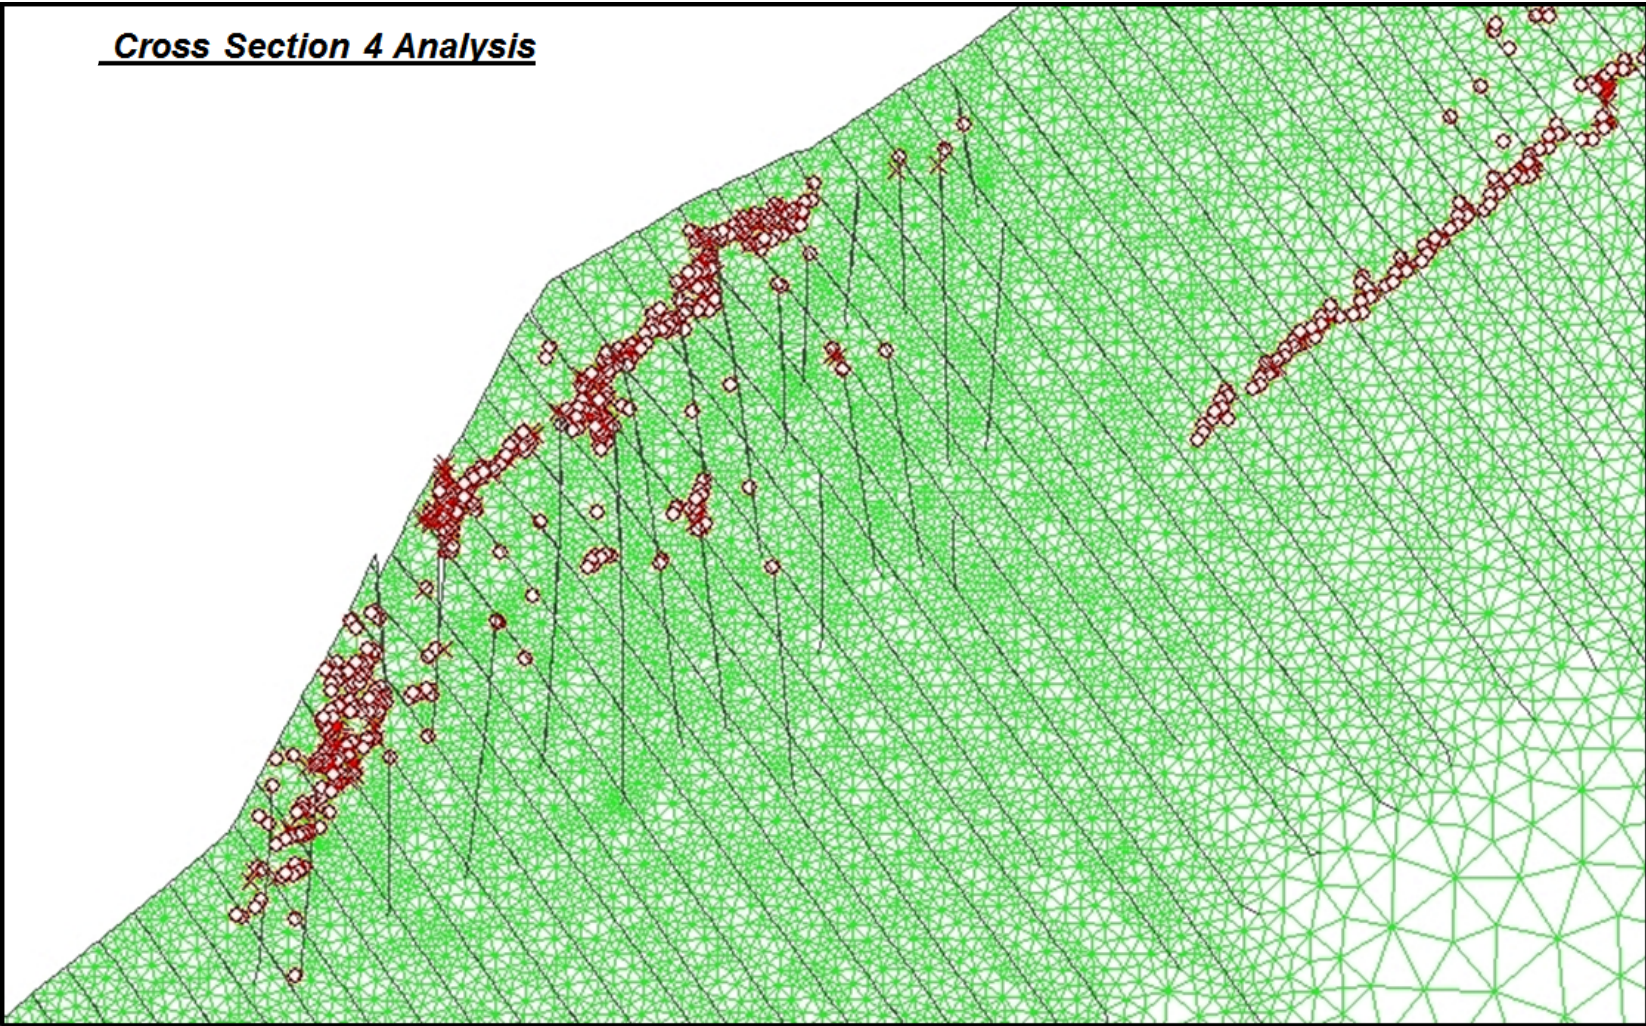
Figure 35
Project No.1300823

Tensile Fracturing/Yielded Element Progression to Failure (3 of 5) for Over Steepened Section 4

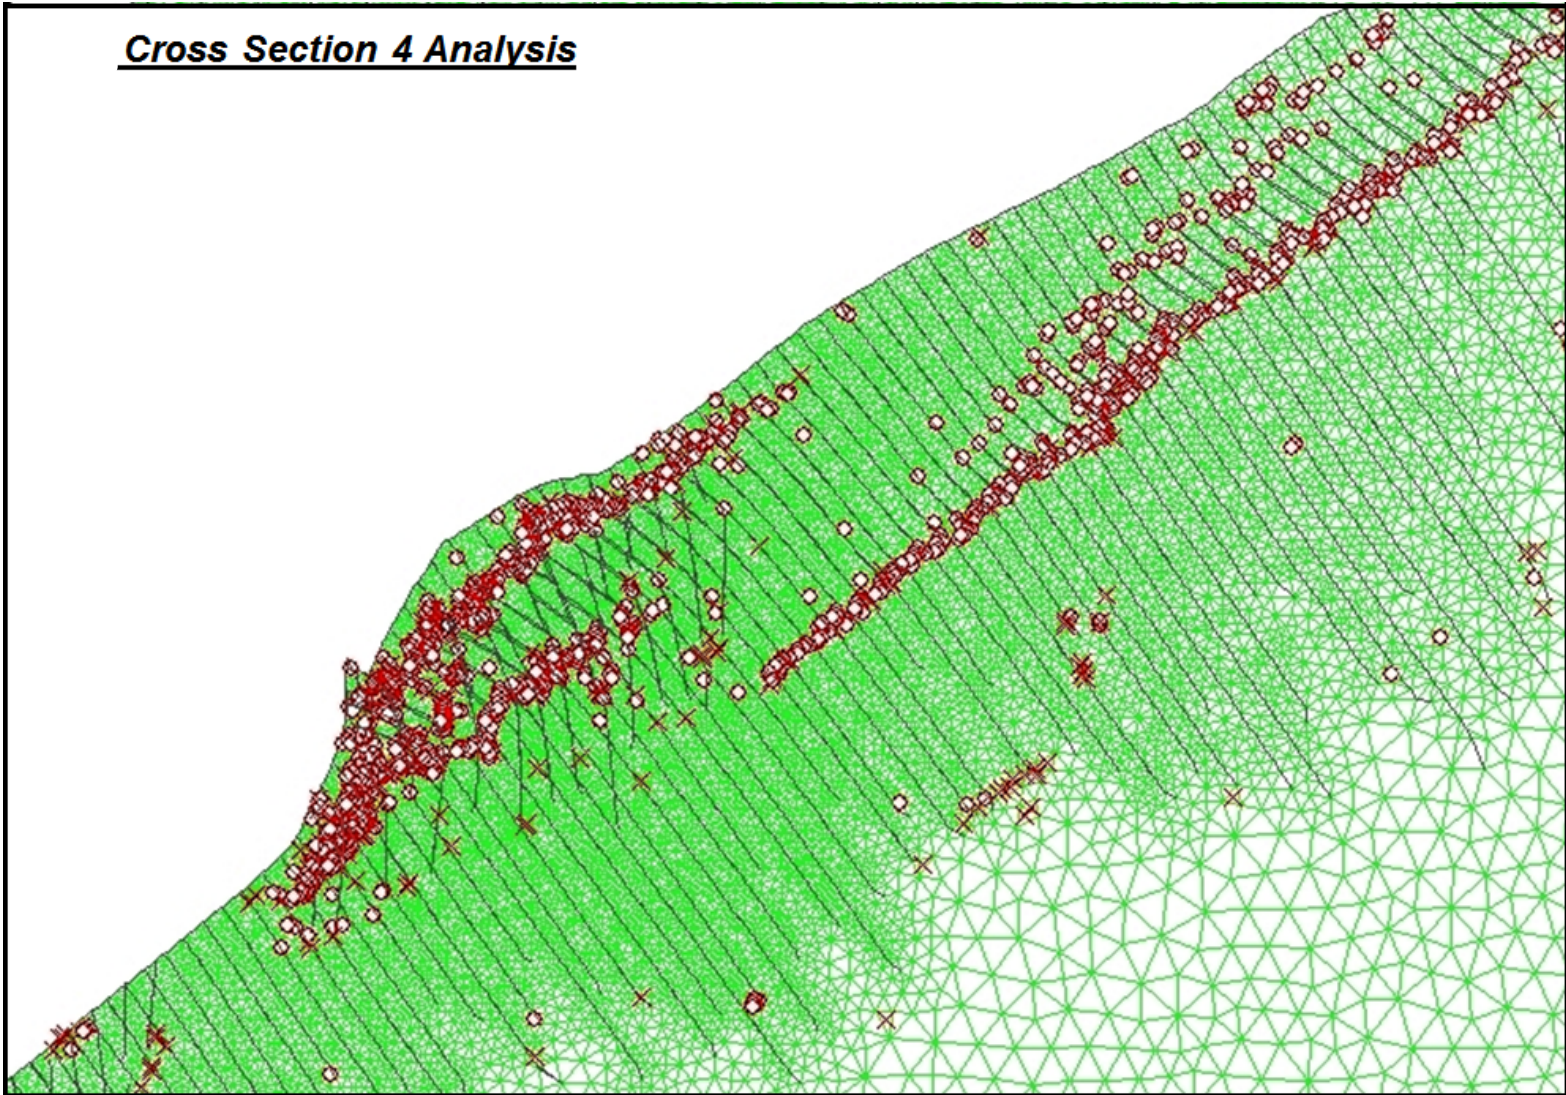
Figure 36
Project No.1300823

Tensile Fracturing/Yielded Element Progression to Failure (4 of 5) for Over Steepened Section 4
