REPORT

AN ENGINEERING ASSESSMENT OF THE CURRENT STABILITY OF THE PILLAR MOUNTAIN SLIDE

KODIAK, ALASKA

November 20, 2013

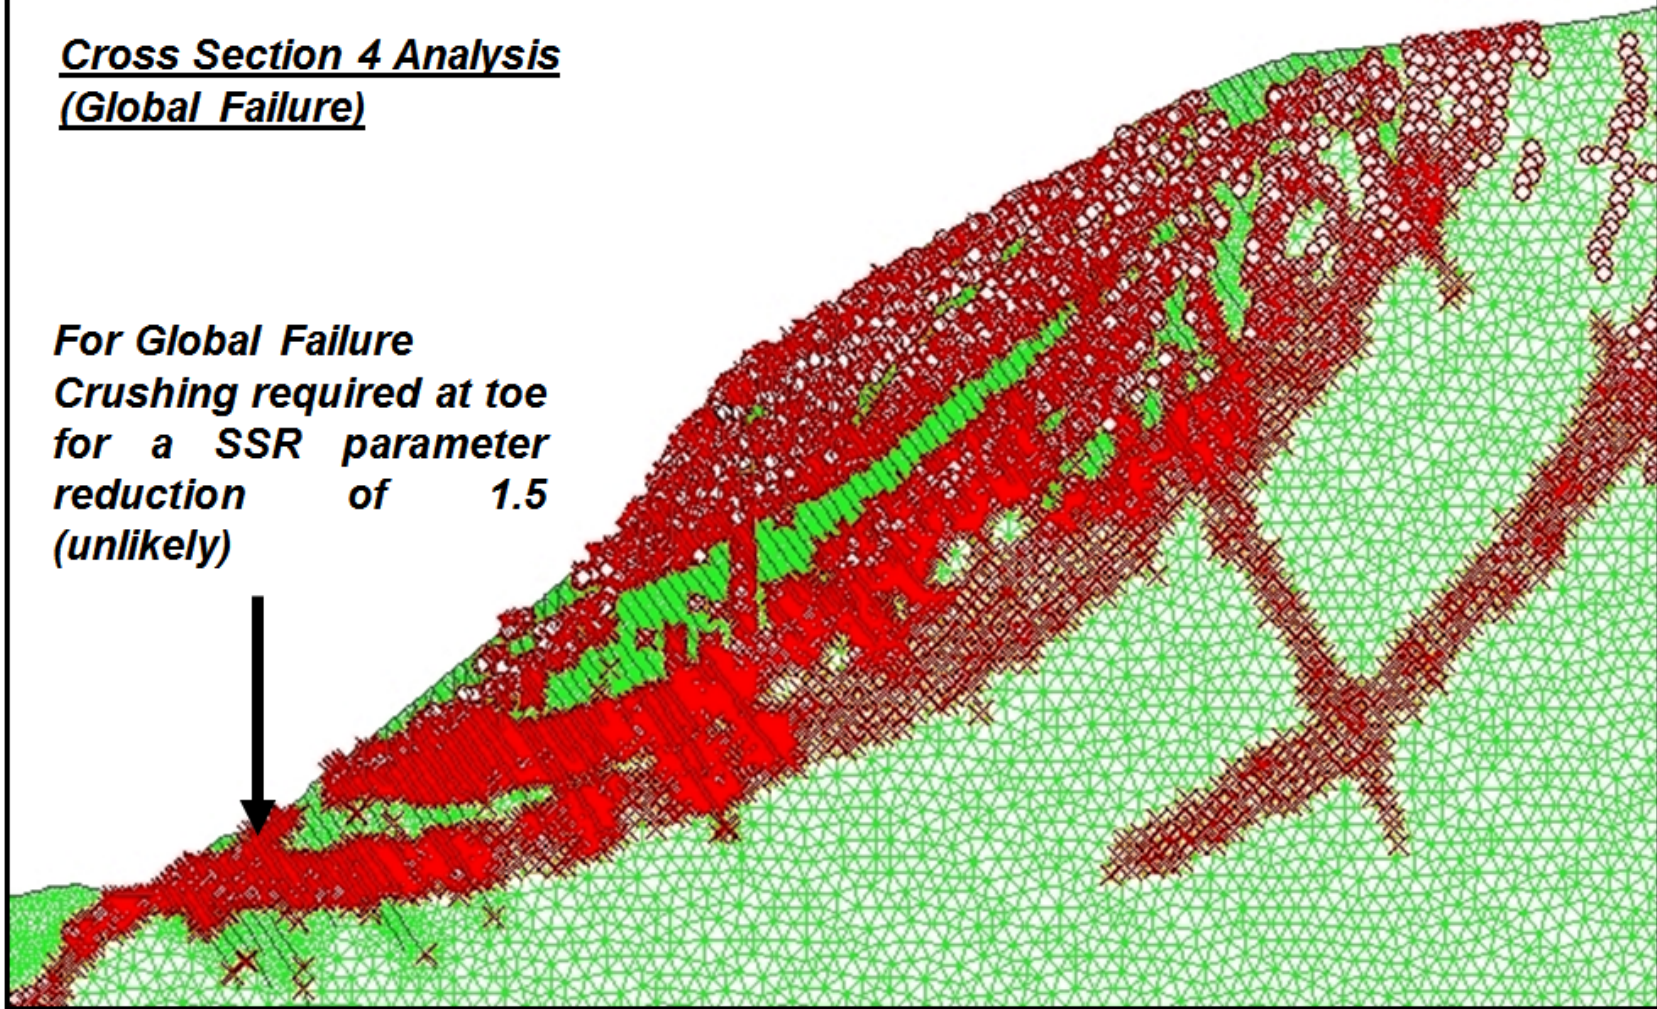
Cross Section 4 Analysis
(Global Failure)

For Global Failure
Crushing required at toe
for a SSR parameter
reduction of 1.5
(unlikely)
