**KODIAK CITY COUNCIL
WORK SESSION AGENDA**

**LIBRARY CONDITION
ASSESSMENT REPORT**

Prepared by:
Stantec Architecture Inc.
2515 A Street
Anchorage, Alaska 99503

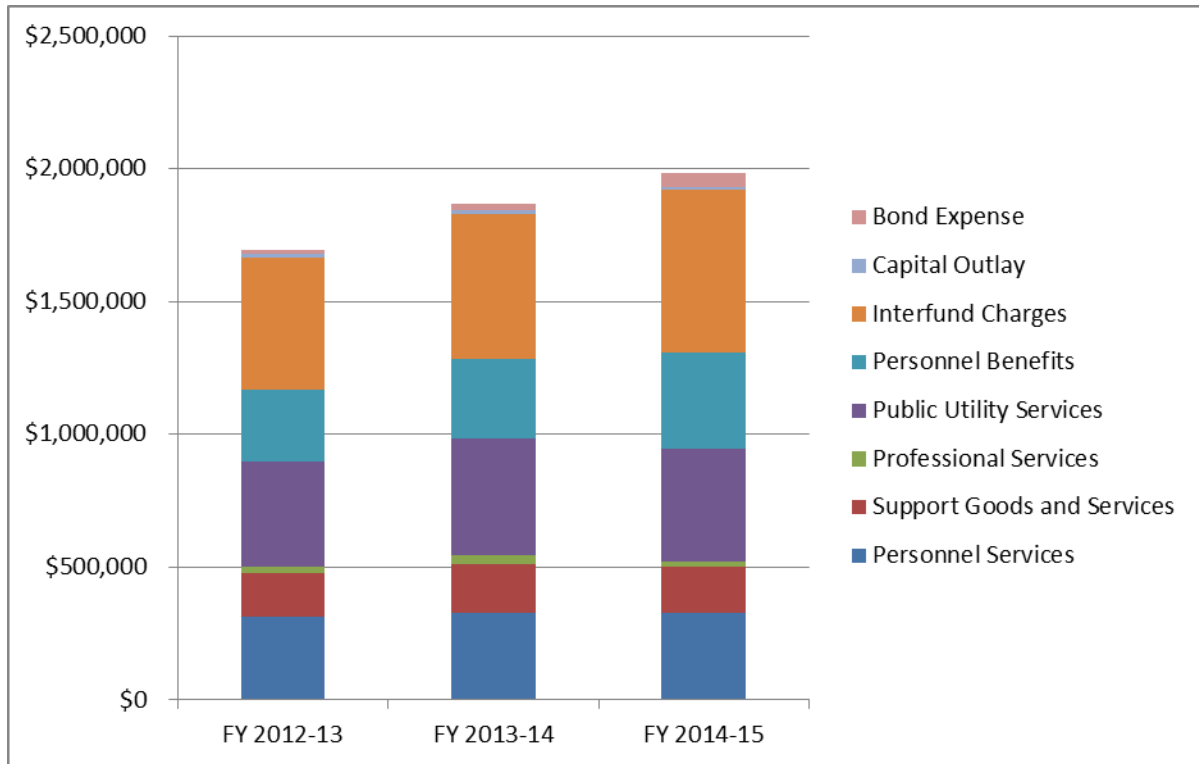
Figure 2. Operation and Maintenance Expenses

O&M expenses include all costs associated with operating and maintaining the water utility, including personnel, utilities, support goods and services, and professional services costs. Interfund charges include transfers to other City departments to cover administrative, financial, public works, and engineering services. Interfund charges also includes a transfer to the Water Capital Projects Fund to help pay for annual capital expenditures. Figure 2 summarizes actual operating expenses for FY 2013 through FY 2015. Cash operating expenses ranged from approximately \$1.7 million in FY 2013 to nearly \$2.0 million in FY 2015.
