## **KODIAK STORM DRAIN INSPECTION REPORT**

**PREPARED FOR DOWL HKM**

**KODIAK, AK**

Inspection Date(s): February 12-13, 2014

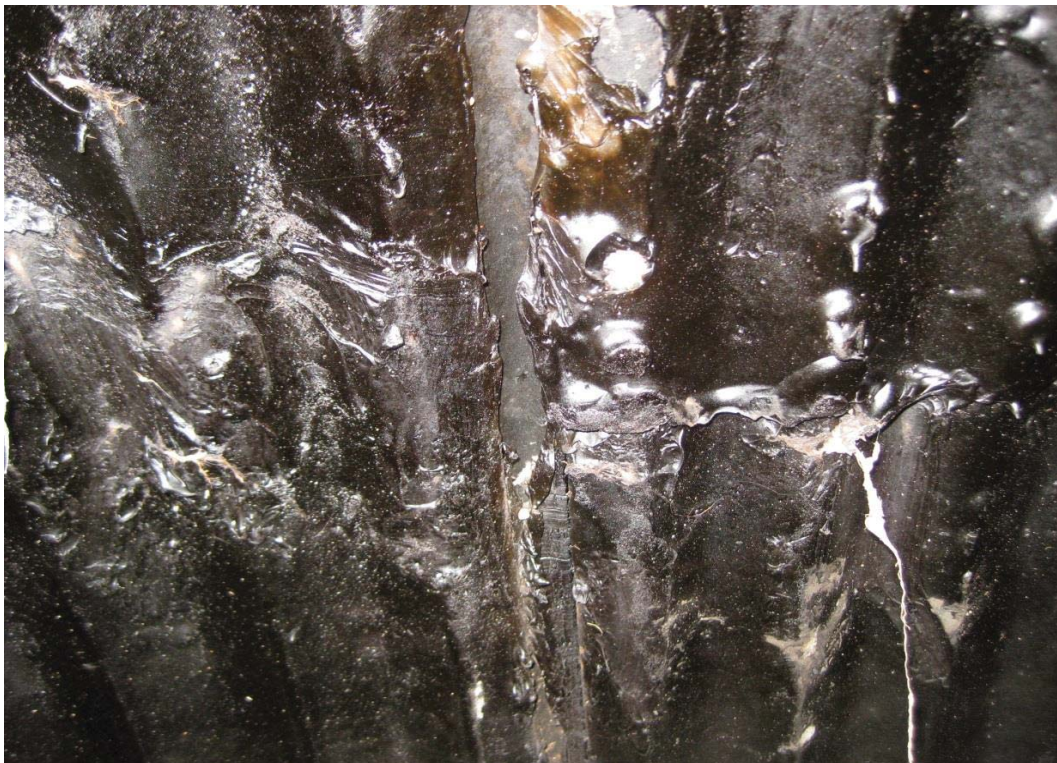
Photo 2

Drain A - 9'  
Seam at 10 o'clock with gap to 1-1/4".

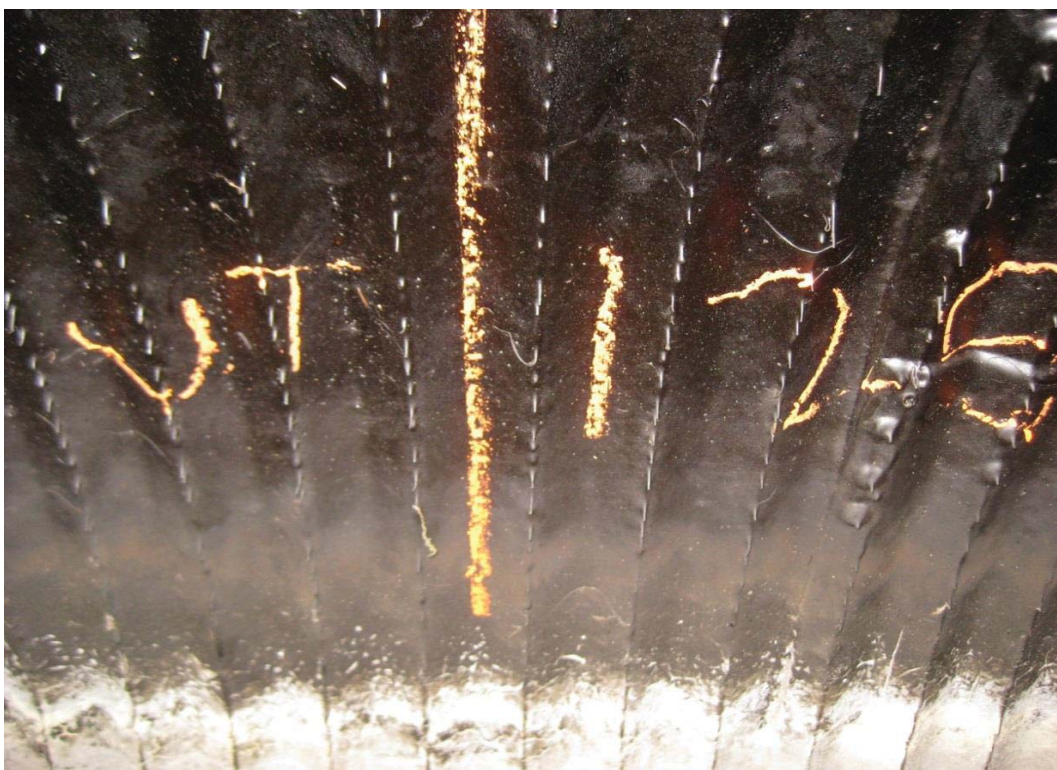
Photo 7

Ultrasonic testing location for Drain A at 125'.

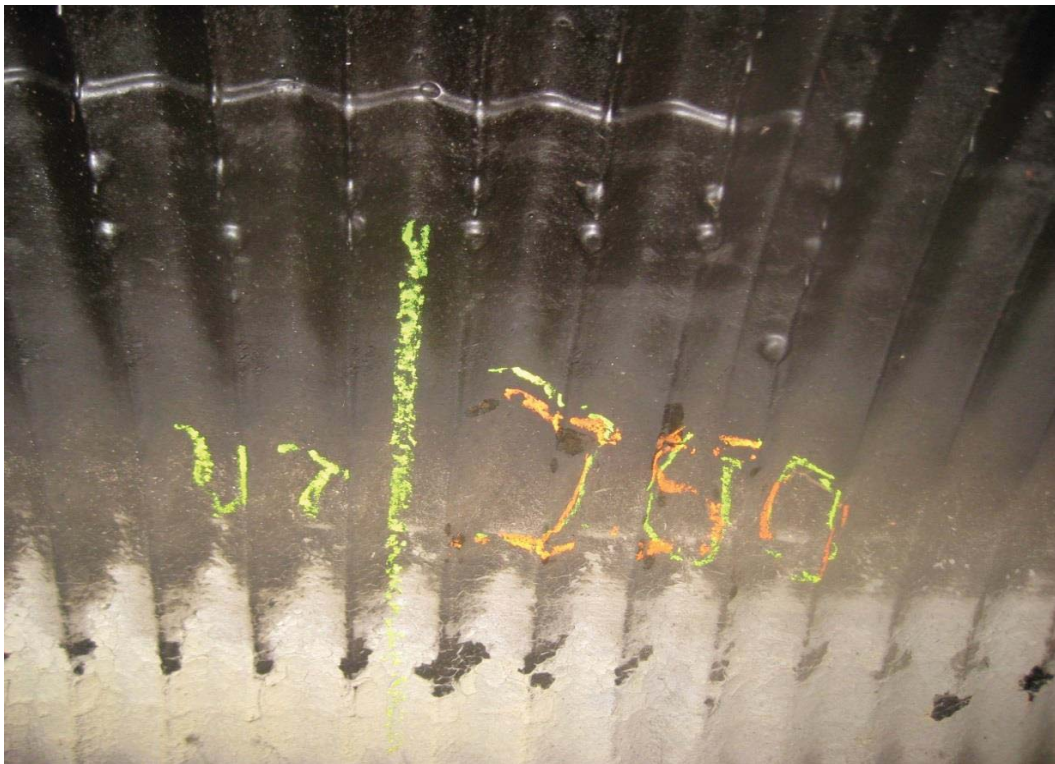
Photo 17

Ultrasonic testing location for Drain A at 250'.

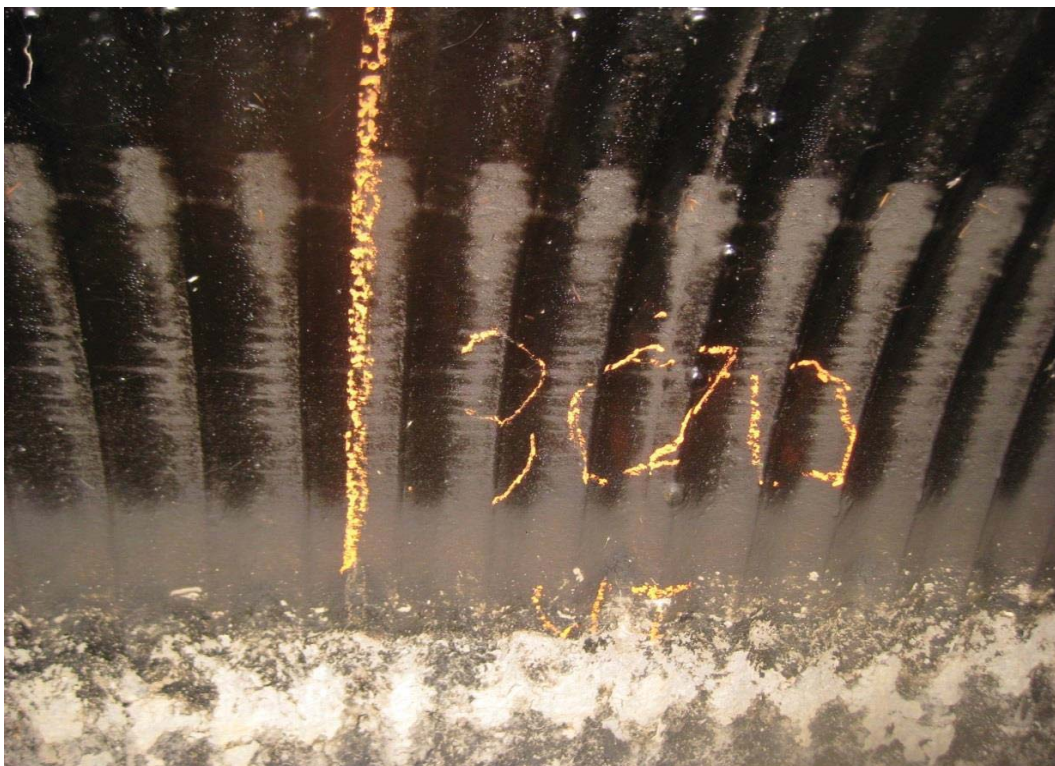
Photo 21

Ultrasonic testing location for Drain A at 300'.

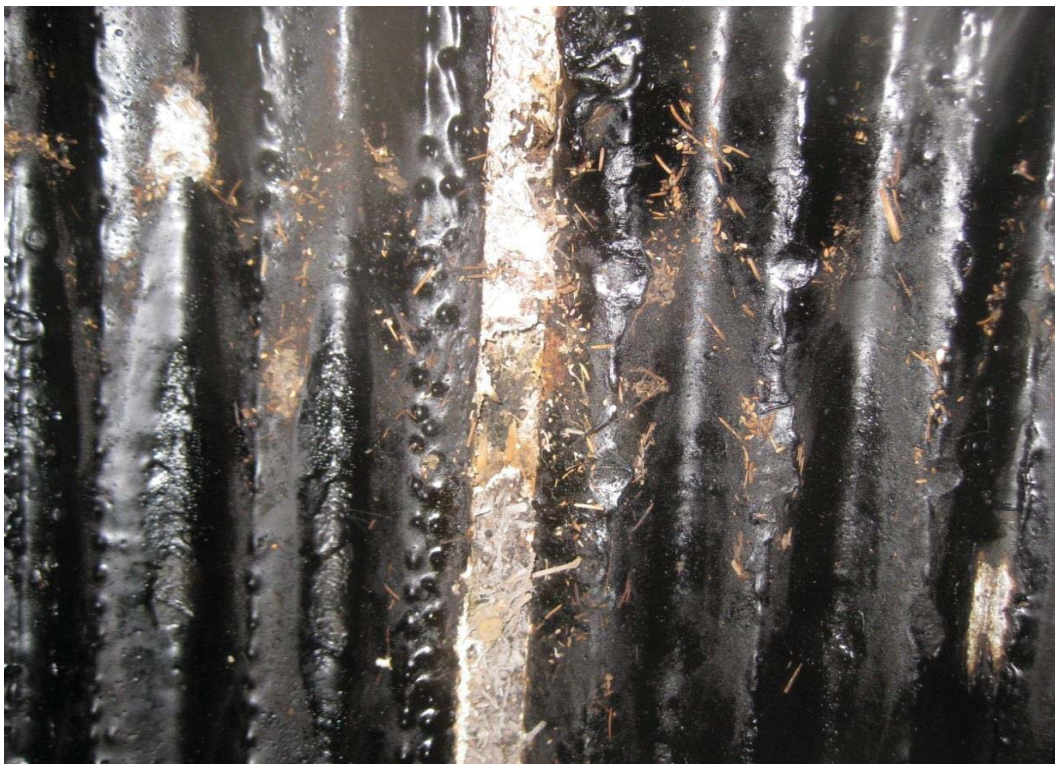
Photo 22

Drain A - 312'

Seam at 12 o'clock with gap to 1-1/4" and an offset of 1/2". Moderate corrosion on edge.

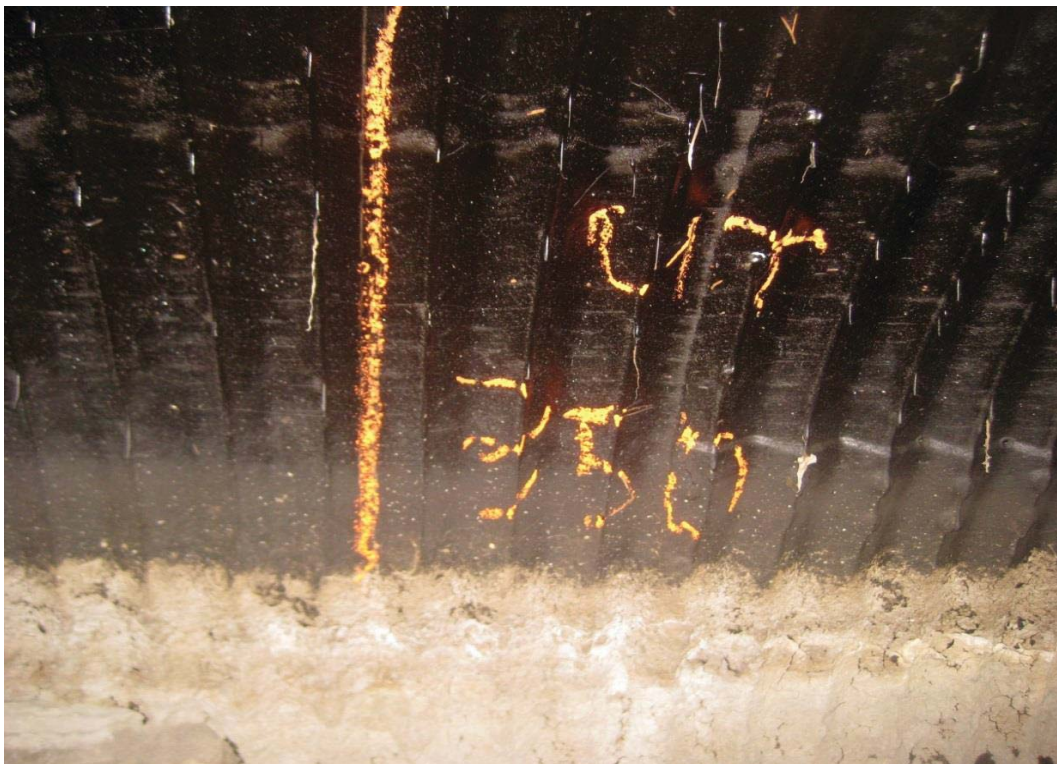
Photo 24

Ultrasonic testing location for Drain A at 300'.

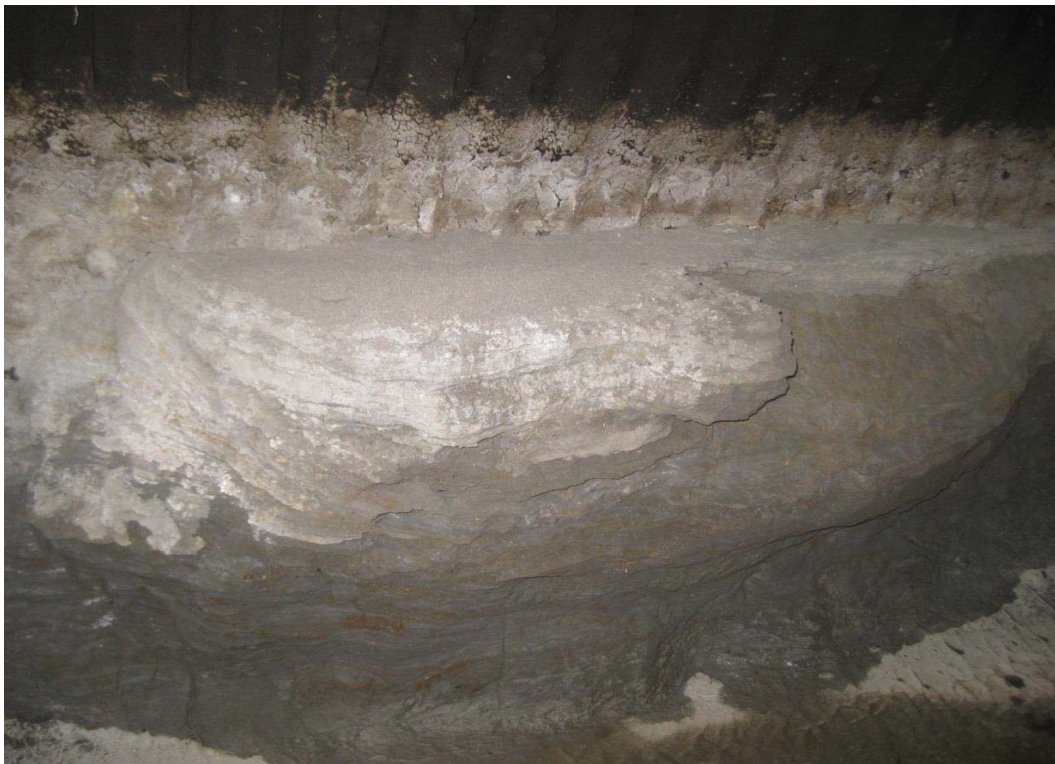
Photo 25

The sediment in the drainage system typically consists of sandy soil with some gravel mixed in. At the outfall end of the drains some silt is present. There are some sizable soil deposits in Drain A between 350' and 358' (Photo25). Sediment type and depth was observed where possible during ultrasonic testing.

Soil deposits between 350' and 358'. Sediment deposits are up to 3-1/2' x 10" x 2'.

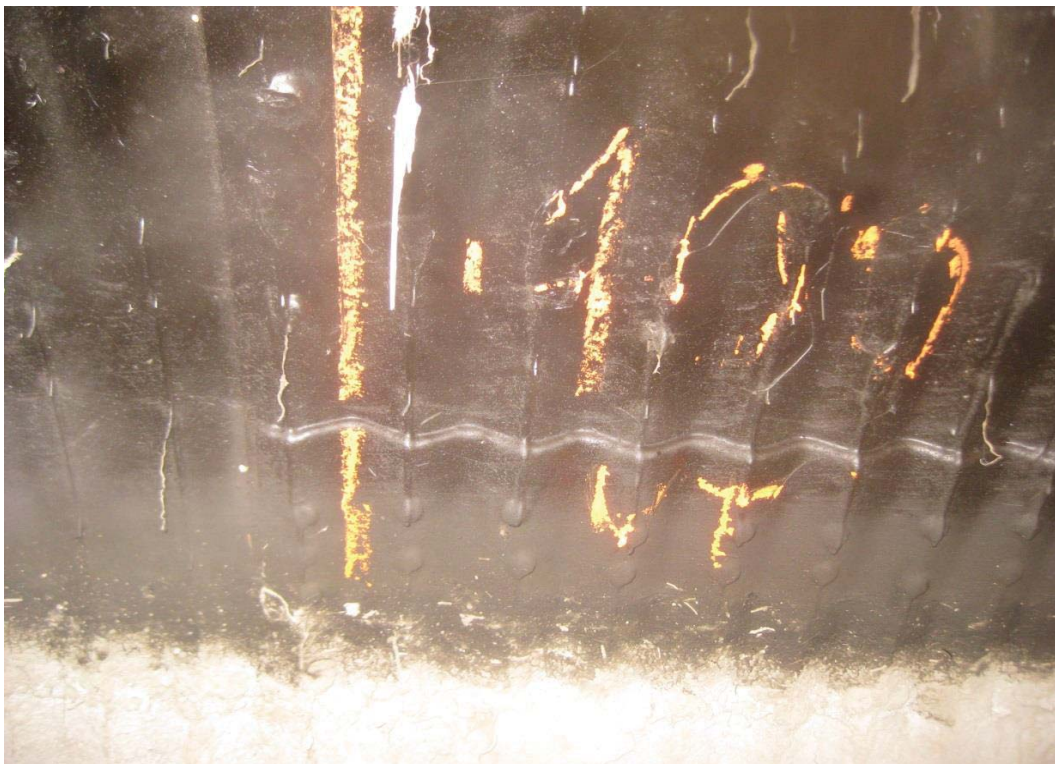
Photo 28

Ultrasonic testing location for Drain A at 400'.

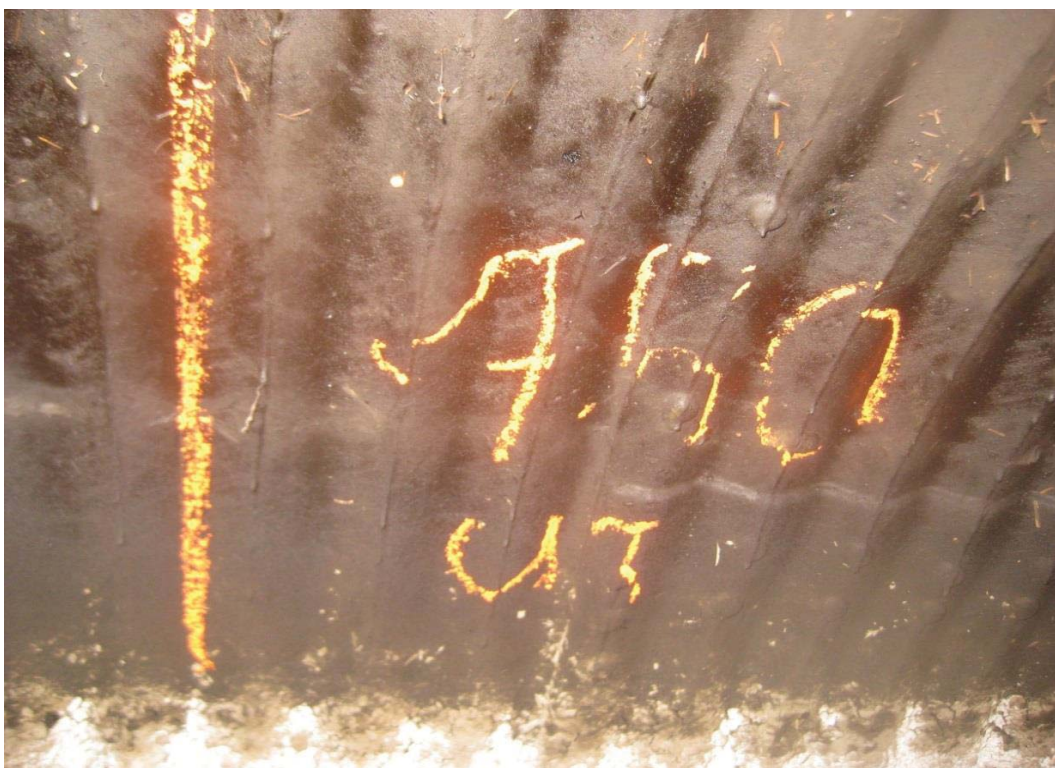
Photo 31

Ultrasonic testing location for Drain A at 450'.

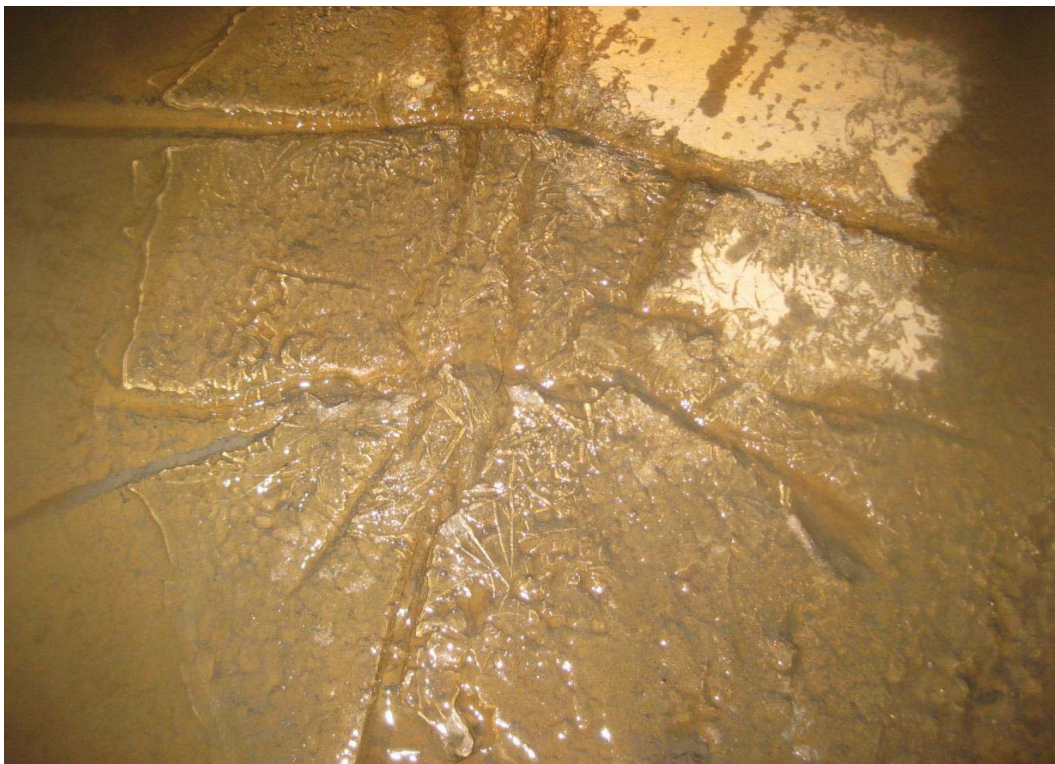
Photo 34

The pipe walls are generally in good condition. The areas of interest related to the walls are in Drain A at 282' where a 2' x 4' area is caved or pressed in 3-1/2" (Photo 19), Drain A at 288' where a 2' x 2' area is pressed in 2" (Photo 20), and Drain A at 497' where a 3' x 2' area is pressed in 2" (Photo 34). There is a horizontal void behind the wall in Drain B at 484' that is 12" deep.

Drain A - 497'  
View of 3' x 2' x 2" caved in area at 6 o'clock for 2".

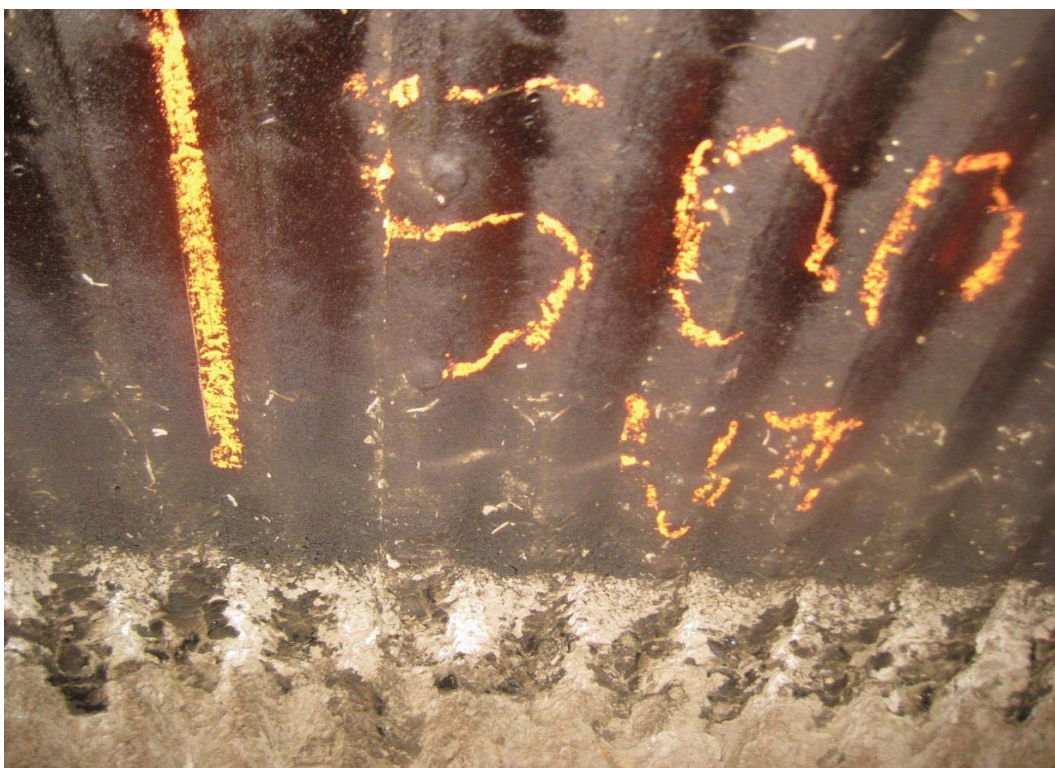
Photo 35

Ultrasonic testing location for Drain A at 500'.

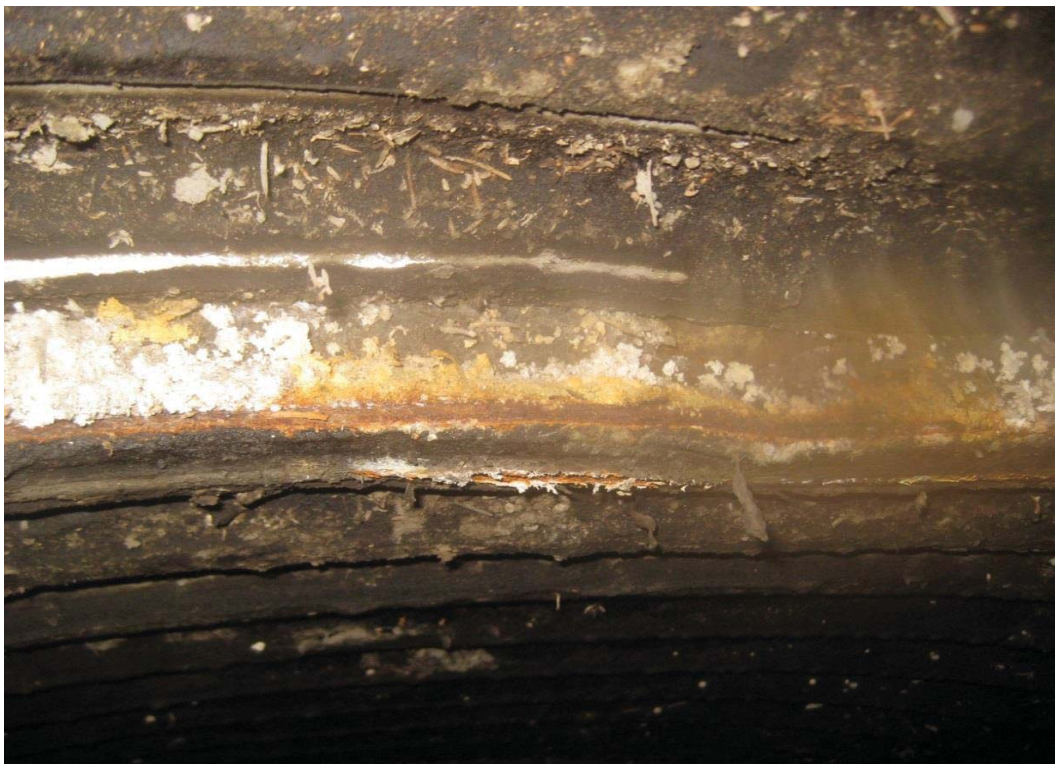
Photo 36

Drain A - 508'

Seam at 12 o'clock looking upstream with gap to 1" and an offset of 1-1/2". Moderate corrosion.

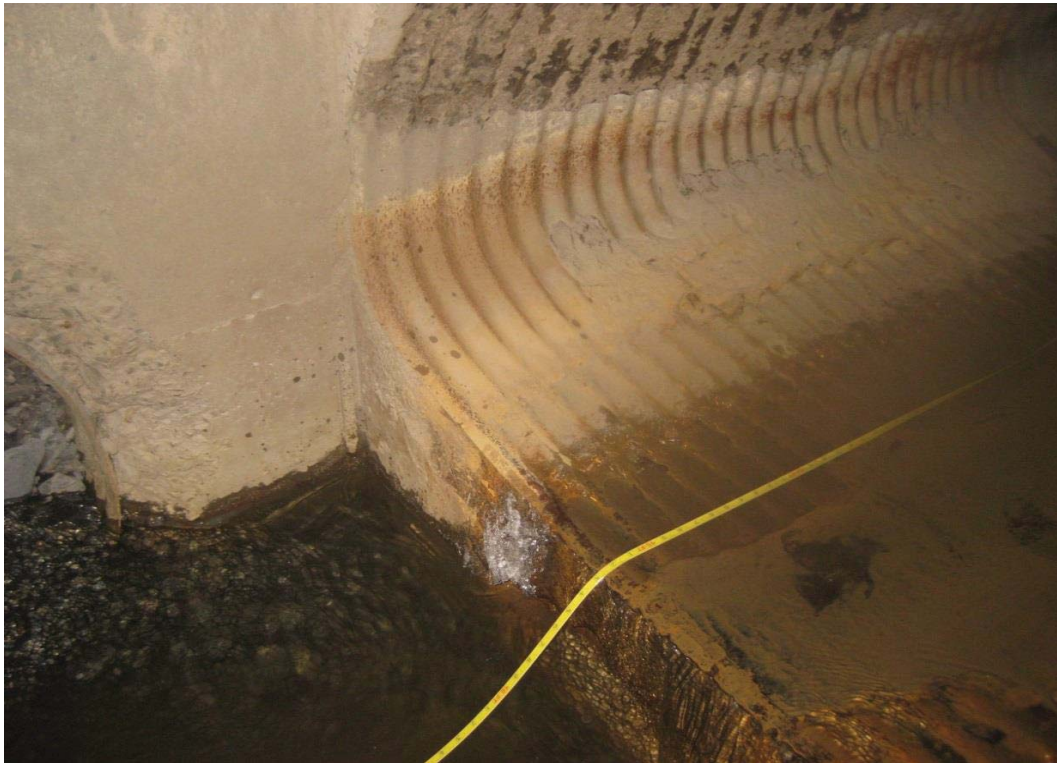
Photo 38

Drain A - 516'  
Drain exit at Marine Drive.

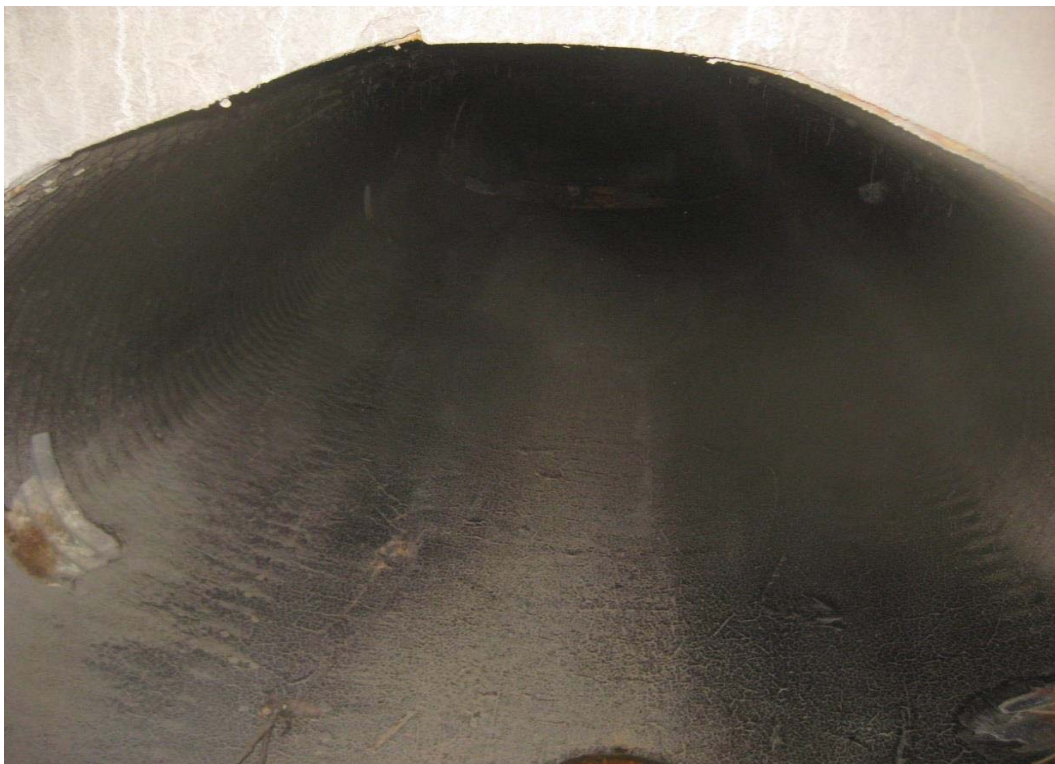
Photo 40

Drain A - 521'

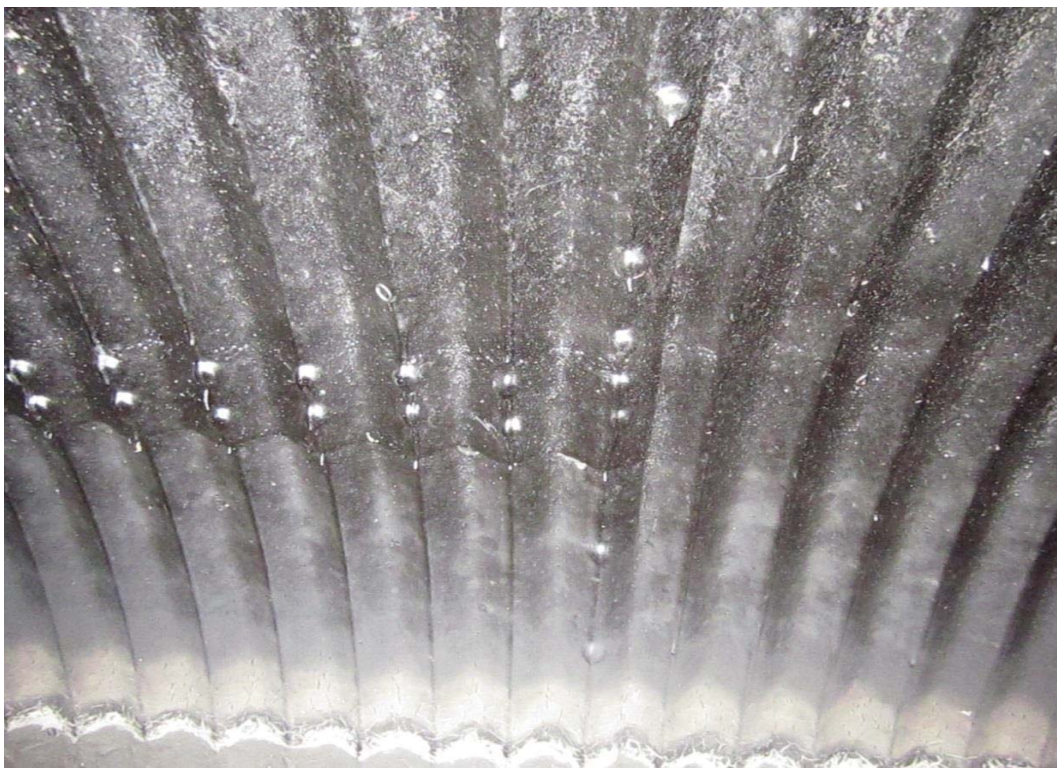
Photo 46

Drain B - 6'  
Seam at 9 o'clock.

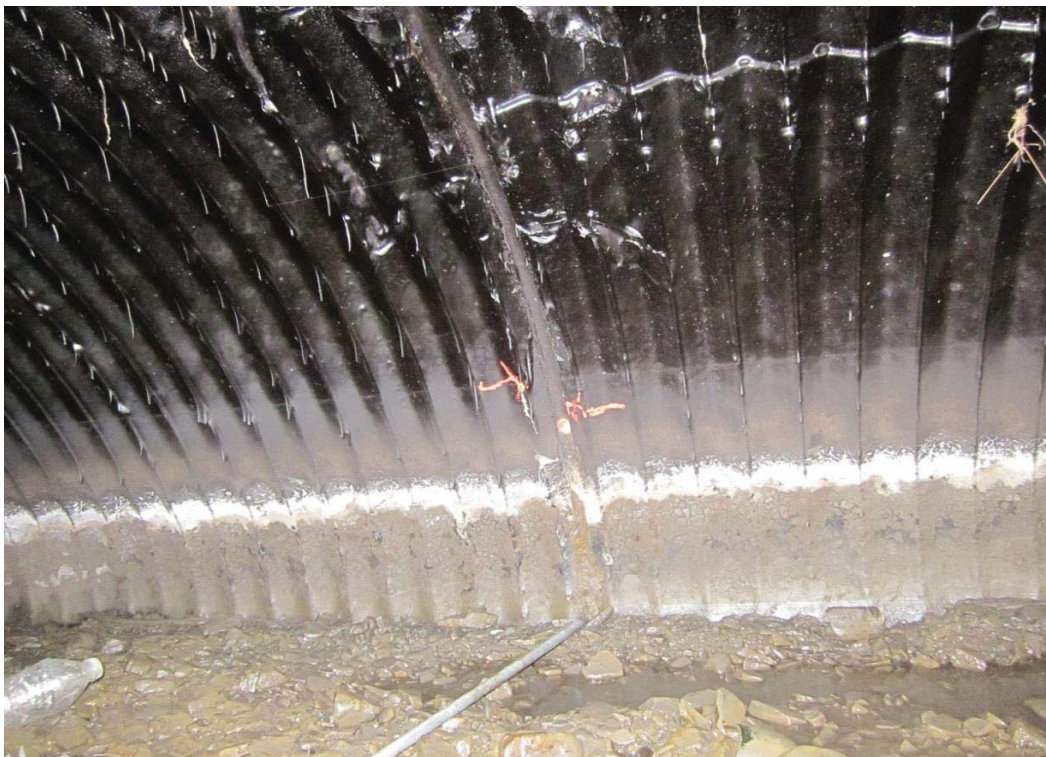
Photo 53

Drain B - 90'  
Seam open to 1-1/2".

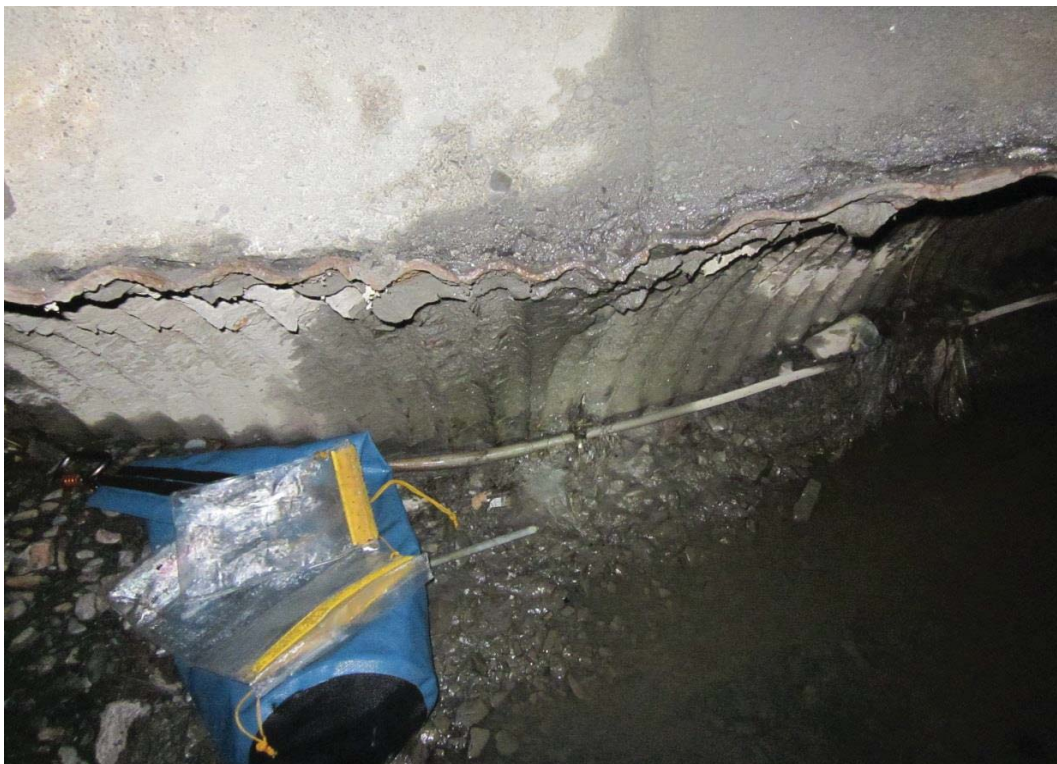
Photo 55

Drain B - 140'

Seam beneath manhole at 1 o'clock. No significant deficiency.

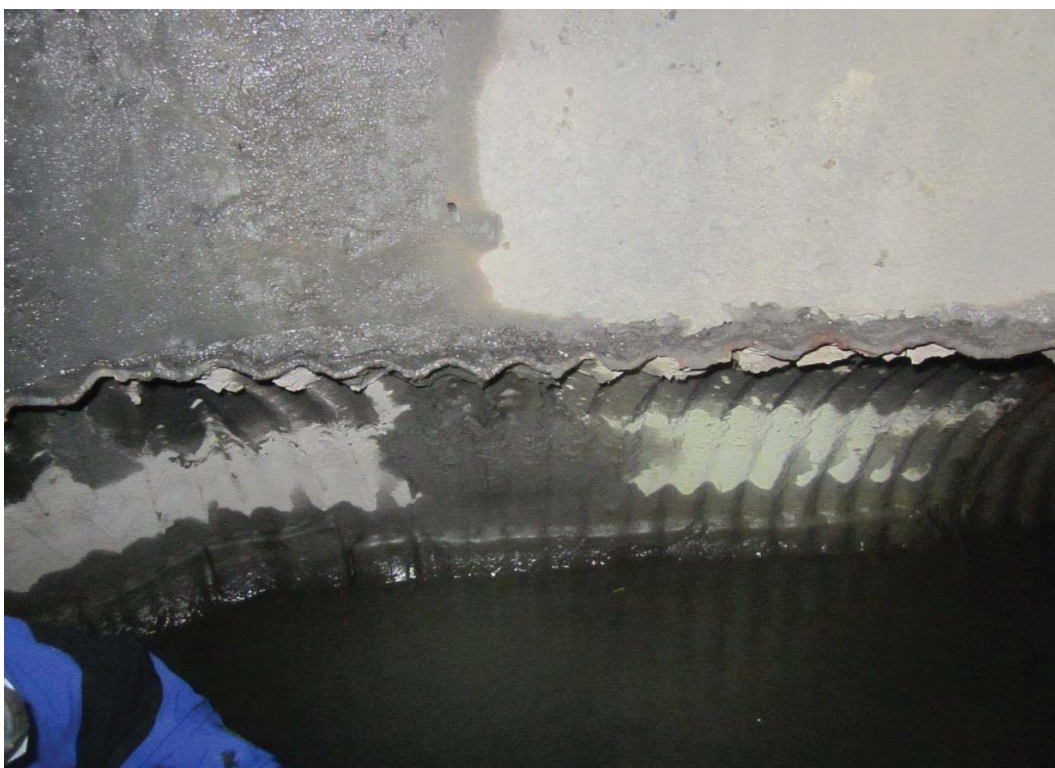
Photo 56

Drain B - 140'  
Seam beneath manhole at 9 o'clock. No significant deficiency.

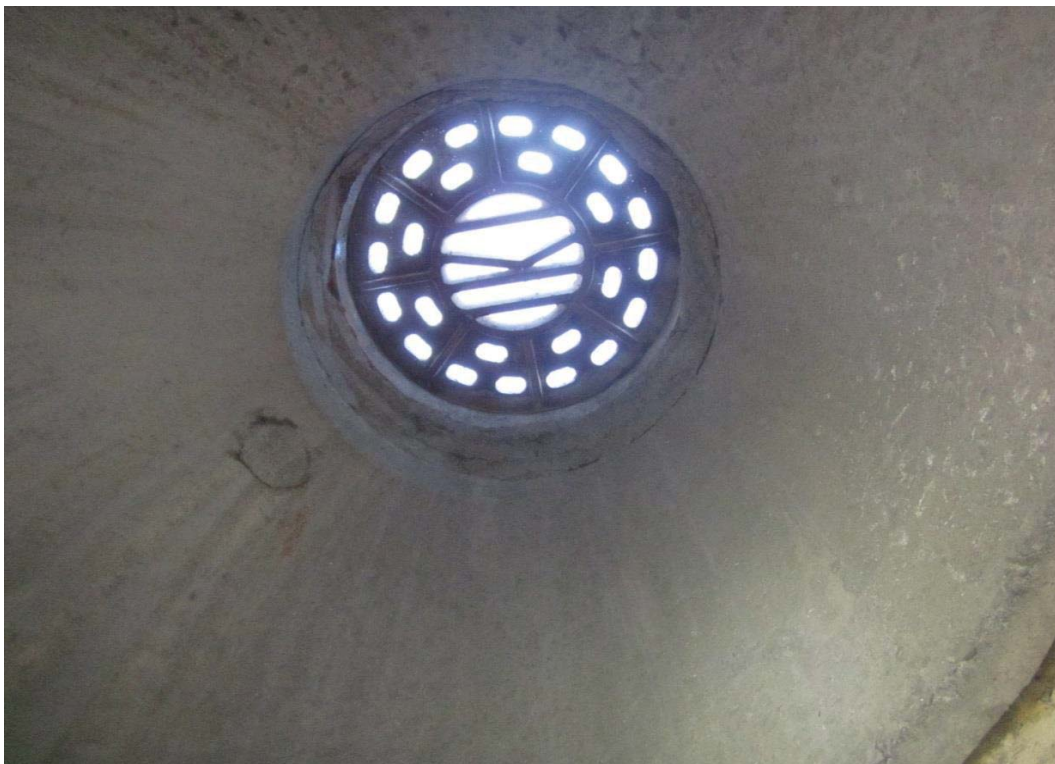
Photo 57

Drain B - 140'  
Looking up at manhole.

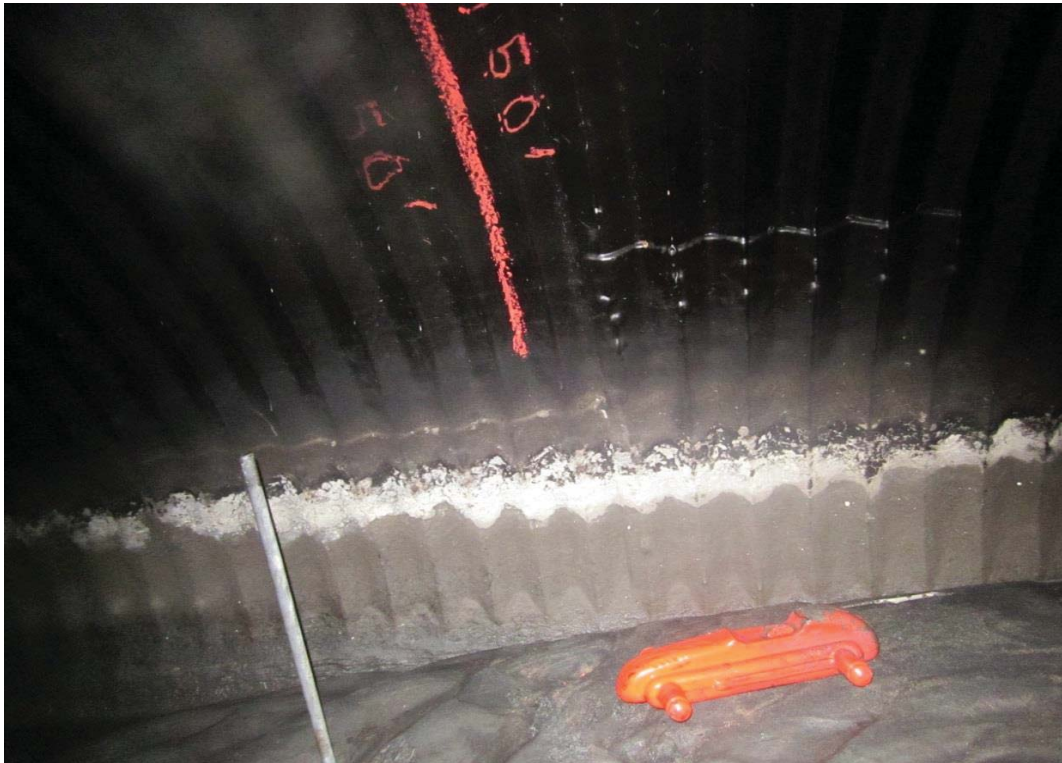
Photo 59

Ultrasonic testing location for Drain B at 150'.

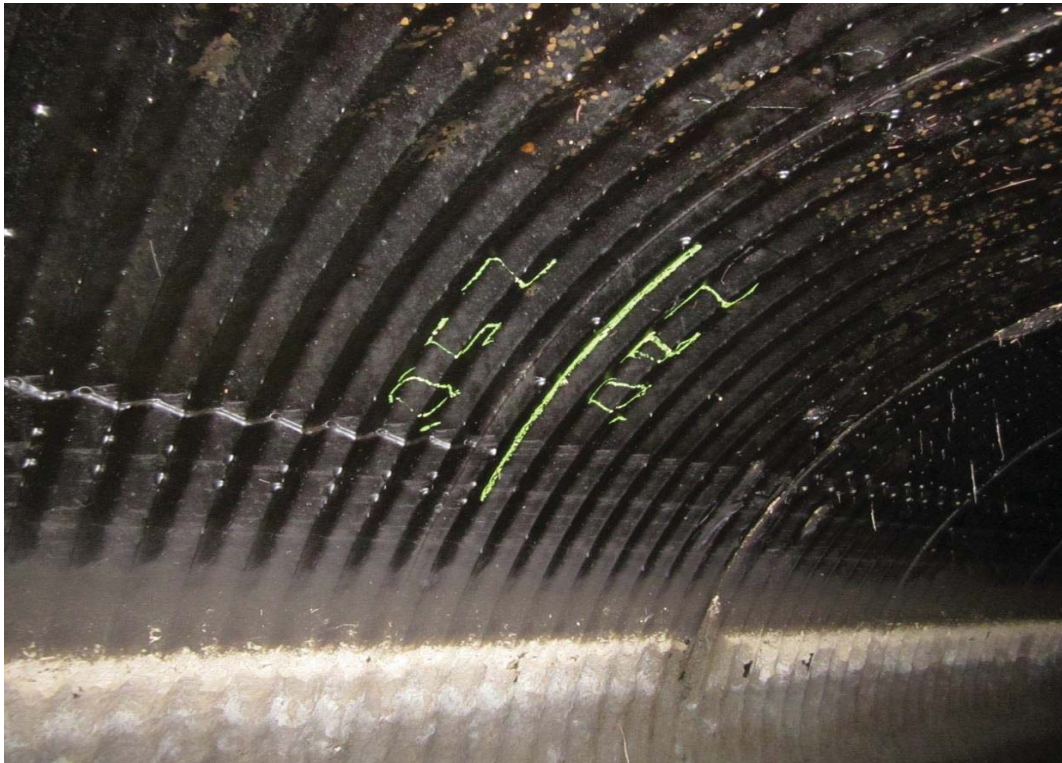
Photo 65

Ultrasonic testing location for Drain B at 250'.

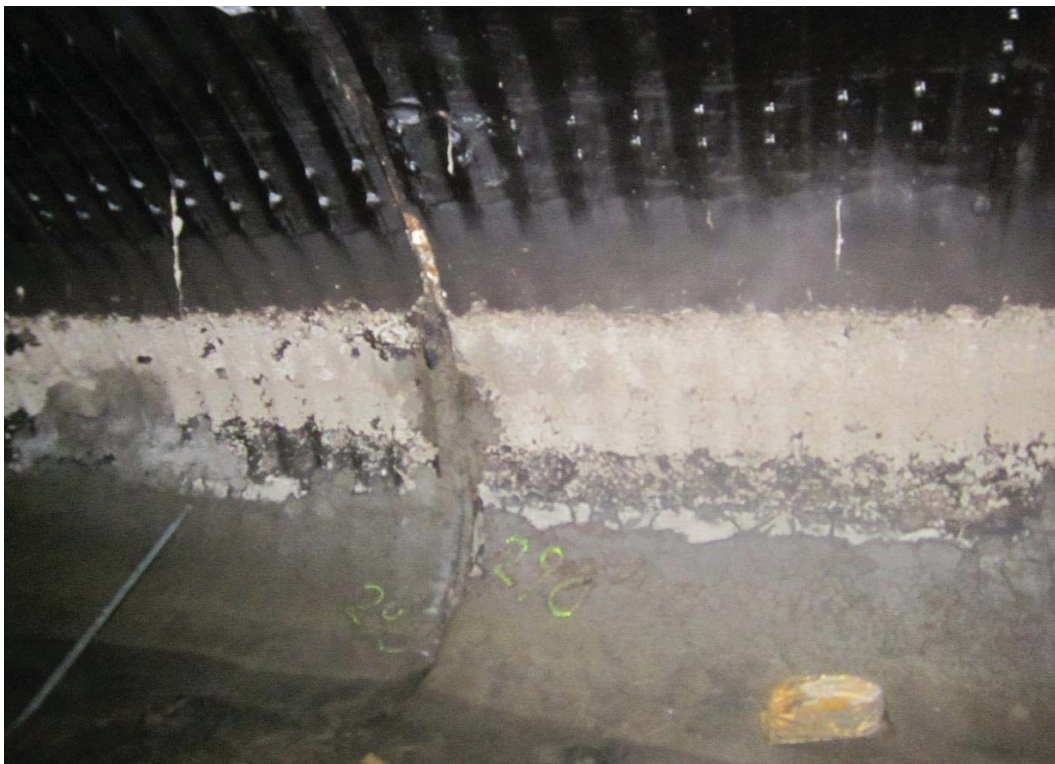
Photo 67

The pipe seams are in fair condition. Many of the seams have gaps and offsets in excess of 1", some with corrosion on the edges. Two of the seams were found to have water leakage. The seam in Drain B at 290' has a gap open to 1-1/2" with water flowing out of the drain pipe into the surrounding soil at a rate of approximately 2 gpm from the 7 o'clock position (Photo 67) at this water level. The seams in Drain B at 312' and 336' also have apparent leakage (Photo 69 and Photo 70).

Drain B - 290'  
Seam with gap open to 1-1/2" with water flowing out at the 7 o'clock position. Flow rate is approximately 2 gallons/minute.

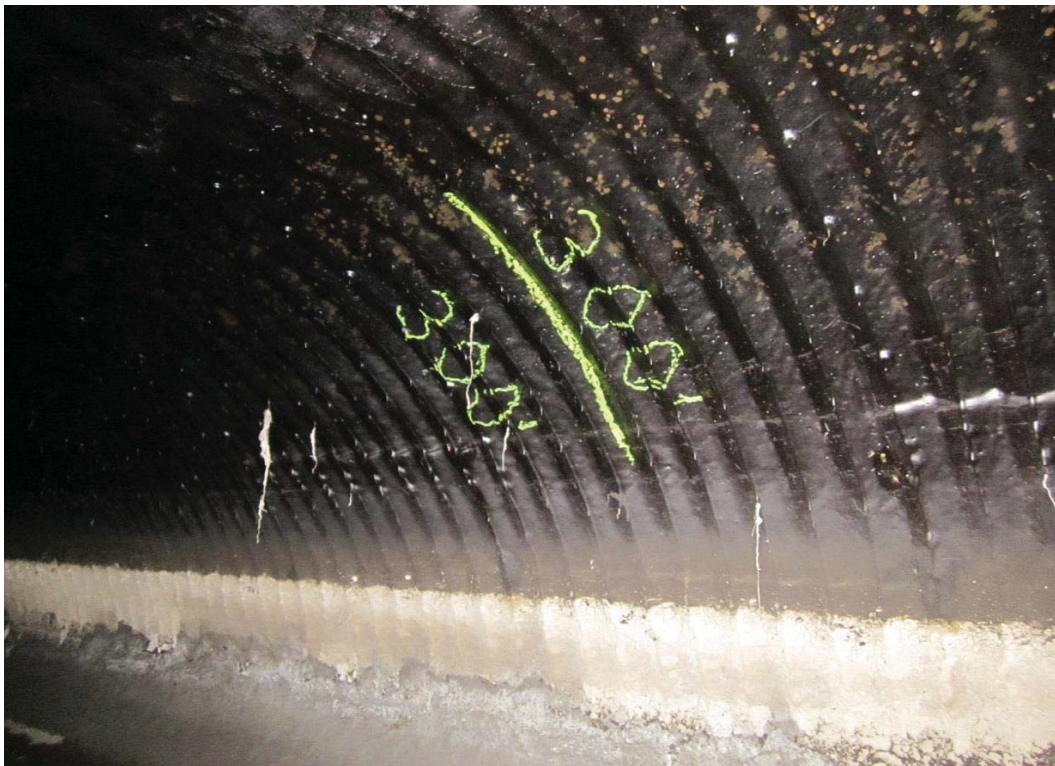
Photo 68

Ultrasonic testing location for Drain B at 300'.

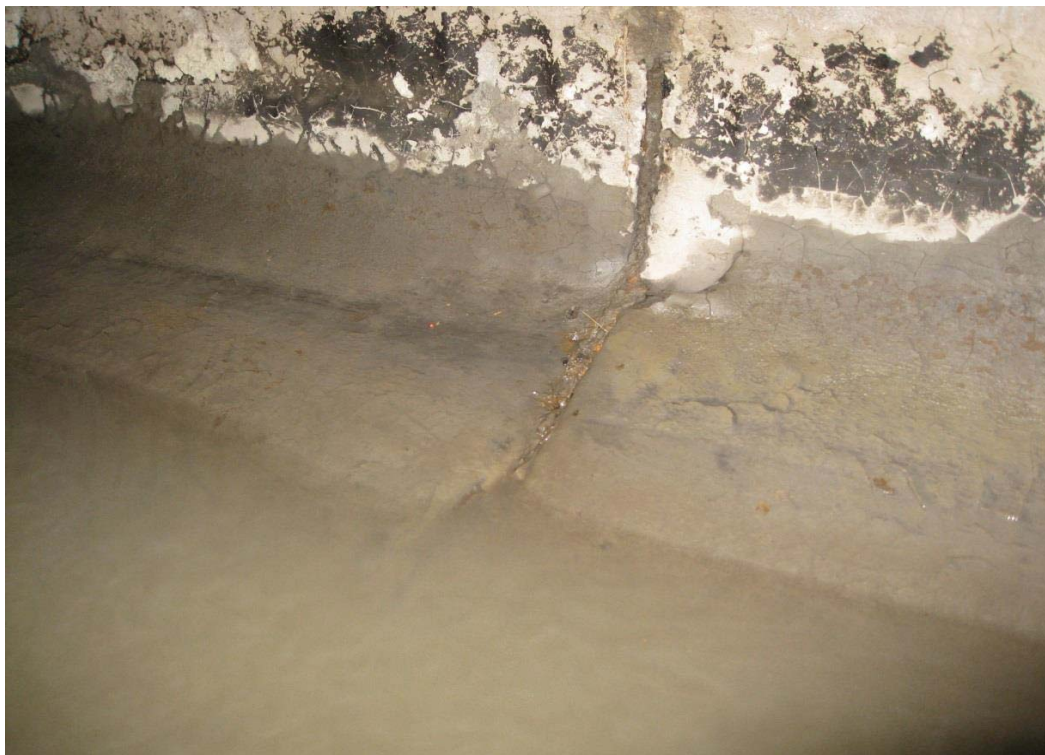
Photo 69

Drain B - 312'

Seam with apparent leakage. Floor sounds unsupported from 300' to 475'. No gap for probe. There is fine silt to 3" deep. Photo is of 9 o'clock position.

The hollow sounding bottom of both drains should be investigated by drilling 3-5 small 1/8" pilot holes in each 175' section and probing with a light welding wire. The holes should be sealed with epoxy, silicone or with self sealing sheet metal screws. This recommendation is a moderate to high priority.

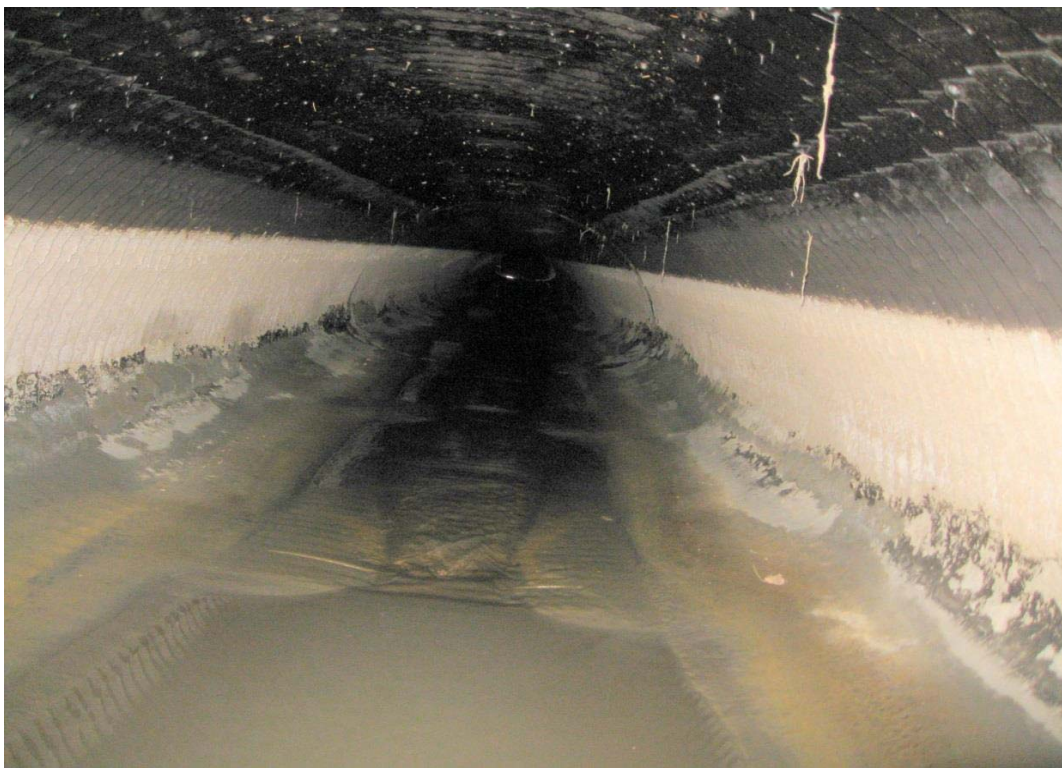
Photo 72

Drain B - 400'  
View downstream. Coating is intact.

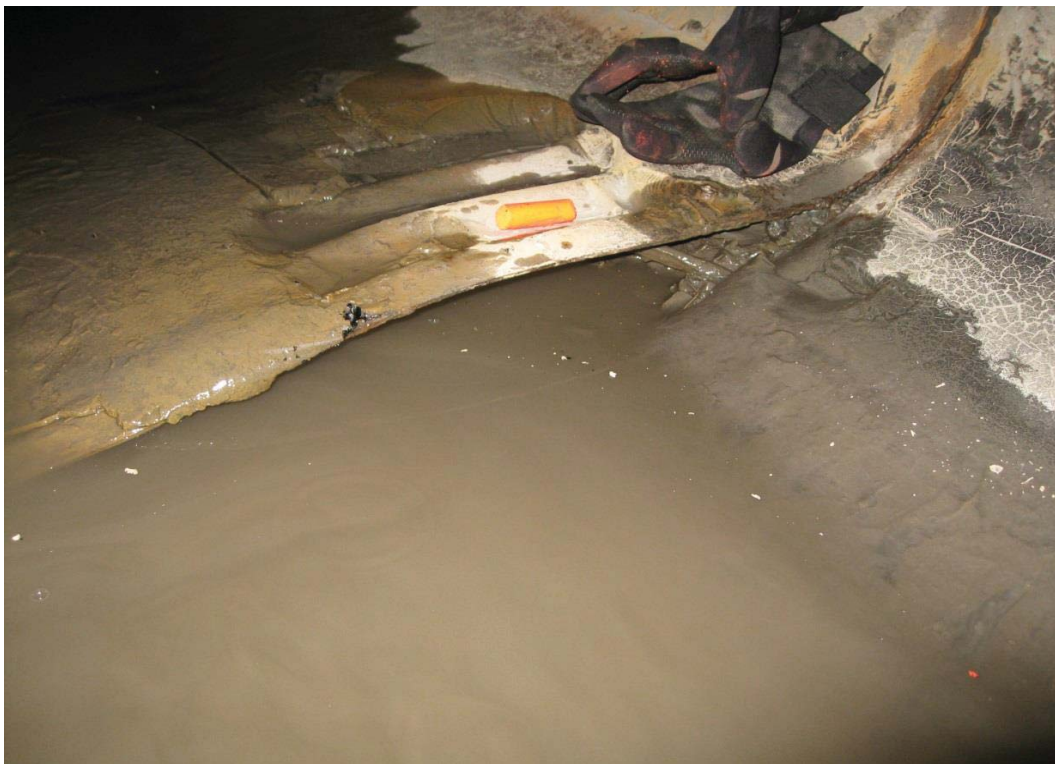
Photo 75

Drain B - 484'

Seam at 5 o'clock with lip lifted 2-3/4". Horizontal void to 12" deep, no vertical void found. The coating is thin and poorly bonded on bottom and sides.

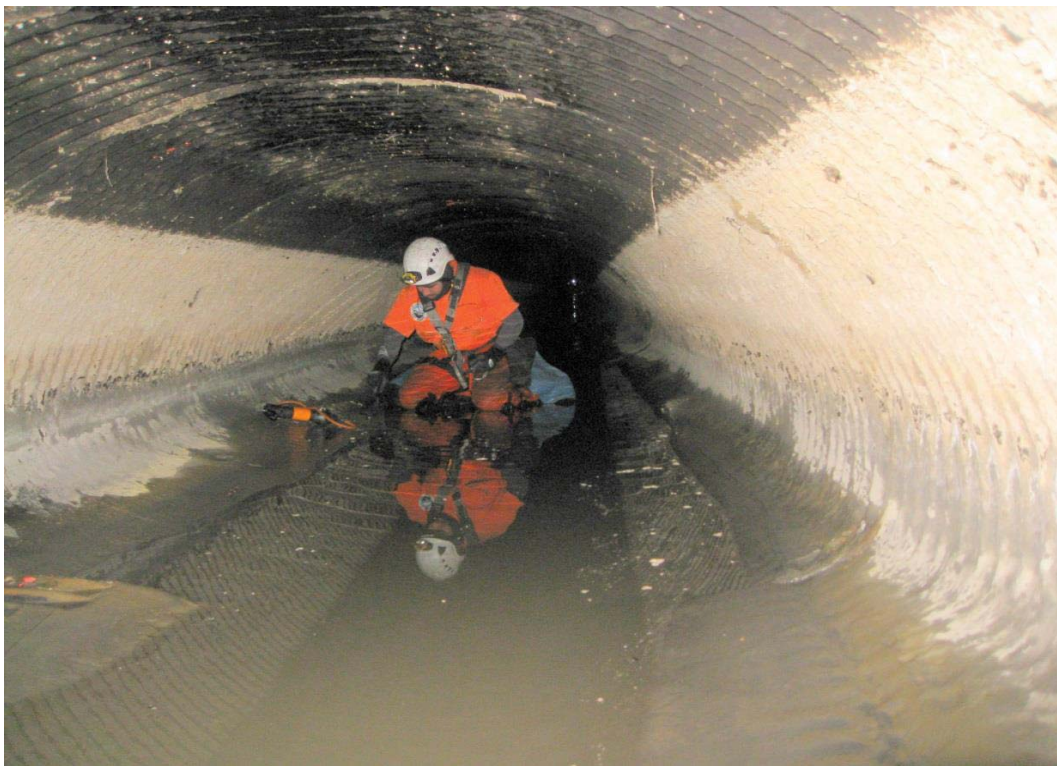
Photo 77

Drain B - 495' looking back at 484'.  
View upstream. Ultrasonic testing and coating removal.
